**REPORT OF AN INVESTIGATION
INTO AN INCIDENT INVOLVING THE
FISHING VESSEL BIKAIN
AT DINGLE, CO. KERRY,
IRELAND
25 NOVEMBER 2022**

**REPORT NO. MCIB/323
(No.6 OF 2023)**

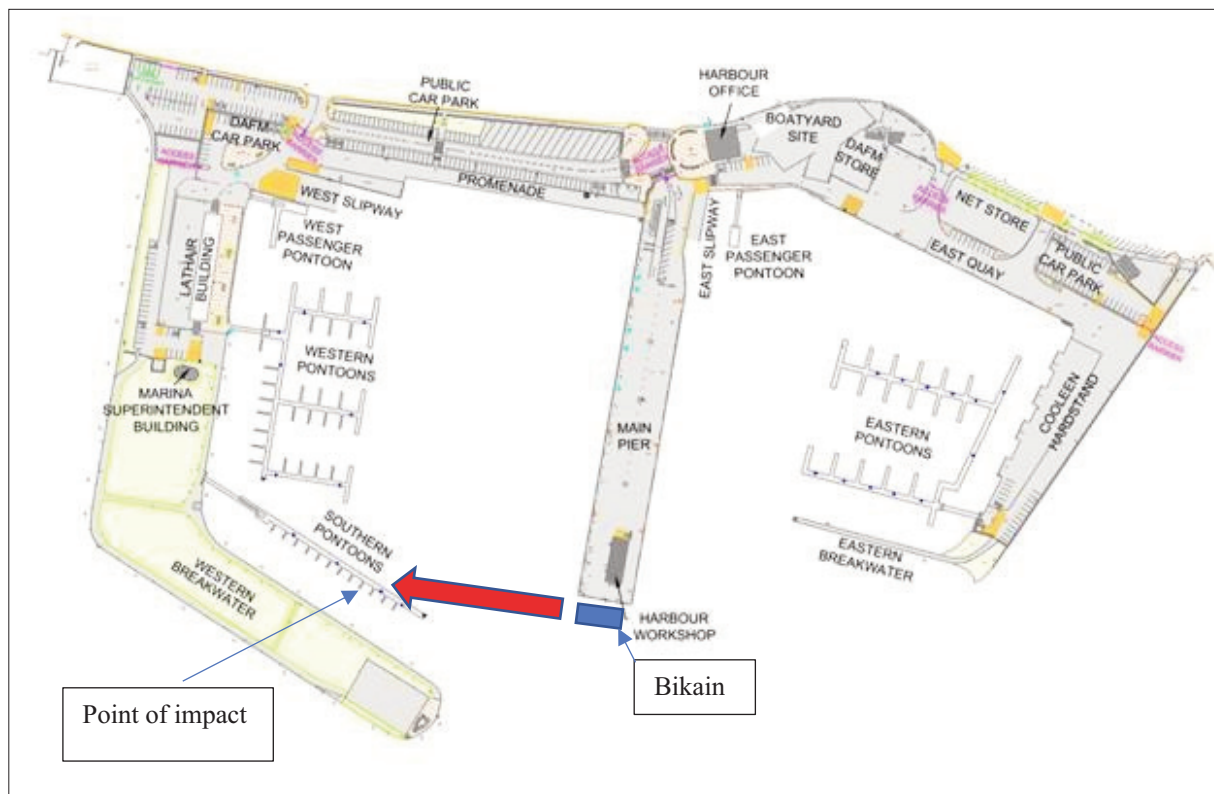
Dingle Harbour showing Location of FV Bikain at the Main Pier and Impact Point on Southern Pontoons.
