**REPORT OF AN INVESTIGATION  
INTO AN INCIDENT INVOLVING THE  
FISHING VESSEL  
AN PORTÁN ÓIR  
DINGLE BAY, CO. KERRY  
14 OCTOBER 2022**

**REPORT NO. MCIB/322  
(No.5 OF 2023)**

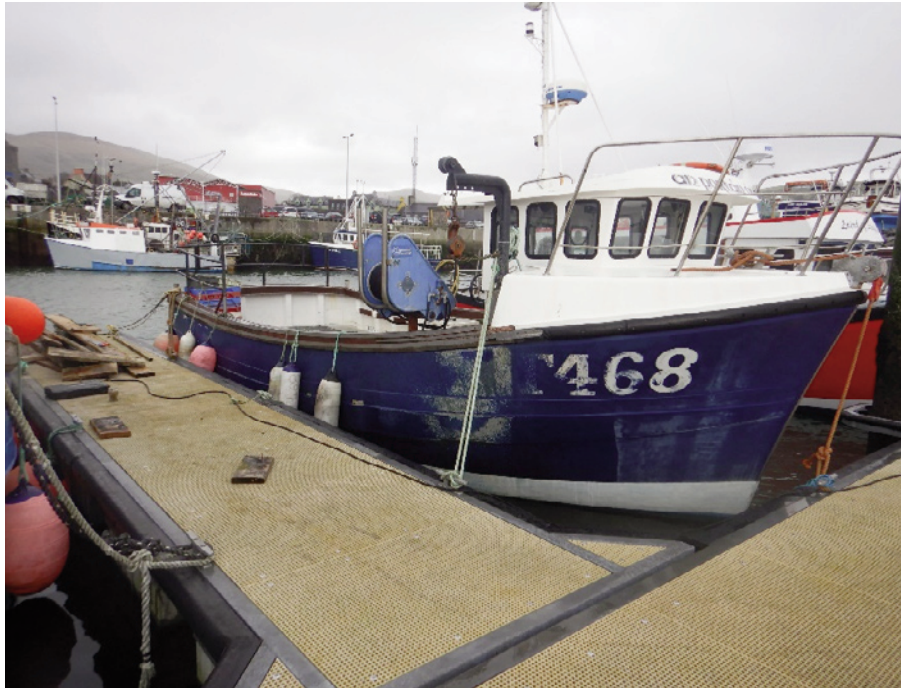
FV An Portán Óir was a glass reinforced plastic (GRP) hulled, decked fishing vessel with forward wheelhouse and an inboard diesel engine. There was a pot hauler fitted starboard forward side and open fishing deck aft.

Boat in Dingle January 2023.

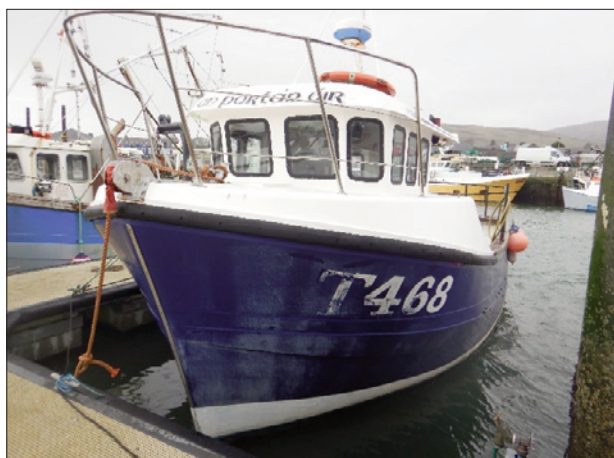
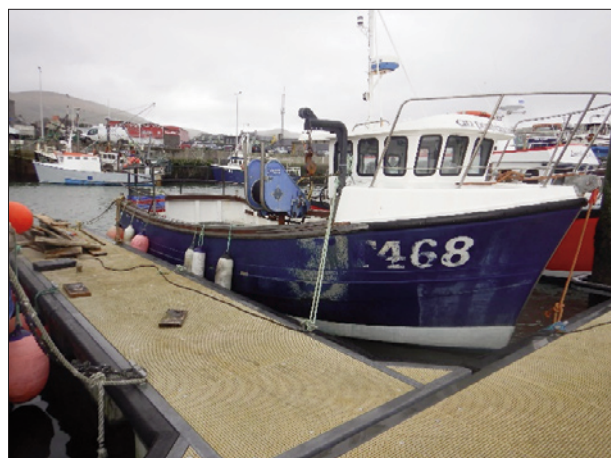
- 3.15 The boat was inspected and there were no damages or defects noted and the boat was found to be in good condition.

Boat Alongside in Dingle.

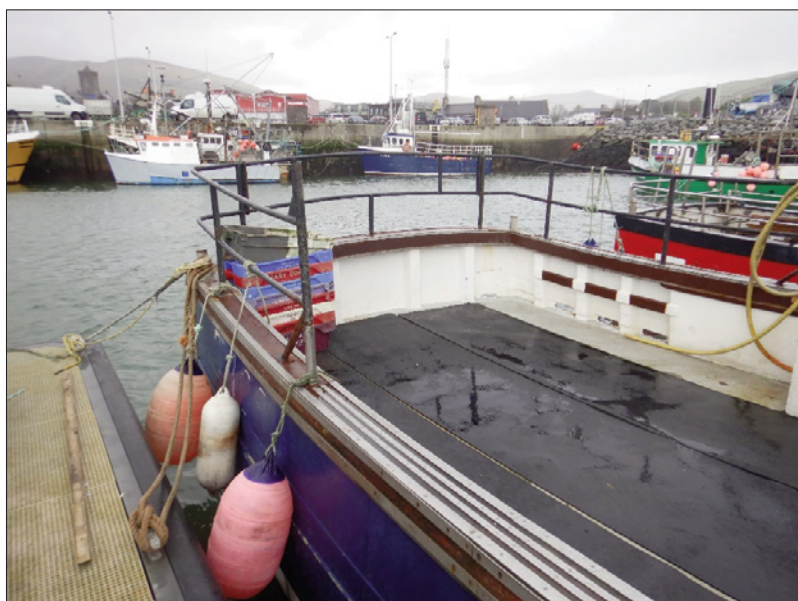
- 3.3 The boat had been fitted with a raised wooden table across the stern and up the port side for shooting the pots. This was level with and protruded over the rails aft.

- 4.5 The Skipper normally had a knife tied to the rails aft, but this had been removed during painting and had not been replaced. This missing knife was a major factor in the Skipper being unable to free himself.

Deck aft with Potting Table Removed.

- 6.1 The Minister for Transport should issue a further Marine Notice reminding owners and operators of fishing vessels of the dangers associated with fishing alone, and of the importance of wearing approved Personal Flotation Device/lifejacket and Personal Location Beacon at all times while on deck. This should also include recommendation that lone fishers always have a suitably protected knife on their person while on deck during fishing operations, especially during potting operations. Knives can also be secured at locations on deck to be available quickly in case of entanglement.
