**REPORT OF AN INVESTIGATION
INTO AN INCIDENT
INVOLVING THE FISHING VESSEL
AQUILA
OFF THE CO. CORK COAST
7 NOVEMBER 2021**

**REPORT NO. MCIB/312
(No.1 OF 2024)**

Report MCIB/312 published by the Marine Casualty Investigation Board.
30th January 2024.

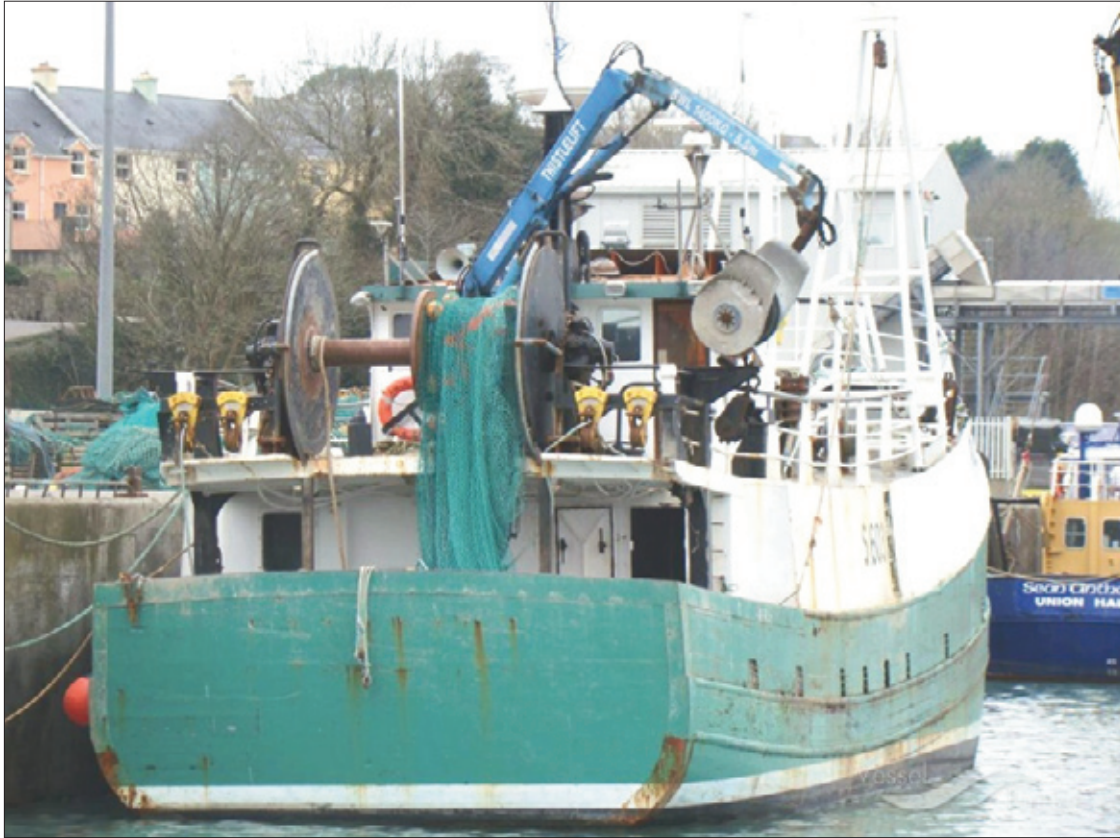
Aquila stern view showing net drum, net handling crane and Gilson frame over the bag hatch for lifting in cod end.

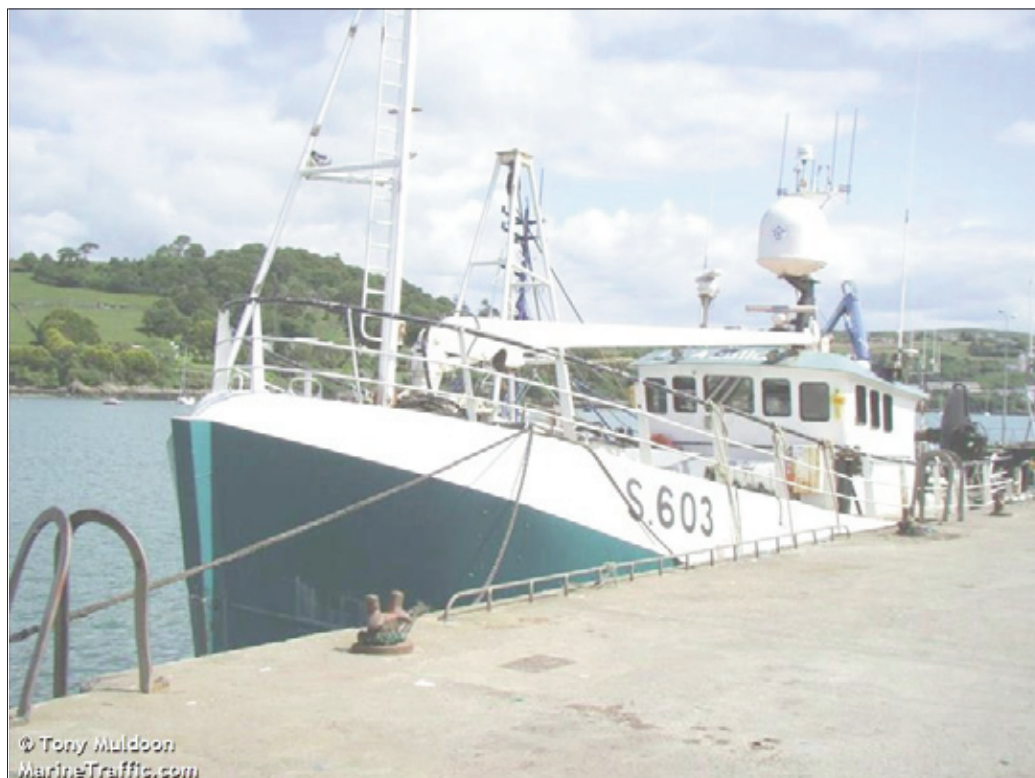
Photograph showing Gilson frame, starboard side, for lifting in the cod end and centre line deck crane for unloading catch.

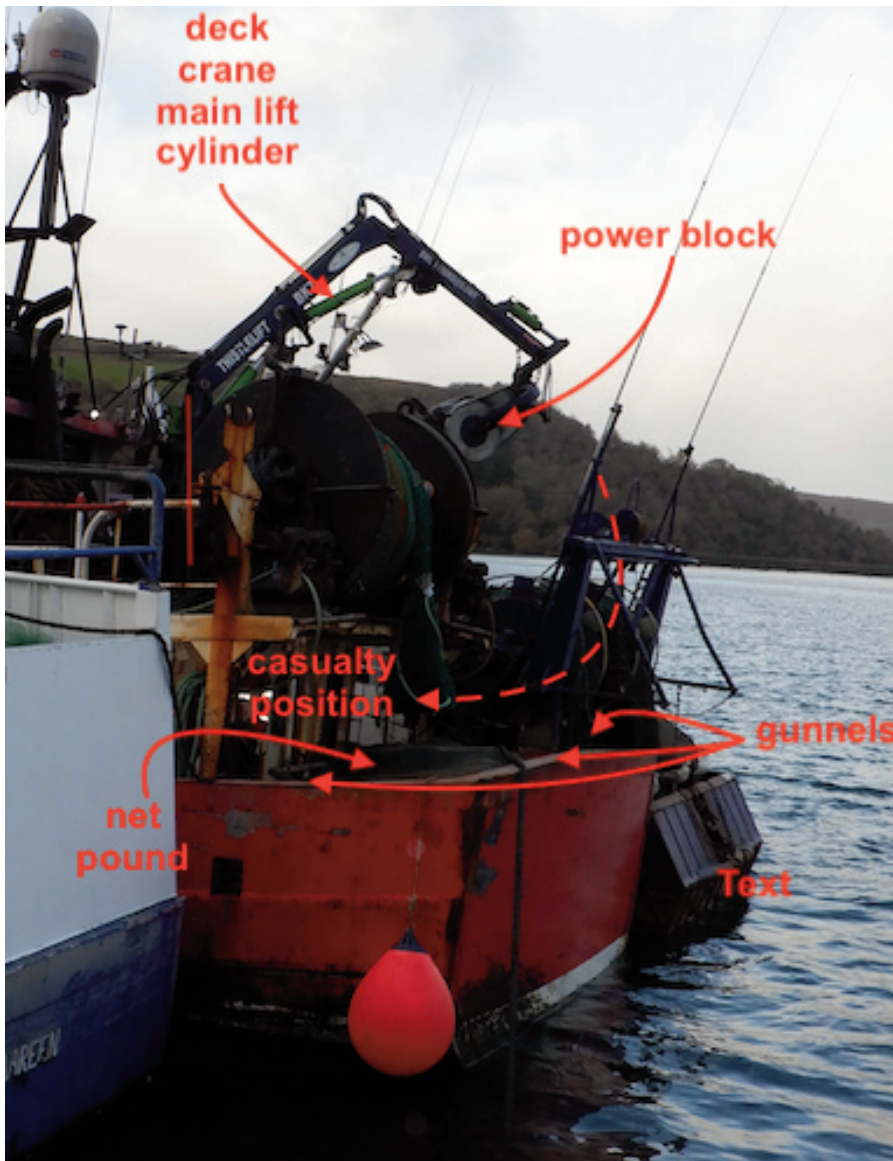
Appendix 7.5 Stern Arrangement

- 2.2 FV Aquila had modifications carried out in 2017 when the net handling crane position was moved slightly forward by approximately 0.5 m. The net drum was also moved slightly forward by 0.5 m. Both changes were to improve the working

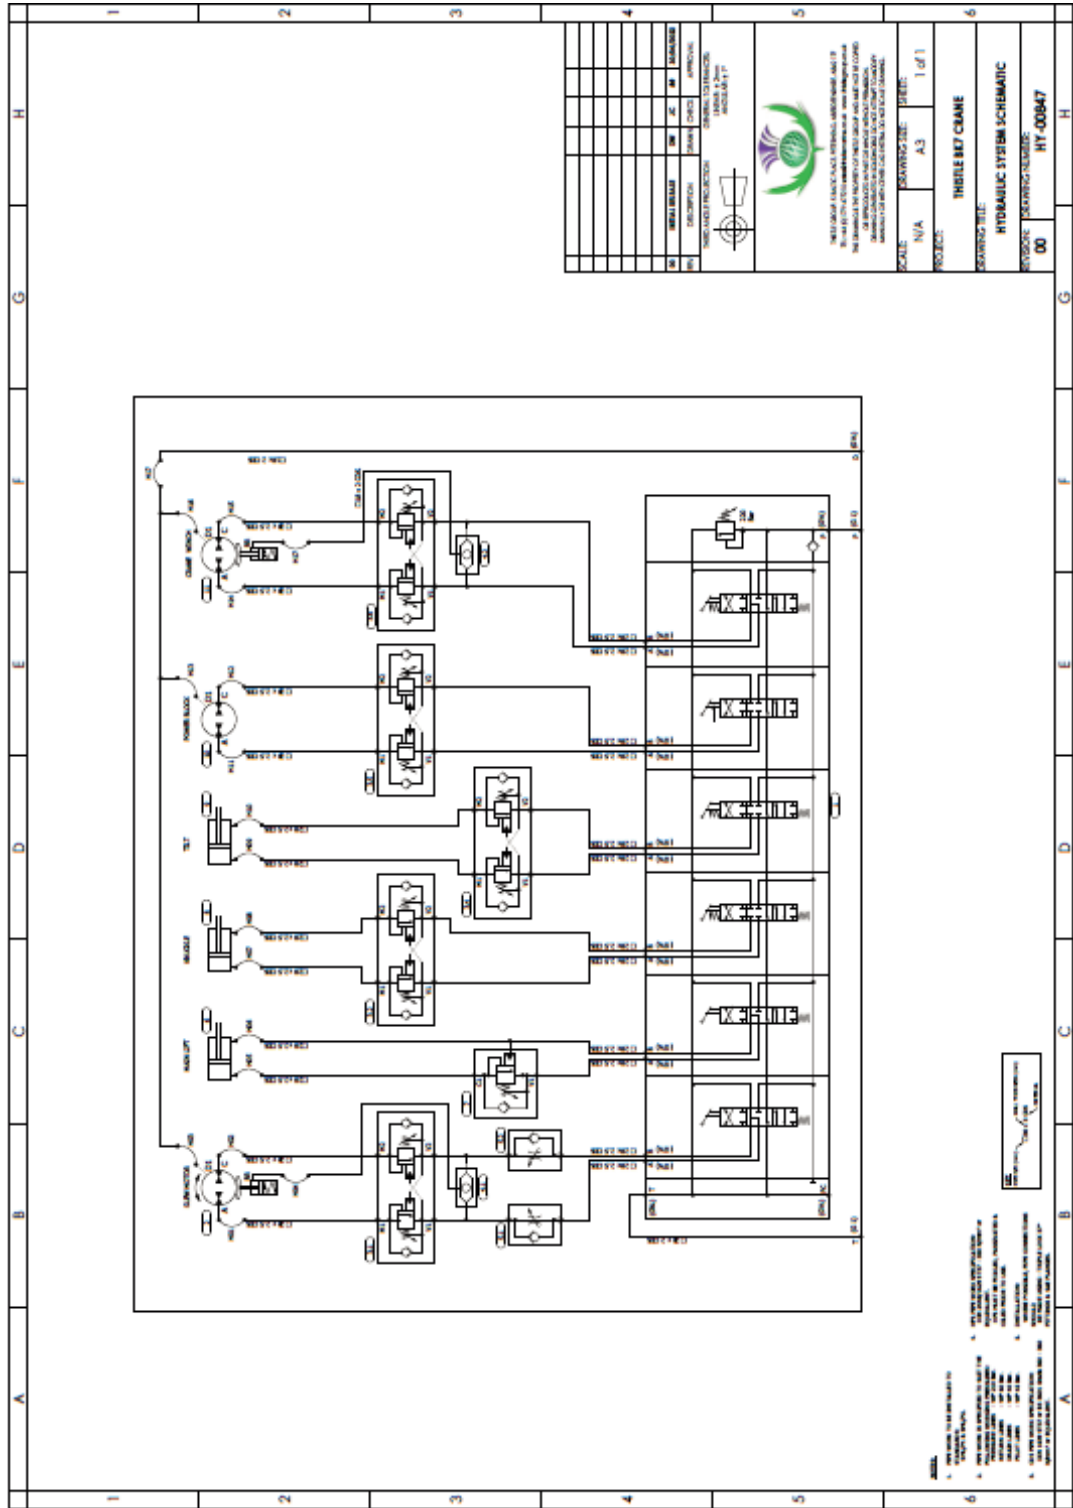
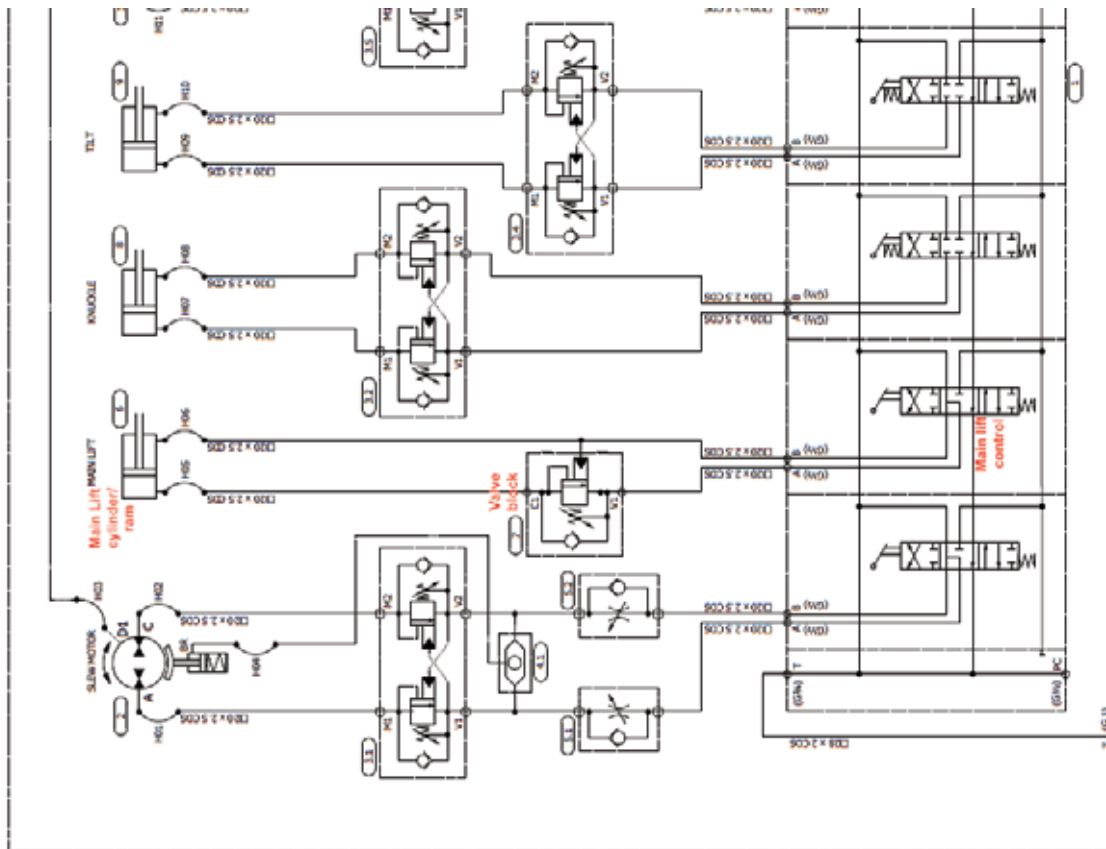
Appendix 7.11 BK7 Hydraulic System Schematic Drawing - HY-00847

- See Appendix 7.11 - BK7 Hydraulic System Schematic Drawing - HY-008474.4.1.
- 4.6.1 Over-centre valves function as check valves locking hydraulic pressure within the ram cylinders in the event of a flexible hose burst or hydraulic system pressure failure and prevents unintentional movement or lowering of the crane's load due to slippage of the hydraulic rams within their respective cylinders when hydraulic pressure is lost.

- 4.6.3 The MCIB learned from the manufacturer that if the steel pipework (including the threaded connectors) between the cylinder and valve block (containing the over centre valve) was intact, without leaks at the connections, and the hydraulic system was free of solid particle contaminants, then, in the event of an interruption in the crane's hydraulic pressure system (for instance a burst flexible hose, electrical failure or hydraulic pump failure), hydraulic oil under pressure was designed to be trapped within the three crane cylinders by their respective over-centre valve and the rams would not move or slip inside the cylinders and the crane's load would remain supported. The over-centre valves are a safety design feature to avoid the crane dropping or lowering its load if the hydraulic pressure system was interrupted.

- 4.6.4 However, if there were small parts of solid particle contamination (rubber, etc.) lodged in the valve or an oil leak or pipe break between the cylinder port and the valve block, then the function of the over-centre valve would be circumvented, and any loss of oil pressure would cause the ram to move or slip inside the cylinder and the crane lower its load. The system was inspected routinely by the crew and/or regularly serviced by a professional marine engineering firm. The oil system had no history of contamination. The likelihood of contamination within the hydraulic system was remote. Contamination of the hydraulic oil system was not considered to be a factor in the incident.

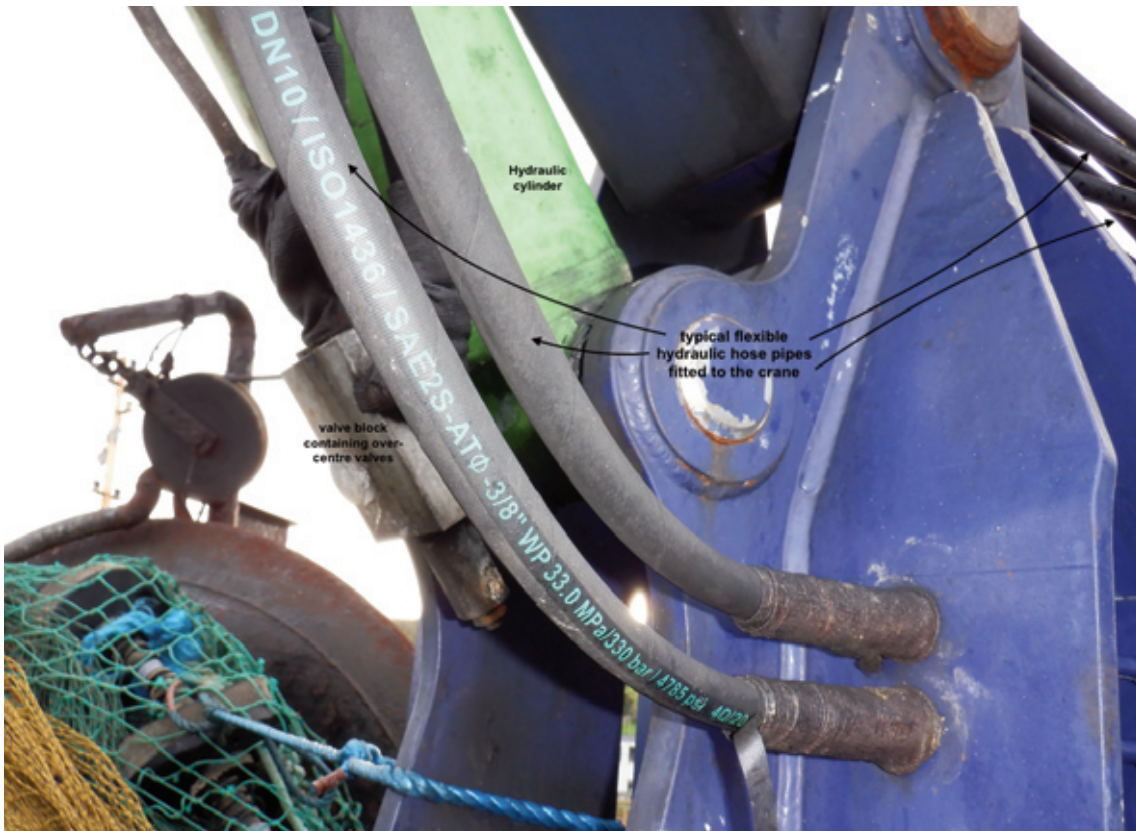
Appendix 7.12 Typical Hydraulic Flexible Hoses Fitted to the Deck Crane

- 2.7.4 Flexible hydraulic hosepipes are fitted to the cylinder valve block steel pipe connections at all knuckle and pivoting points. These flexible hosepipes connect the crane's working parts to the hydraulic circuit and control lines and due to their flexible nature are prone to kinking, perishing of surface materials and bulging. Regular inspections and service routines reduce the risk of hose failures.

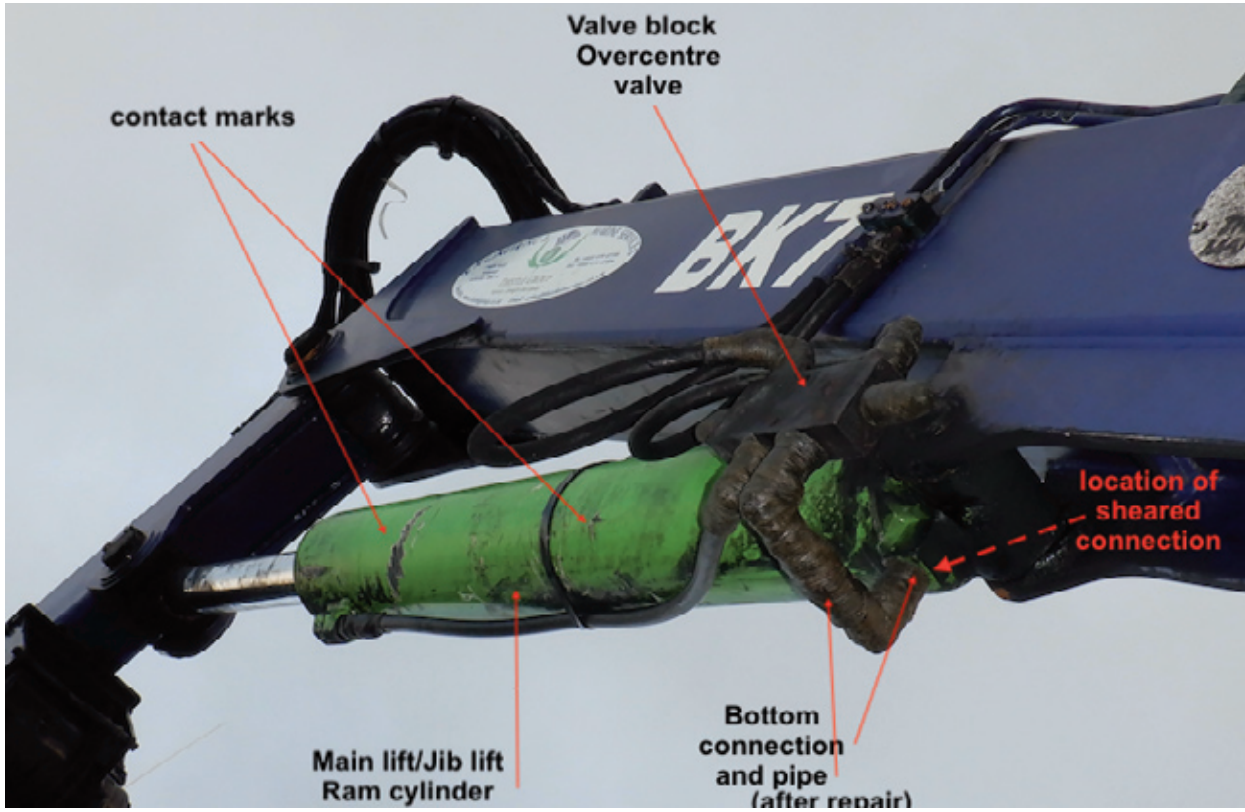
Appendix 7.16 Main Lift Cylinder - After Repairs

- 3.6 On the vessel docking at the fishing port of Union Hall the crane and hydraulic system was examined by the proprietor of the marine engineering firm who had previously carried out maintenance to the vessel's hydraulic system. The proprietor recalled that when he arrived to the vessel, he found that the crew had plumbed in flexible hydraulic hoses to the main jib lift cylinder as a temporary repair to enable operation of the crane and recovery of the net. He surmised that in order to plumb in the flexible hydraulic hose the crew had removed and replaced the threaded connector between the main cylinder and its lift side valve block because the original part was sheared off flush to the cylinder's lower outside surface. There were signs of heavy mechanical contact to the main lifting cylinder barrel surface in the form of large scrapes to it.

- See Appendix 7.16 - Main Lift Cylinder - After Repairs.
- 4.6.6 Given the exposed position of the lower lift ports valve block underneath the main lift cylinder, and that the valve's steel connection parts to the cylinder required replacement due to mechanical damage, it is deduced that the location of the main cylinder valve block underneath the main hydraulic cylinder exposes the valve block and its associated steel pipework to mechanical damage and is considered to be a possible causative factor to this incident.

- 5.1 The incident occurred as a result of loss of fluid from the main jib hydraulic cylinder which occurred between the cylinder and the check valve.
- 5.2 The position of the main cylinder valve block underneath the main hydraulic cylinder exposes the valve block and its associated steel pipework to mechanical damage.

- 3.7 The proprietor carried out essential repairs to restore the crane to its design parameters by replacing the threaded connection between the main cylinder lower port and the steel pipe connecting the cylinder port to the over-centre valve block. When he completed the replacement of the connector and re-installed the valve block and steel pipe, he checked the crane's operation. The main lift cylinder and valve block and its over centre valves were found to be operating correctly. He carried out a system check and found all system components were functioning. The crane was operating correctly and in no need of further repair.

- 6.1 The manufacturers Thistle Group Limited trading as Thistle Marine should review the pipe connecting arrangements of the valve blocks onto the hydraulic cylinder ports on the BK7 model of marine cranes with a view to reducing the risk of mechanical damage causing oil leaks and sudden loss of hydraulic pressure in the operating hydraulic cylinders. Risk mitigation measures such as fitting valve block guards or relocation of the valve block safety mechanisms should be considered.

- 6.2 The manufacturers Thistle Group Limited trading as Thistle Marine should review the threaded pipe connecting arrangements and, as with hydraulic hoses, recommend an inspection and replacement regime with original equipment manufacturer approved parts.
