**REPORT OF AN INVESTIGATION
INTO A MARINE CASUALTY
INVOLVING THE FISHING VESSEL
ARDENT**

**EAST OF PORT ORIEL,
CLOGHERHEAD, CO. LOUTH**

31 OCTOBER 2022

**REPORT NO. MCIB/320
(No.2 OF 2024)**

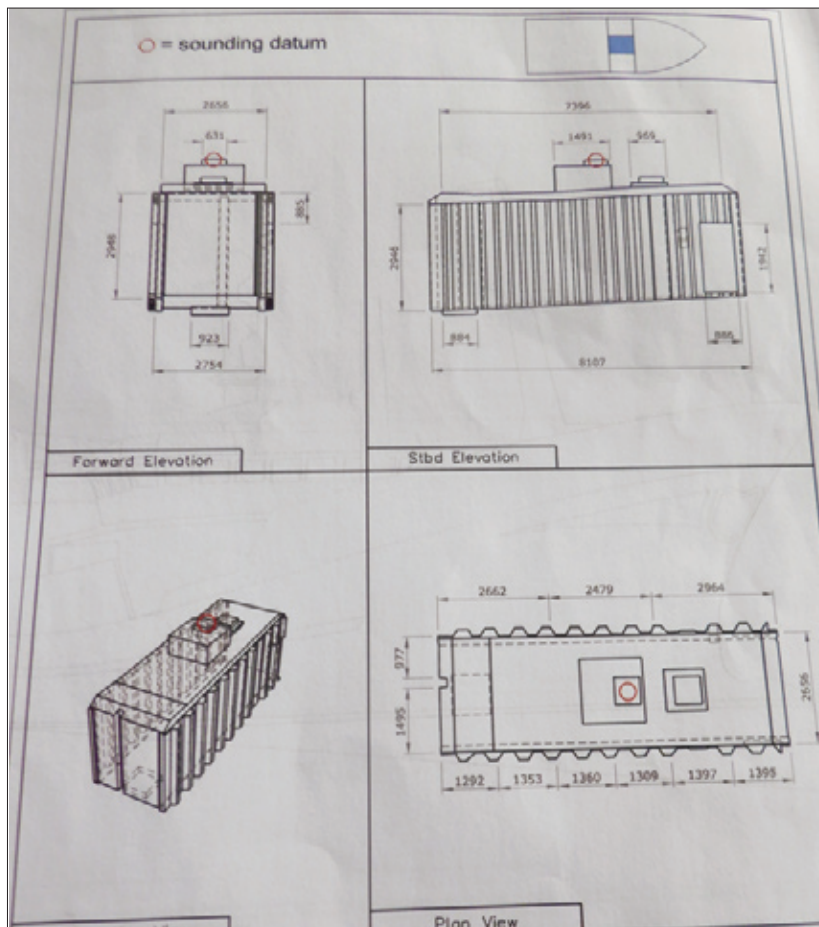
Figure 1- Centre Tank Dimensions and Details

Recorded figures for all seawater pipes, catch suction pipes and diffusers within each tank:

Port m ³	Centre m ³	Starboard m ³
Volume – m ³	0.843	0.929	0.767
% of Tank Volume	1.6	1.3	1.4

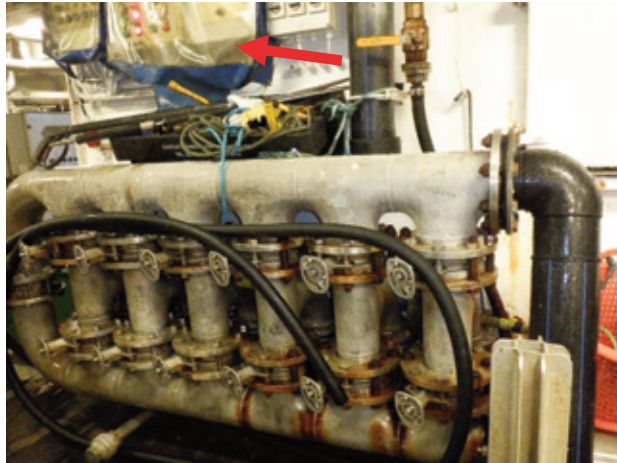
Picture No.1 Valve Chest

The outboard tanks were first to be cleaned with the Skipper opening the required valves (Picture No.1) and operated the pump to flush water into the tanks. The flushing requires the pumping of water to the upper and then lower diffuser while discharging the water via a bilge pump fitted in the engine compartment but operated via the deck panel (red arrow Picture No.1).

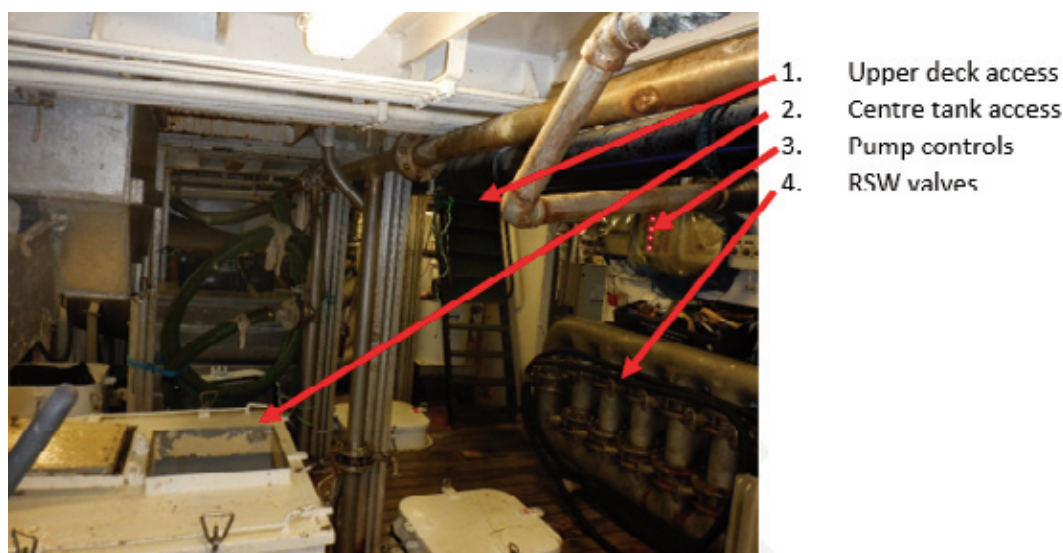
Picture No.3 RSW Tank Access and Valve Chest

- 3.3.3 Noticing a number of fish on the tank sump Crewmember (A) proceeded to the aft section of the tank passing below the internal tank boards to collect the remaining fish and material. Having collected three to five fish, Crewmember (A) then proceeded forward to exit via the tank ladder that is approximately five metres away from the tank aft bulkhead. While passing below the baffle boards in the centre of the tank Crewmember (A) placed the bucket on the tank floor. While maintaining contact with the bucket handle, he lowered his upper body and head towards the bucket, placing some weight on the handle for support while passing below the boards. Maintaining a hold on the bucket Crewmember(A) then stood upright. When standing upright Crewmember (A) immediately knew something was wrong and he was in trouble and noted “*feeling a burning sensation in his head*”. Crewmember (A) attempted to reach the ladder while calling for assistance from the Skipper on the deck above. At this point Crewmember (A) lost consciousness.

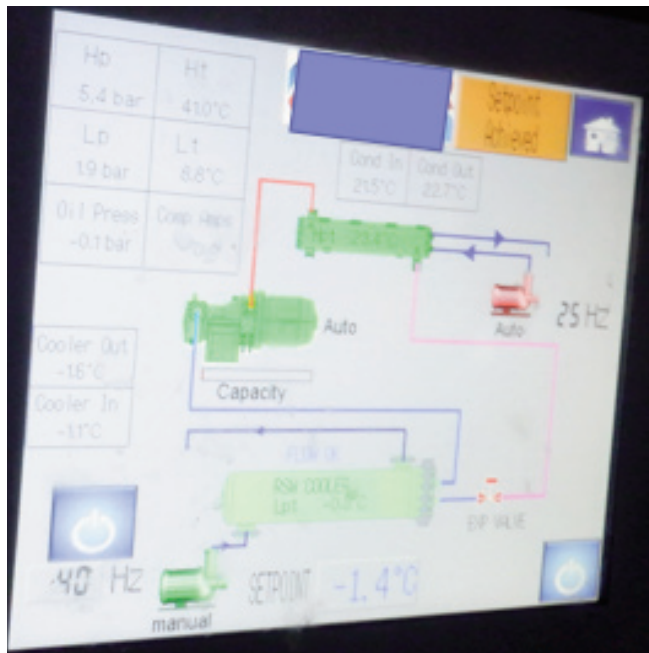
The RSW refrigeration system was monitored and fitted with alarms to indicate system failure or operational alarm status state. On review of the refrigeration system data logger page on the status screen, no alarm status or fault was noted on the 31 October 2022 (see Appendix 7.9 - Additional Photographs Picture No.5 and No.6).

Picture No.5 RSW System Status Screen (during visit 6 November 2022)

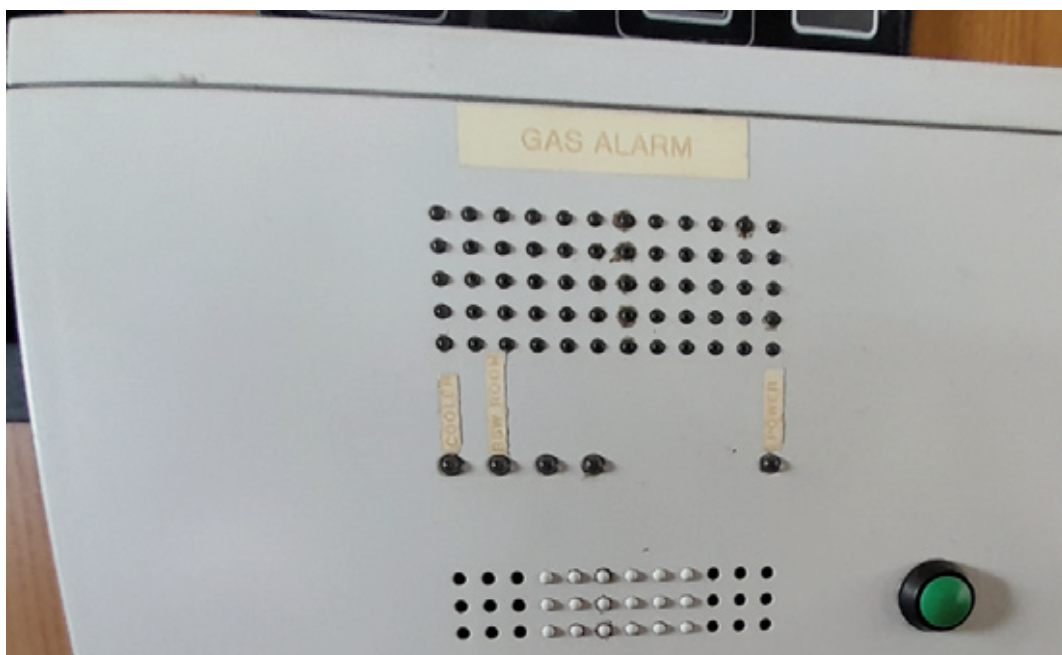
Picture No.7 Vessel Gas Alarm System

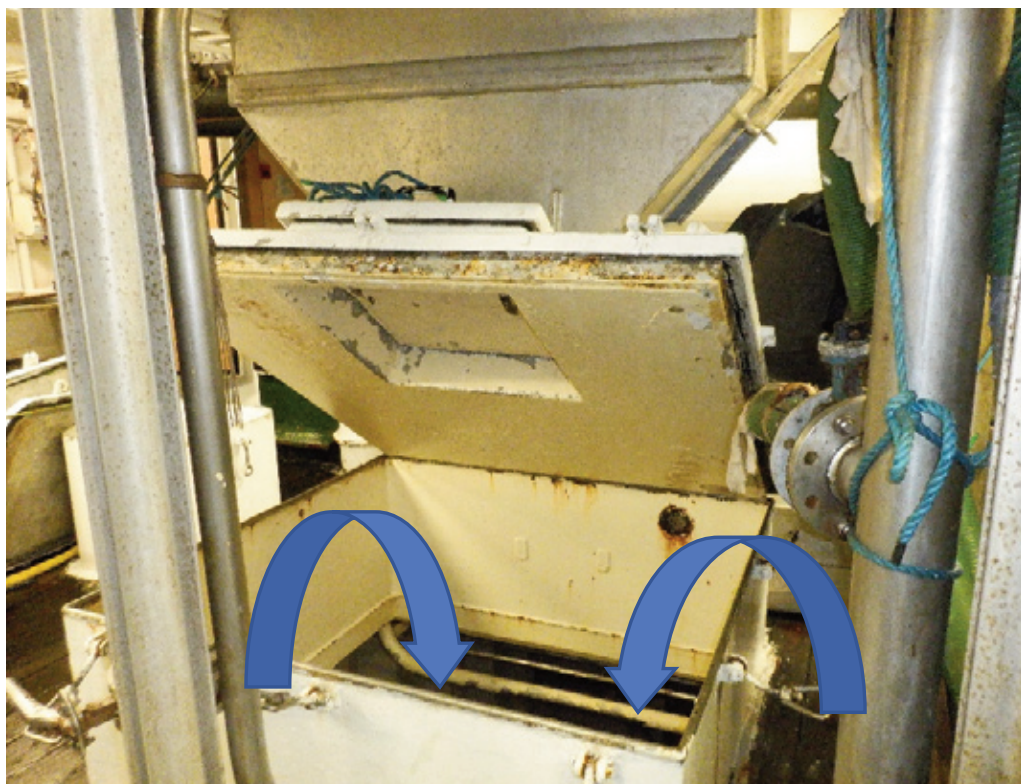
The actions taken by the crewmembers including the opening of additional hatches and vents would have provided additional ventilation below decks (see Appendix 7.9 - Additional Photographs Picture No.8 and No.9).

Picture No.9 Main Hatch Opened to Increase Air Flow
