**REPORT OF AN INVESTIGATION INTO
A MARINE CASUALTY INVOLVING
MULTIPLE ROWING VESSELS
IN OR AROUND SALMON WEIR,
RIVER CORRIB,
CO. GALWAY
14 JANUARY 2023**

**REPORT NO. MCIB/325
(No.4 OF 2024)**

- 1.4 The University of Galway Boat Club experienced this marine casualty event because of a combination of the following causal factors:
 - a. Unsuitable weather conditions.

- b. Unsuitable river conditions.
 - c. Inadequate trip planning.
 - d. Inadequate safety systems.
 - e. Unsuitable Rules of the River.
 - f. Unsuitable weir safety booms.

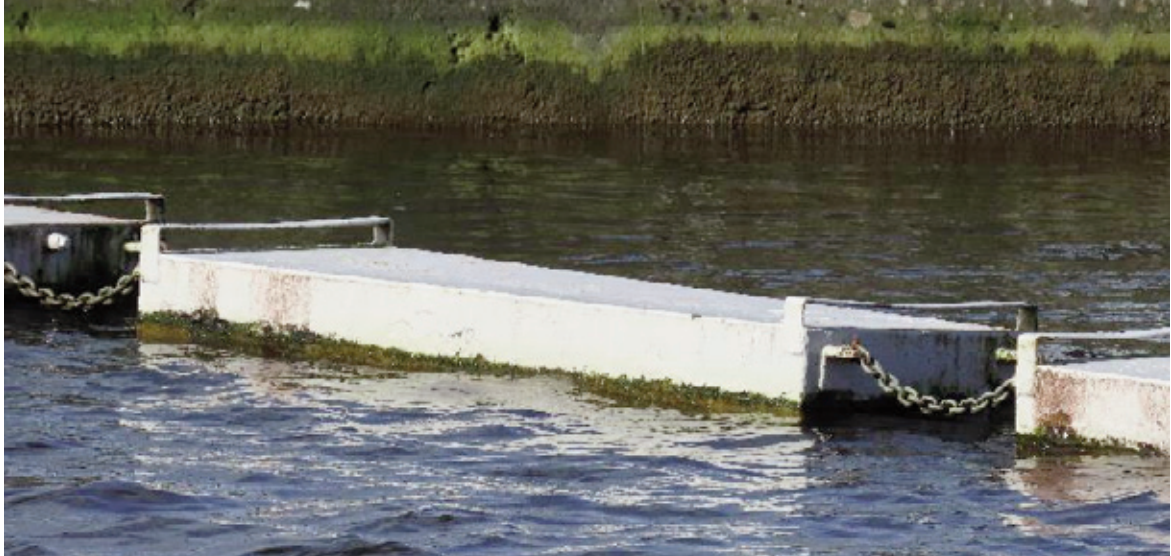
Figure 14: Example of the safety boom in place above the weir.

2.4.8 When these safety booms were installed in the 1980s the old railway bridge piers from a defunct Victorian era railway line were utilised as fixings points for the chains/supports for the safety booms. See Figures 15 and 16. As the railway bridge had crossed the river at right angles, the use of the railway bridge piers as the safety booms' anchor points created a physical barrier at right angles to the river. The safety booms are also anchored with chains to the river bed. This arrangement means that the section of safety booms across the middle part of the river are enclosed on both sides by the walls of the bridge piers, and the safety booms have sagged downstream. This means that objects or persons entering onto this part of the safety booms can only progress downstream into the weir or await human extraction back upstream against the flow; they cannot extract themselves. This is the situation that occurred during this casualty event.

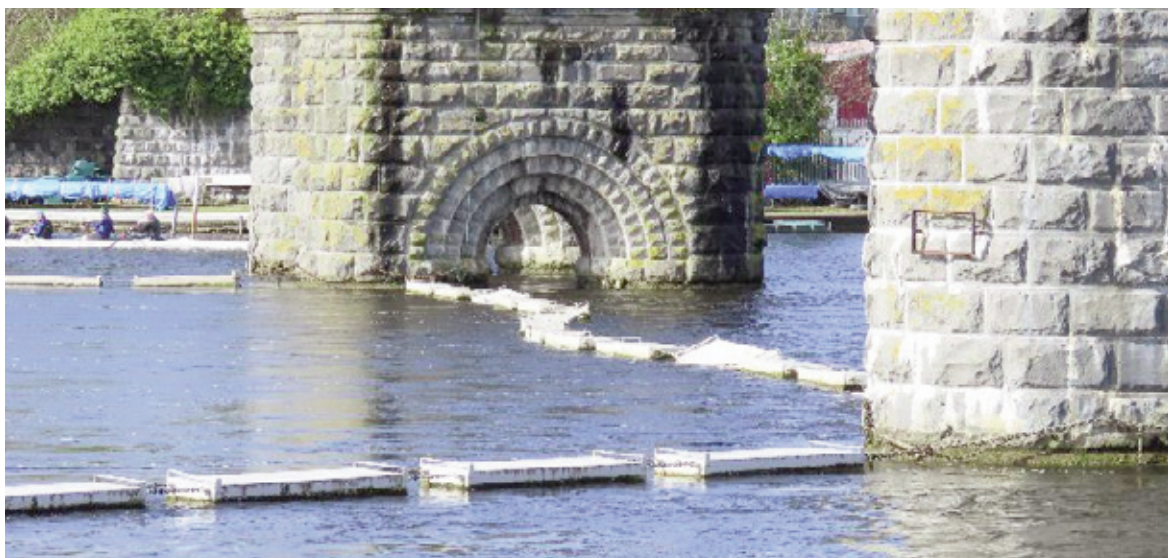
Figure 15: The safety boom protection, 100 m upstream from the Salmon Weir.

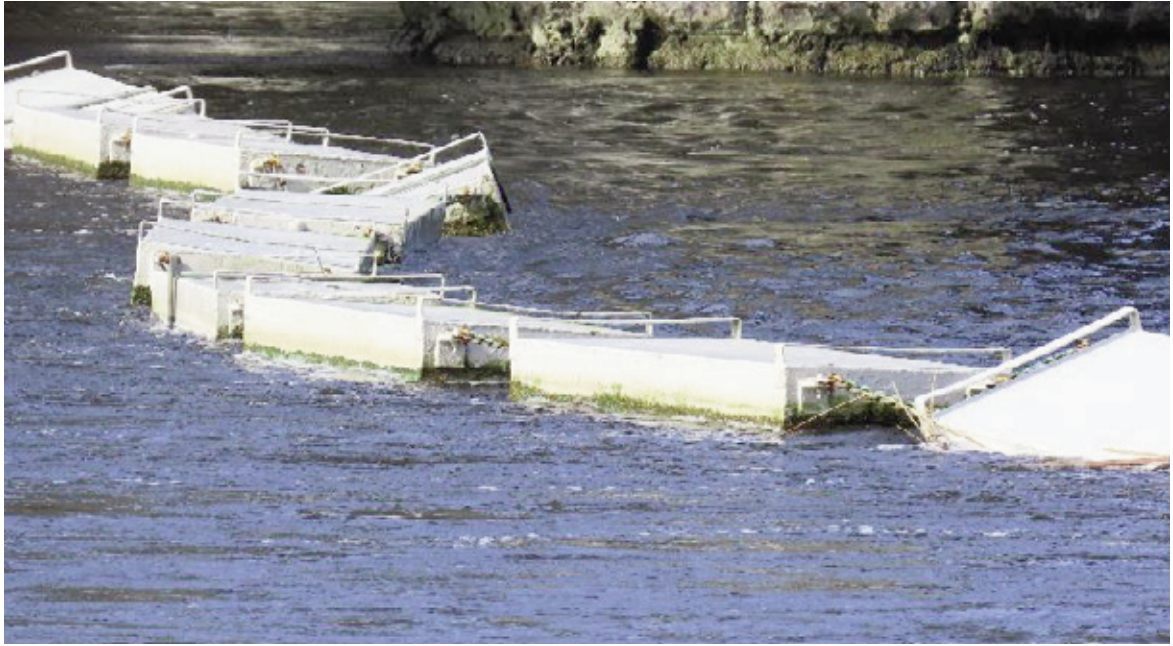
Figure 16: The safety boom protection, 100 m upstream from the Salmon Weir.

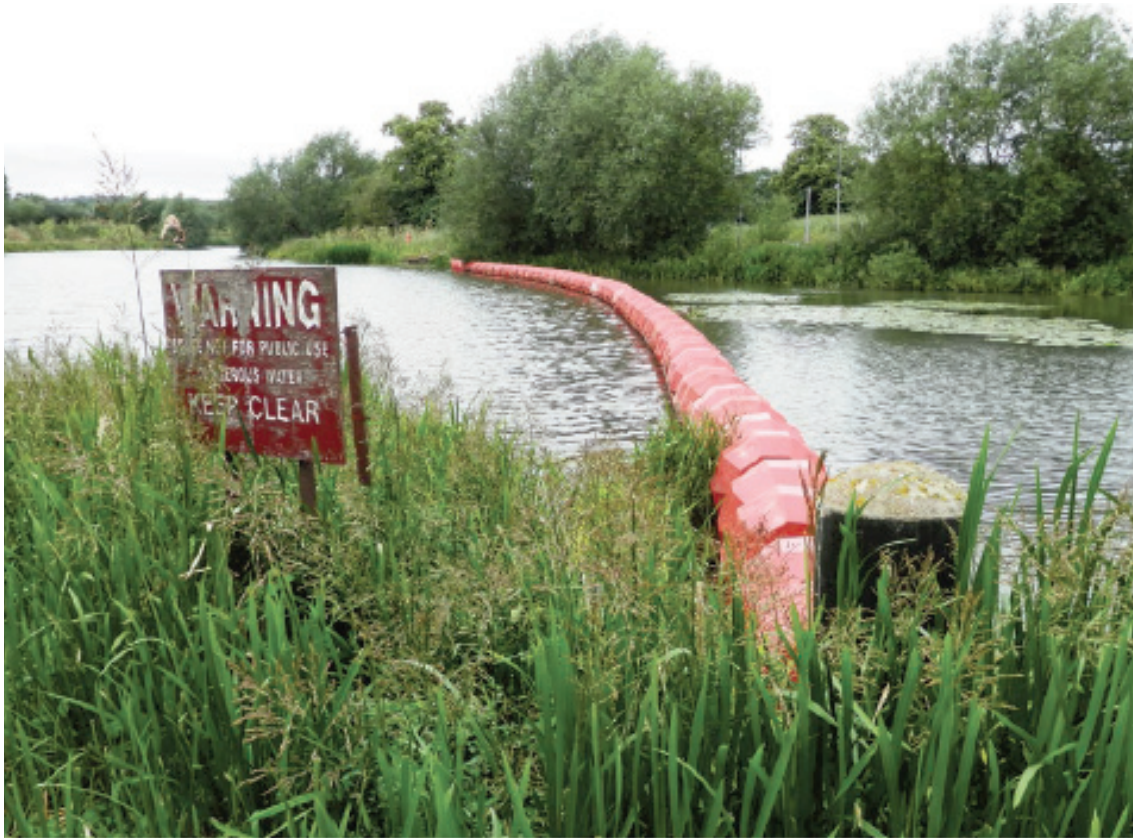
- 2.4.9 On the subject of physical barriers at a weir, modern authoritative guidance¹⁷ recommends that safety booms are installed at an oblique angle relative to the river's direction of flow, not at right angles. See Figure 17. This guidance states that:

Figure 17: Recommendations relating to the alignment of safety booms relative to the direction of water flow. Source: Figure 10.6a, *River Weirs: Design, Maintenance, Modification and Removal*, Construction Industry Research and Information Association, 2016.

- a A safety boom upstream of a weir should be installed at an oblique angle to direct debris towards one bank where it can be removed.

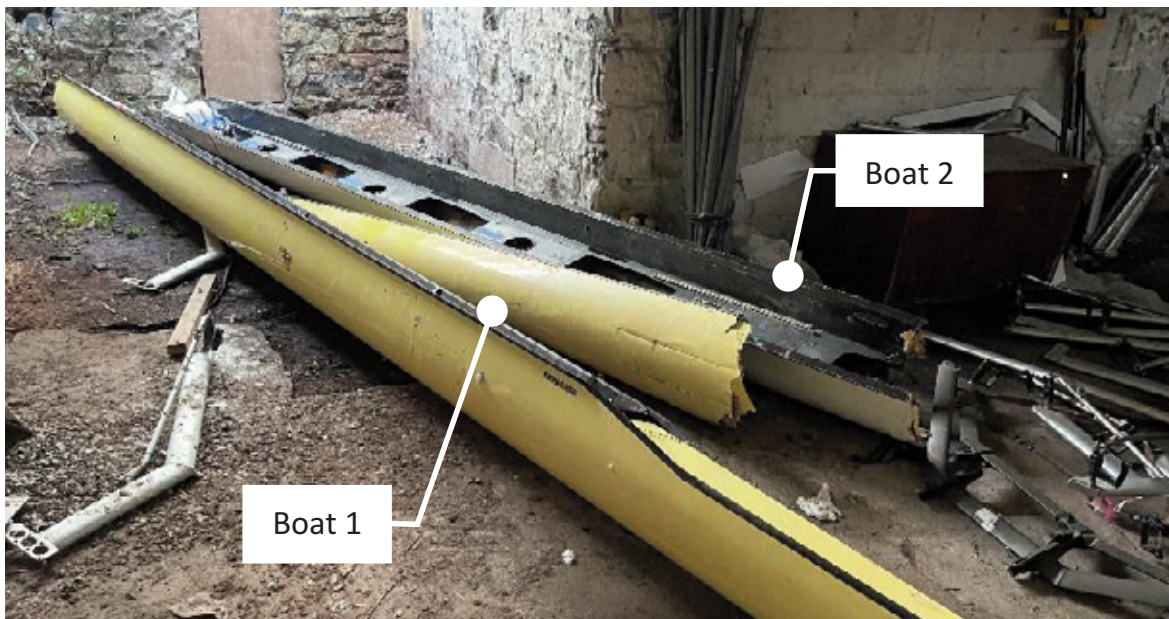
2.6.2 These two rowing boats were damaged beyond repair by this marine casualty event. The partial remnants of these boats were taken from the river and put in temporary storage in the University of Galway Boat Club. See Figure 18.

Figure 18: The remnants of the two rowing boats involved in this casualty event.

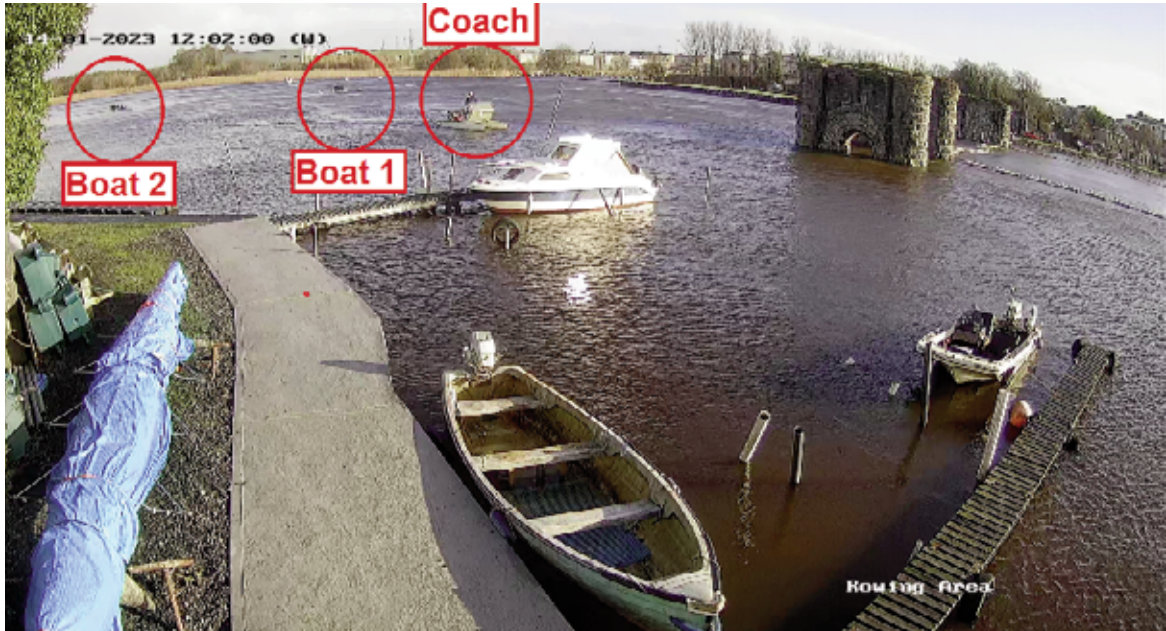
2.14.9 **Time stamp 12:02:00** - The coach's launch boat is ahead of the group, followed by Boat 1 and then Boat 2. The trees in leaf are swaying in the wind. Gusts of wind are visible across the water surface, blowing in a westerly direction (from the bank out across the river towards the opposite side). See Figure 29.

Figure 29: CCTV still image at time stamp 12:02:00, showing the respective positions of the vessels from the University of Galway Boat Club. Source: CRYC

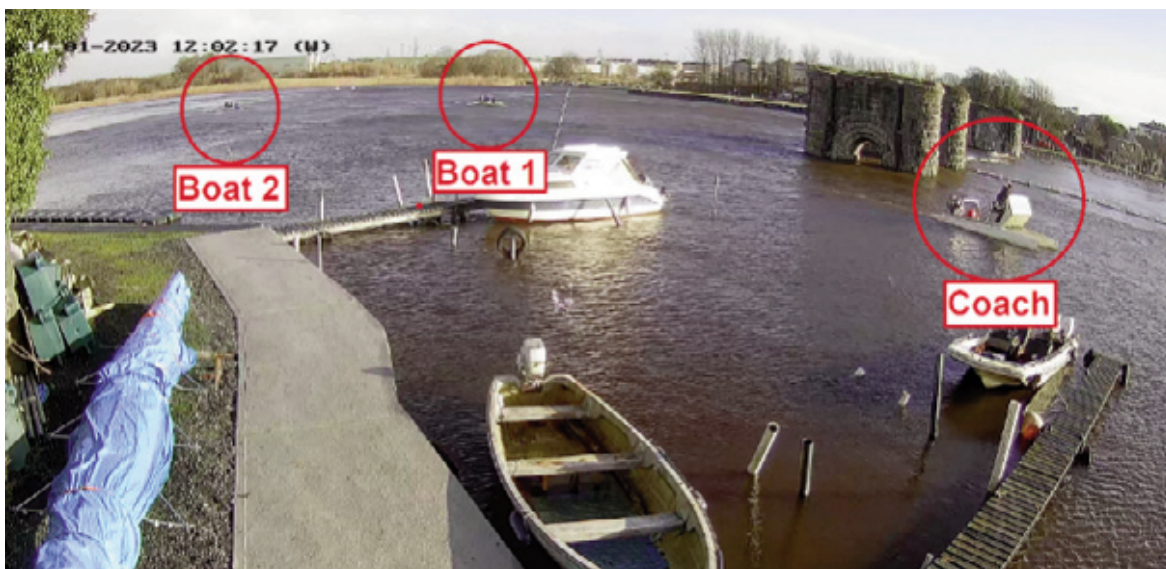
2.14.10 **Time stamp 12:02:17** - 17 seconds has elapsed. The coach's launch proceeded downstream of the old railway piers while Boat 1 and Boat 2 continued on their downstream course towards the piers' safety booms. The swaying trees and wind gusts continue. The rowing boats are on a direct course for the safety booms but the crews are not taking effective action to divert their course. See Figure 30.

Figure 30: CCTV still image at time stamp 12:02:07, showing how the coach's launch proceeded downstream of the safety booms while the two rowing boats continued on their course towards the safety booms Source: CRYC

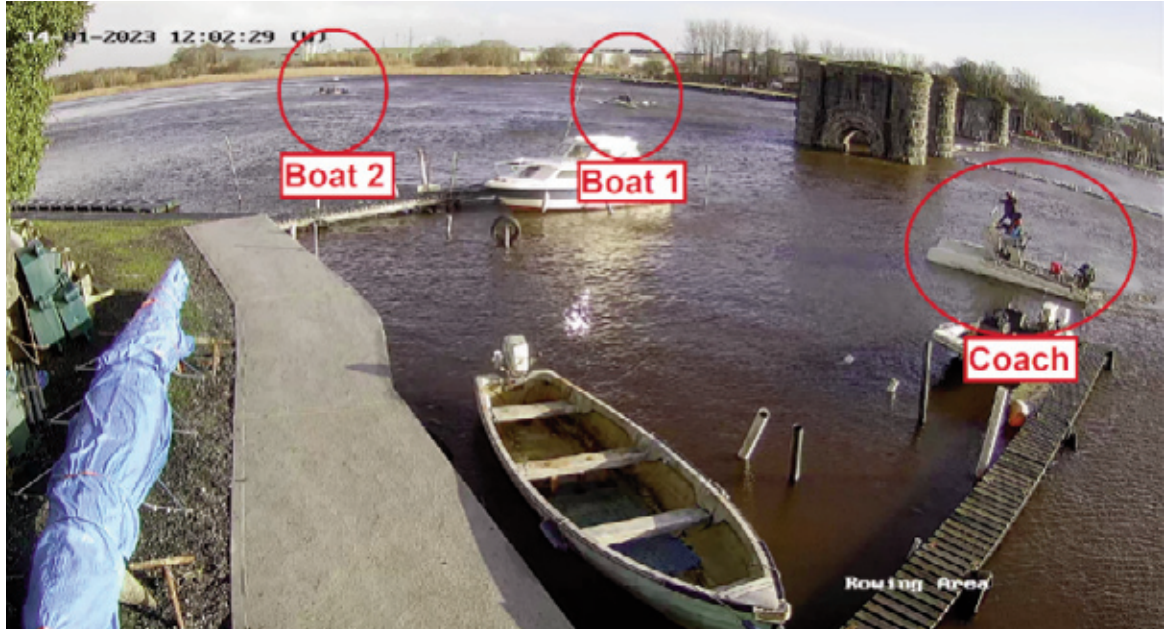
2.14.11 **Time stamp 12:02:29** - A further 12 seconds has elapsed. The coach realised the impending situation and turned her launch boat to progress back upstream. Boat 1 and Boat 2 continued on their downstream course but the crews are not taking effective action to divert their course. See Figure 31.

Figure 31: CCTV still image from time stamp 12:02:29, showing how the coach had realised the impending situation and had turned her launch boat to progress back upstream. Source: CRYC

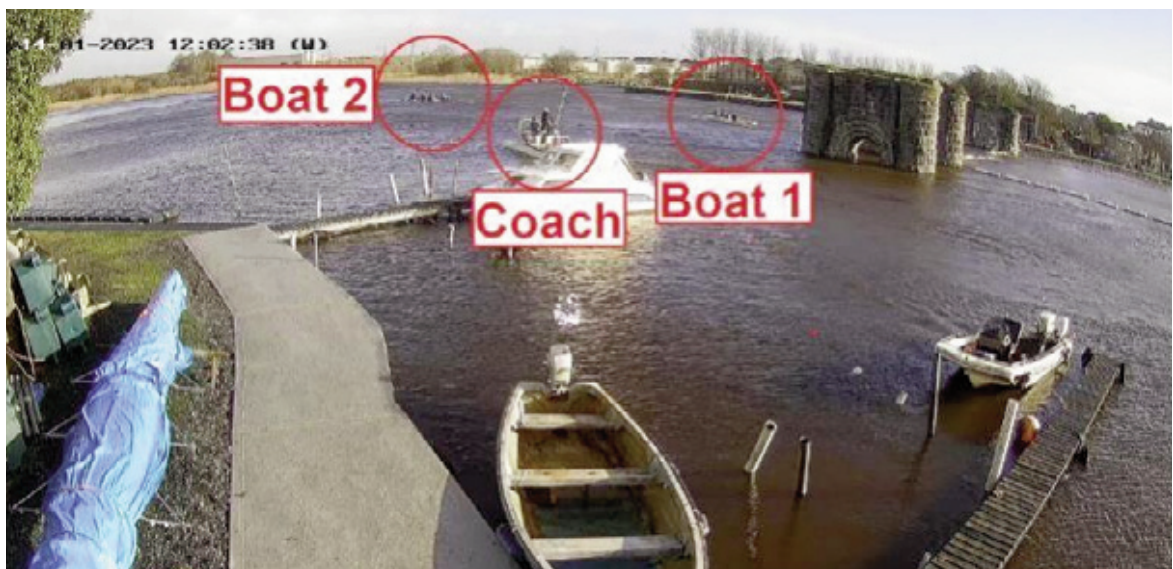
Figure 32: CCTV still image from time stamp 12:02:39. Source: CRYC

2.14.12 **Time stamp 12:02:38** - A further seven seconds has elapsed. The coach has returned to a position upstream of the old railway piers. Boat 1 has started to turn right towards the west bank but has progressed too far downstream to be able to bypass the old railway piers. Boat 2 has continued its downstream course. See Figure 32.

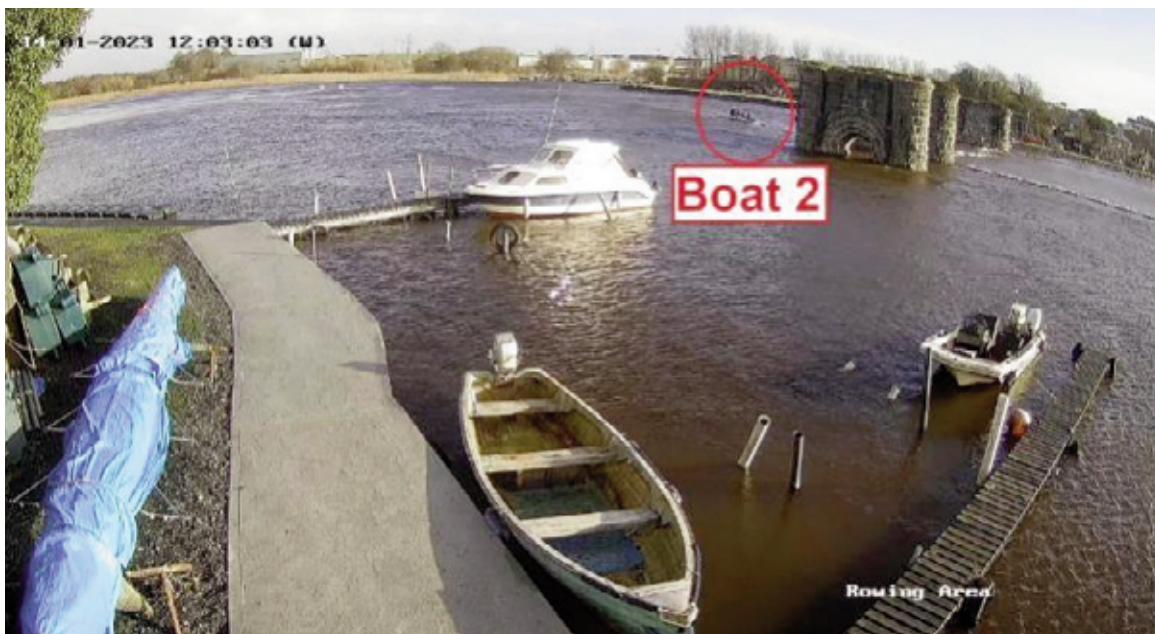
Figure 33: CCTV still image from time stamp 12:03:03. Source: CRYC

2.14.13 Time stamp 12:03:03 - A further 25 seconds has elapsed. Boat 1 has passed behind the old railway piers and is about to imminently allide with the safety booms, out of camera view. The coach has approached Boat 1 but starts to turn to manoeuvre back upstream. Boat 2 has continued its downstream course and has started to turn right towards the west bank but has progressed too far downstream to be able to bypass the old railway piers. See Figure 33.

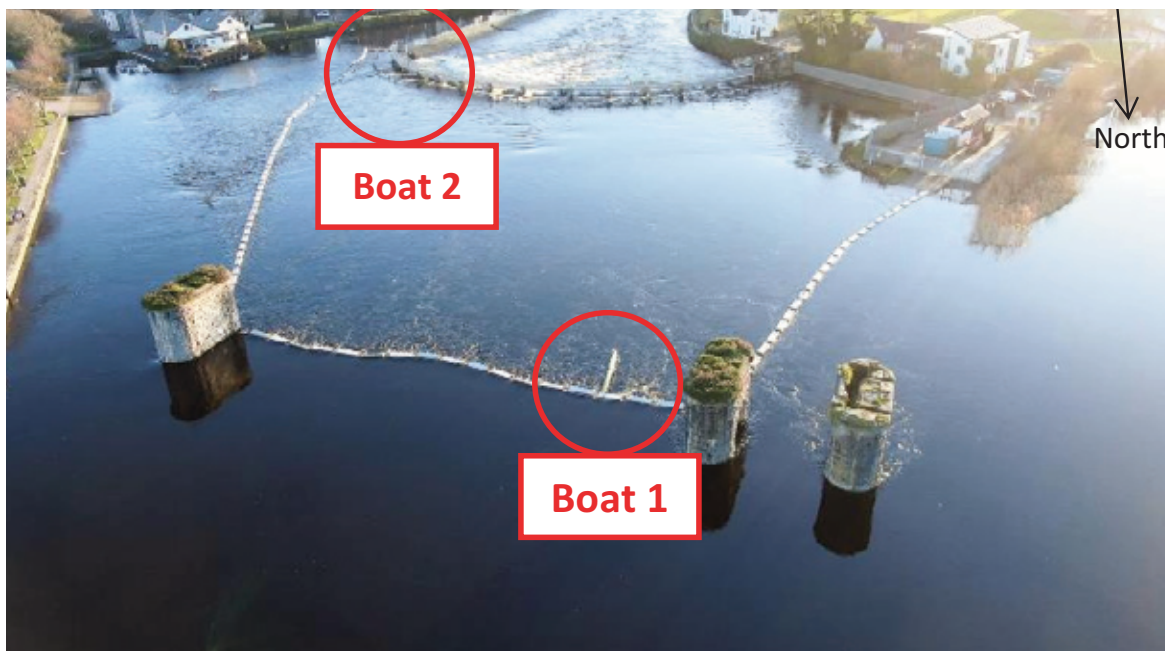
Figure 37: Aerial overview of the river on the day after this casualty event, highlighting part of Boat 1 on the safety booms and Boat 2 on the chains immediately above the weir. Source: Galway Aerial Cinematography

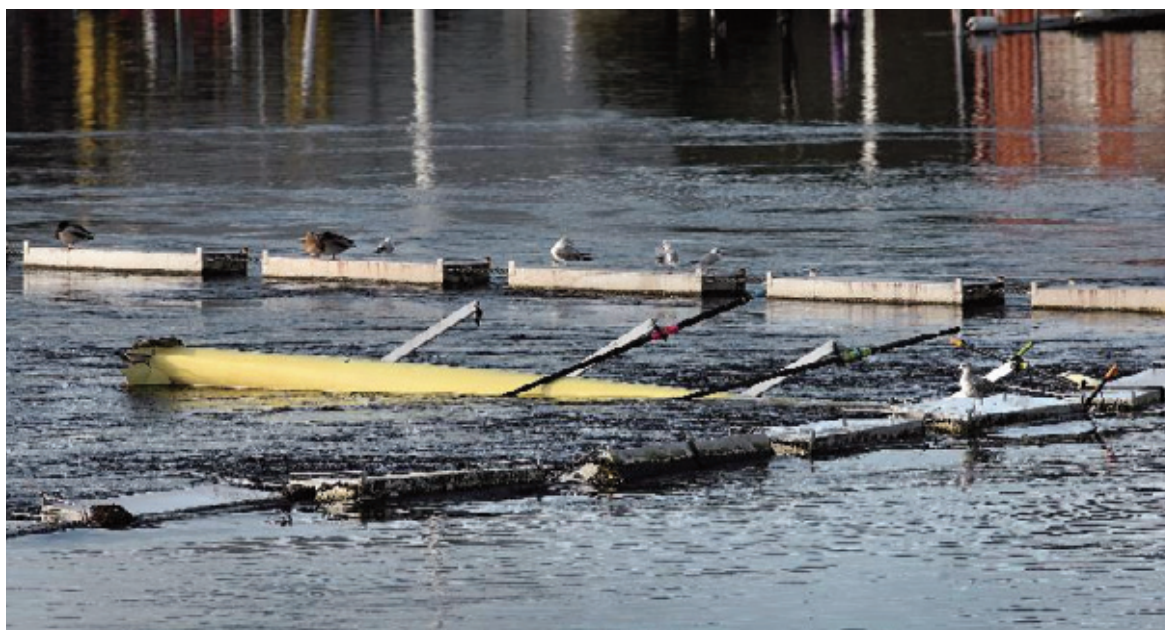
Figure 38: Part of Boat 1 on the safety booms above the weir. Source: Joe Shaughnessy/Connacht Tribune

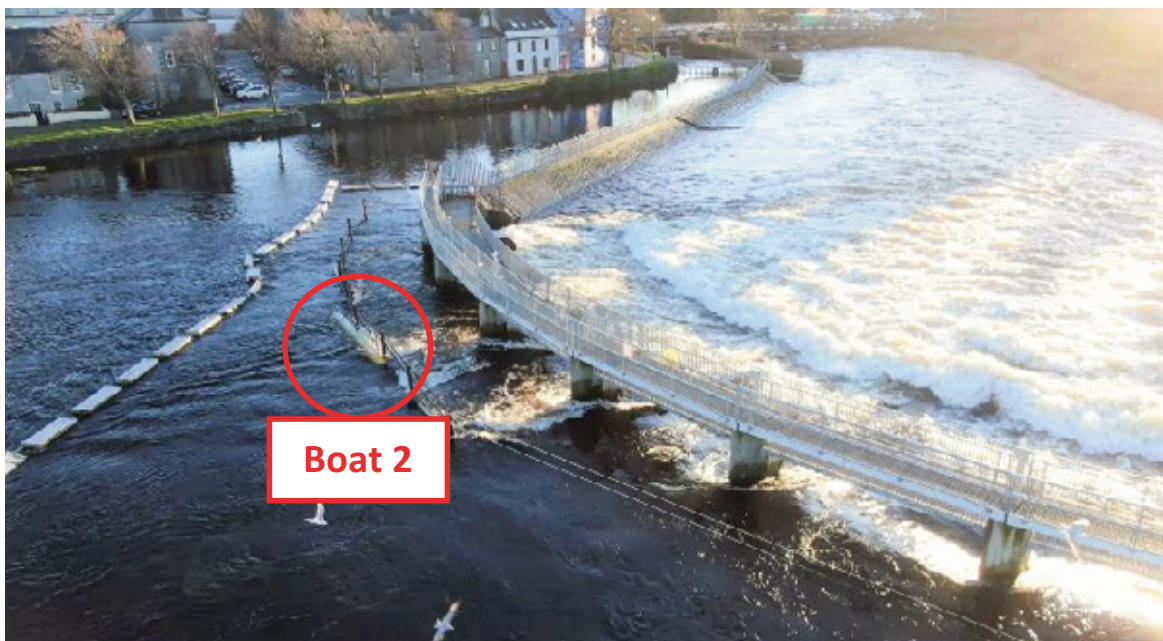
Figure 39: Boat 2 on the chains immediately above the weir.
Source: Galway Aerial Cinematography

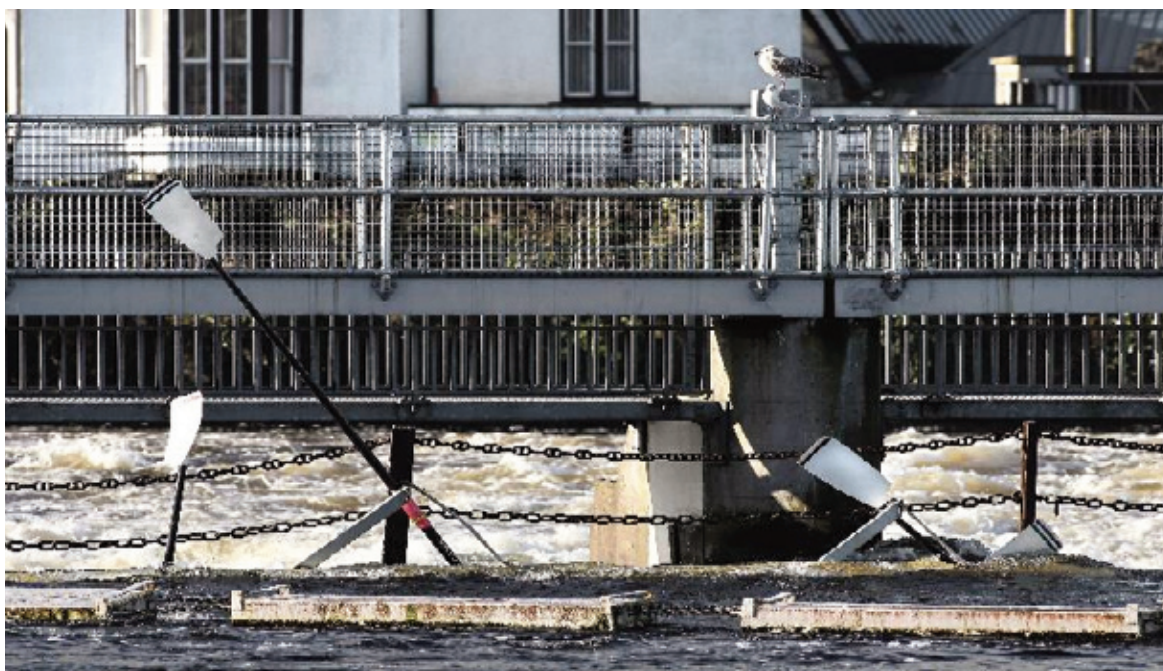
Figure 40: Oars from this casualty event on the chains immediately above the weir.
Source: Joe Shaughnessy/Connacht Tribune
