**REPORT INTO AN INCIDENT  
INVOLVING THE  
'FV DILLON OWEN'  
OFF ARDGLASS HARBOUR  
23rd OCTOBER 2019**

**REPORT NO. MCIB/295  
(No.5 OF 2020)**

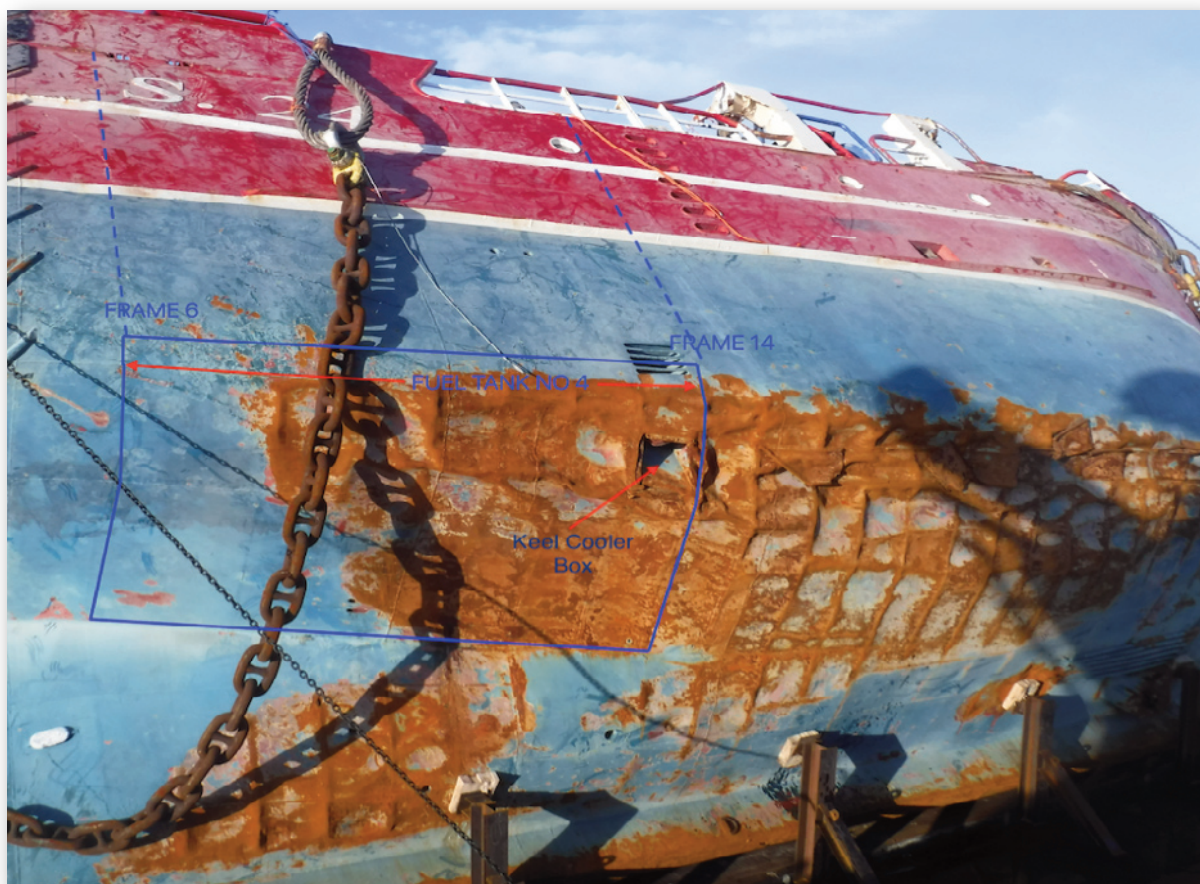
Photographic evidence shows significant damage in the vicinity of the bilge keel, keel cooler and No.4 fuel tank.

Photograph No.3 - Position of No.4 fuel bunker tank located between frames 6 to 14.

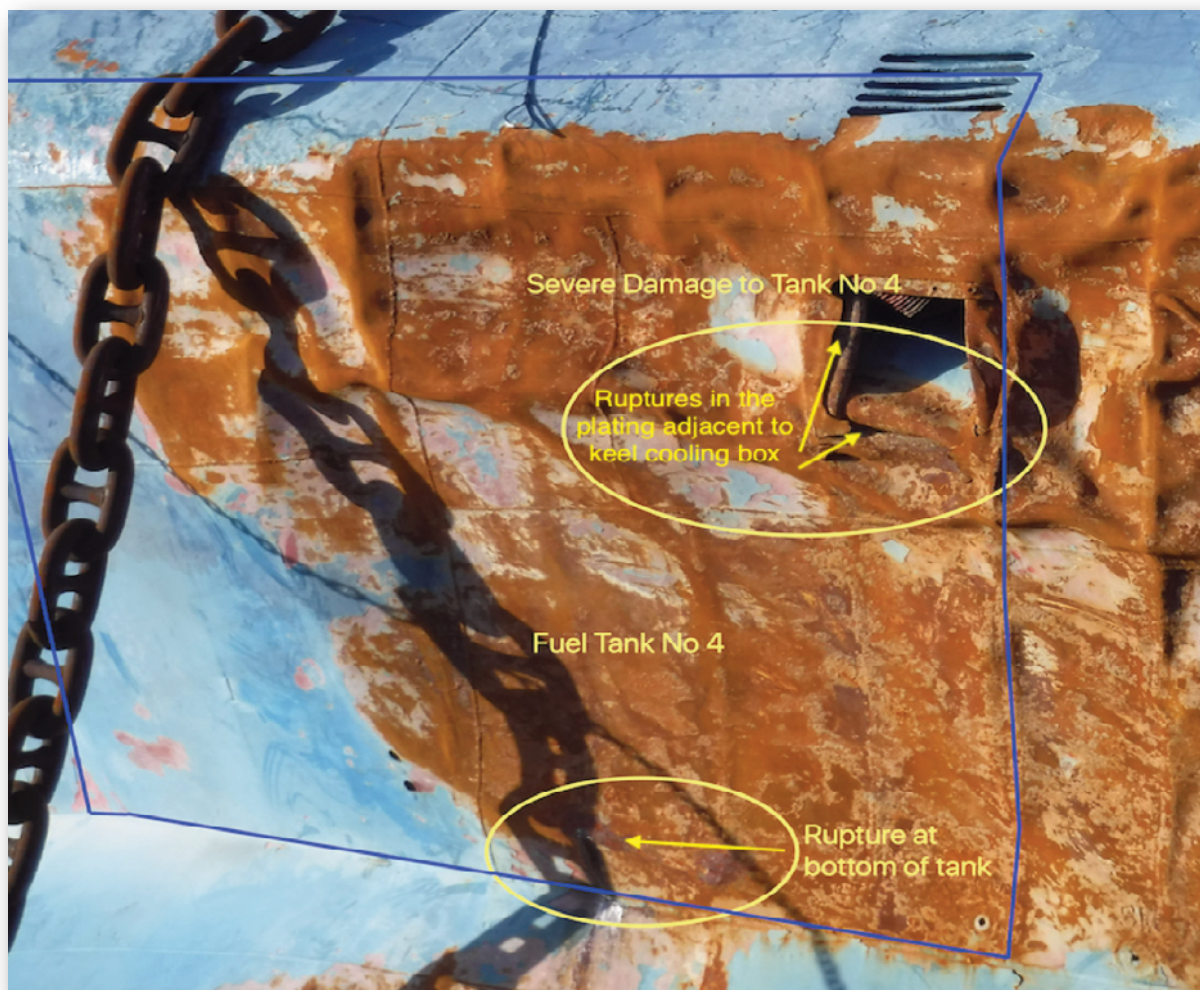
damaged and the plating ruptured in way of fuel tank No.4 adjacent to the keel cooler box. The keel cooler box bottom grid was missing and the keel cooler box bottom aperture through the hull significantly deformed. No.4 fuel tank was open to the sea through the ruptured plating.

- 4.5 Photographs of the vessel's starboard side shows hull plating damage below the waterline in line with the bilge keel extending lengthways (approximately 12 m long) between frames 6 to frame 25. The damaged plating between frames 8 to

frame 14 are integral to No.4 fuel bunker tank and frames 14 to frame 25 are integral to the starboard fish hold. No.4 fuel tank opened to the sea when the tanks hull plating adjacent to the bilge cooler inlets was ruptured at frame 13 to frame 14.

Photograph No.4 - Damage to No.4 fuel tank showing hull plating rupture adjacent to the keel cooler box and at the bottom of the fuel tank.

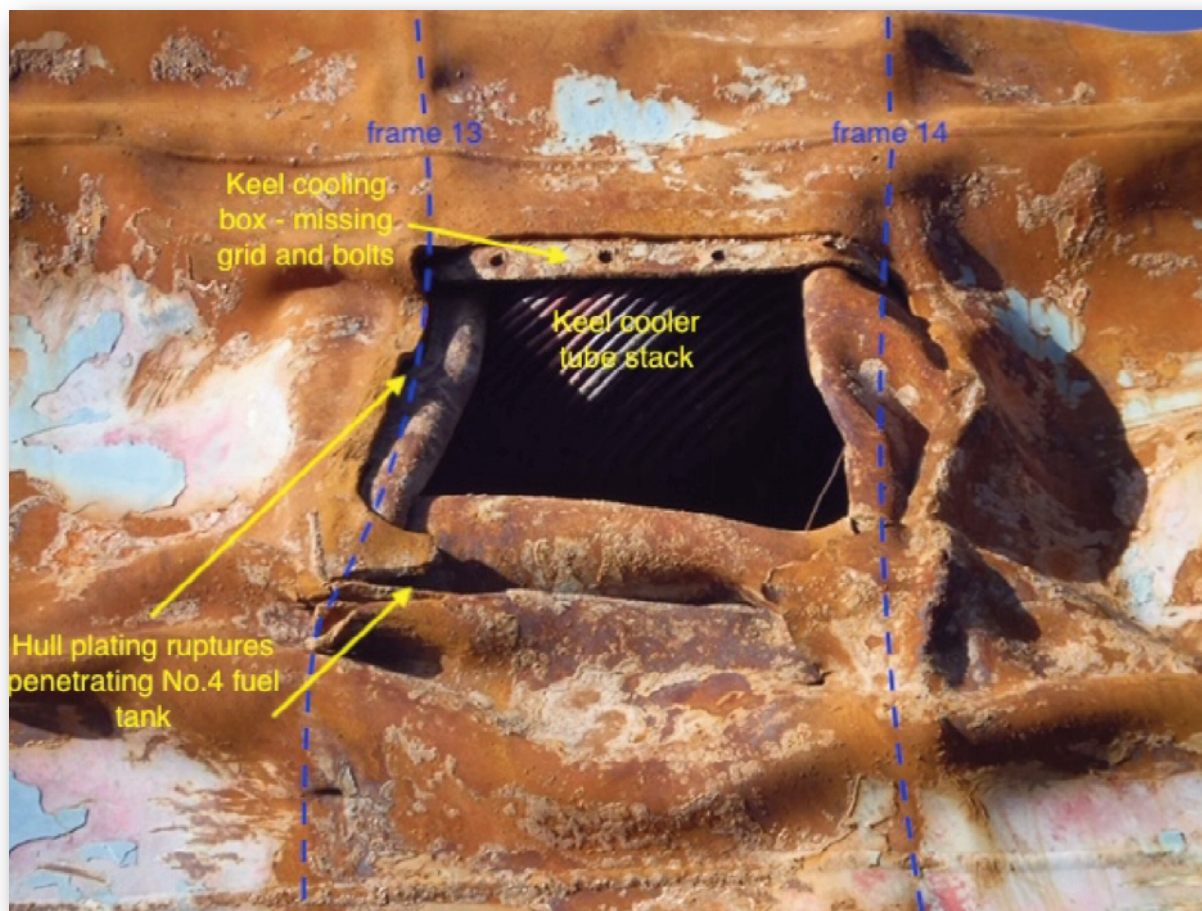
- 5.2 The magnitude of the vessel's impact (as reported by the crew) shortly after 03.54 hrs (UTC), the vessel's AIS track of speed and position and the photographic evidence of damage, indicates that the vessel struck the ground on its starboard side, at or on the shallow water shelf south of Ardtole Beacon, with sufficient force to rupture the hull plating of No.4 fuel tank and open the tank to the sea. There is no evidence to show that the impact of the first grounding event caused the vessel to be fatally damaged at this time.

Photograph No.5 - Hull plating rupture in way of No.4 fuel tank adjacent to the Keel.

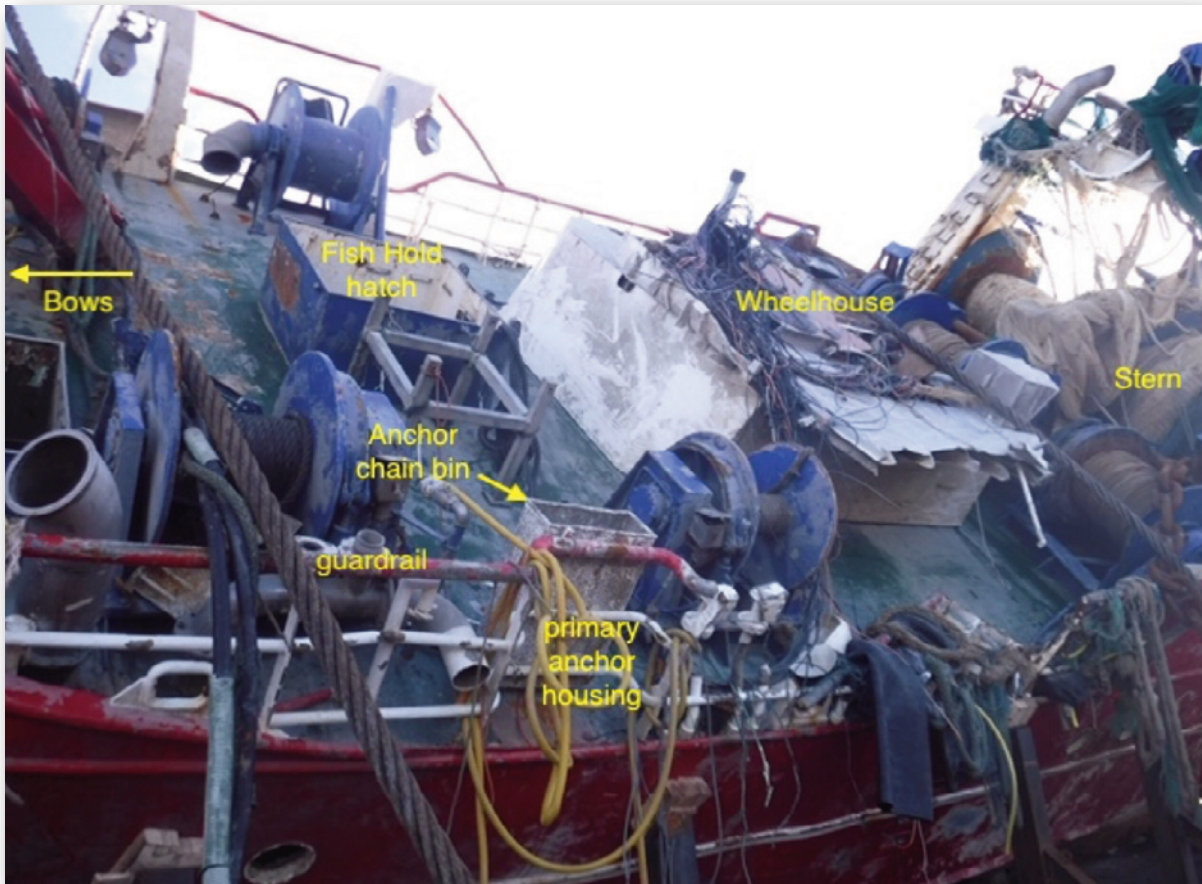
The crew of the *'FV Dillon Owen'* attempted to arrest the vessel's drift towards the shore by using the trawl doors as an anchor. However, this action required the trawl door to be lifted off its securing clips which could only be accomplished by using a powered hydraulic winch. The vessel was in a dead ship condition with no power available and this attempt was unsuccessful.

- 5.4 The causal factor leading to the vessel's second grounding on Phennick Point was the failure of the crew to deploy the primary anchor as the prevailing wind sea direction drove the powerless vessel towards the north shoreline and Phennick Point. The depth of water here was shallow enough to drop an anchor in order to stop the vessel's drift. By first focusing on attempts to release the trawl doors the crew lost valuable time and indicates they did not understand the recommendation contained within S.I. No. 640 of 2007 Merchant Shipping (Safety of Fishing Vessels)(15 - 24 metres) Regulations 2007, Schedule 2 'Recommended Practice for Anchor and Mooring Equipment'. Paragraph 17, which states that 'the use of otter boards/trawl doors should only be used if the vessel has lost its anchors'. The *'FV Dillon Owen'* had not lost its anchors and timely release by the crew of the vessel's primary anchor at this time would likely have averted the vessel's second grounding at Phennick Point.

Photograph No.6 - Main (Primary) anchor arrangement.

- 6.1 The Minister for Transport, Tourism & Sport should issue a Marine Notice to remind vessel owners and operators to ensure all navigation is planned in adequate detail and with contingency plans where appropriate.
- 6.2 The Minister for Transport, Tourism & Sport should issue a Marine Notice stating that fishing vessel owners and operators develop contingency plans and procedures and conduct emergency exercise drills to prepare for a grounding event or collision incident.
- 6.3 Where owners and operators of fishing vessels have an anchoring arrangement whereby chain cables are replaced by trawl warps, that crews ready anchors for deployment when entering or leaving port by connecting the trawl warp to the free end of the primary anchor chain.

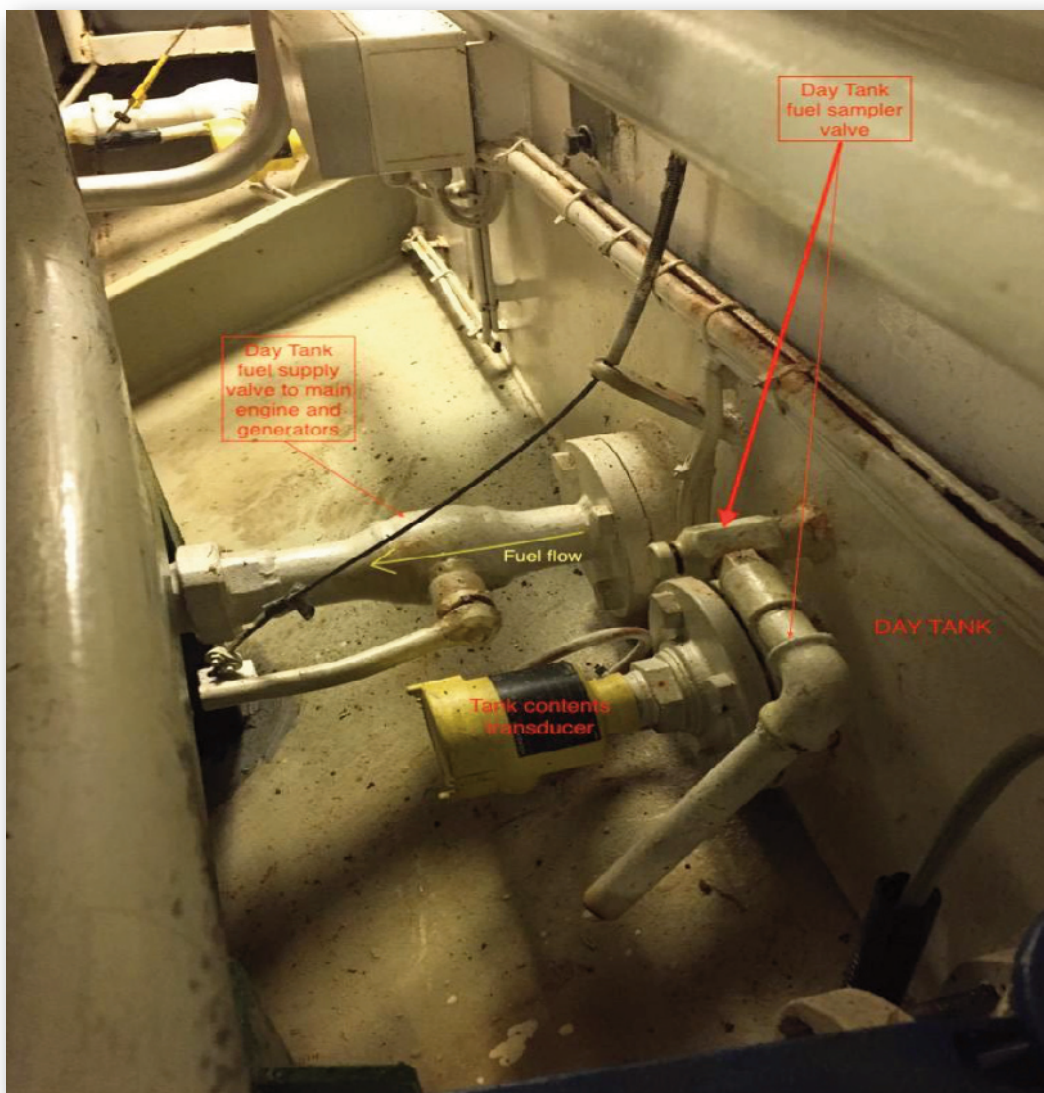
- 3.7 The vessel's emergency light systems tripped in and Crewmember No.1 and Crewmember No.2 were able to make checks in the engine room of the fuel system supply to the main engine and generators. They found that opening the fuel Day Tank sampling valve produced copious amounts of water at an abnormally high pressure instead of diesel fuel oil as would be normal. Opening the drain valve on the inline CJC fuel filter/water separator also produced large amounts of water. Crewmember No.1 deduced that the fuel supply system was contaminated with water, which was the reason the generators and main engine had stopped.

- 5.3 The rupture of No.4 fuel tank immediately filled the tank with seawater and the practice of continually circulating fuel oil through the CJC filter in turn contaminated the daily service tank supplying fuel to the main engine and the generators, causing the vessel to lose electrical and propulsion power. If the transfer and recirculation of fuel from the bunker tank through the CJC unit into the Day Tank had been stopped as the vessel approached shallow waters and restricted navigation, or if a procedure was in place to stop this pump should a suspected grounding event occur, then the Day Tank fuel contents would not have been contaminated and the vessel would not have lost power after the first grounding.

Photograph No.7 - Fuel Day Tank bottom valves ('FV Ardent') Cooler Box.

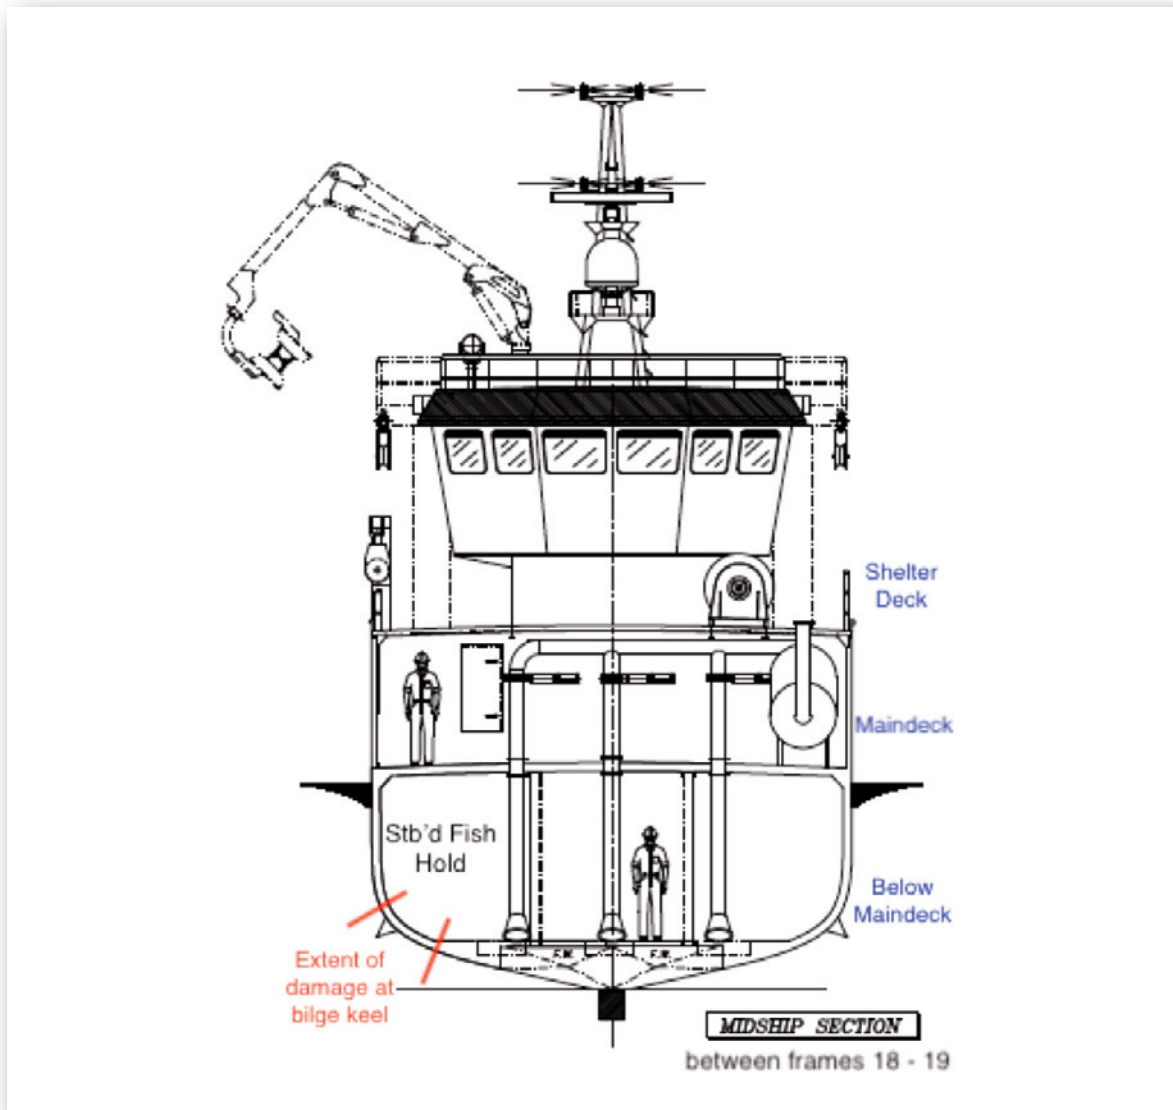
Both No.4 fuel bunker tank and the Day Tank were situated at the 'Below Maindeck' level, within the engine room and below the waterline (on the occasions when the vessel was in the loaded condition). This was the situation as the 'FV Dillon Owen' approached Ardglass Harbour.

The evidence that no water was found in the ships spaces at this time indicates that seawater ingress from the first grounding event was contained to No.4 fuel bunker tank and starboard fish hold only.

Fig.2. Orientation of hull damage to the vessels compartment(s) (Elevation).

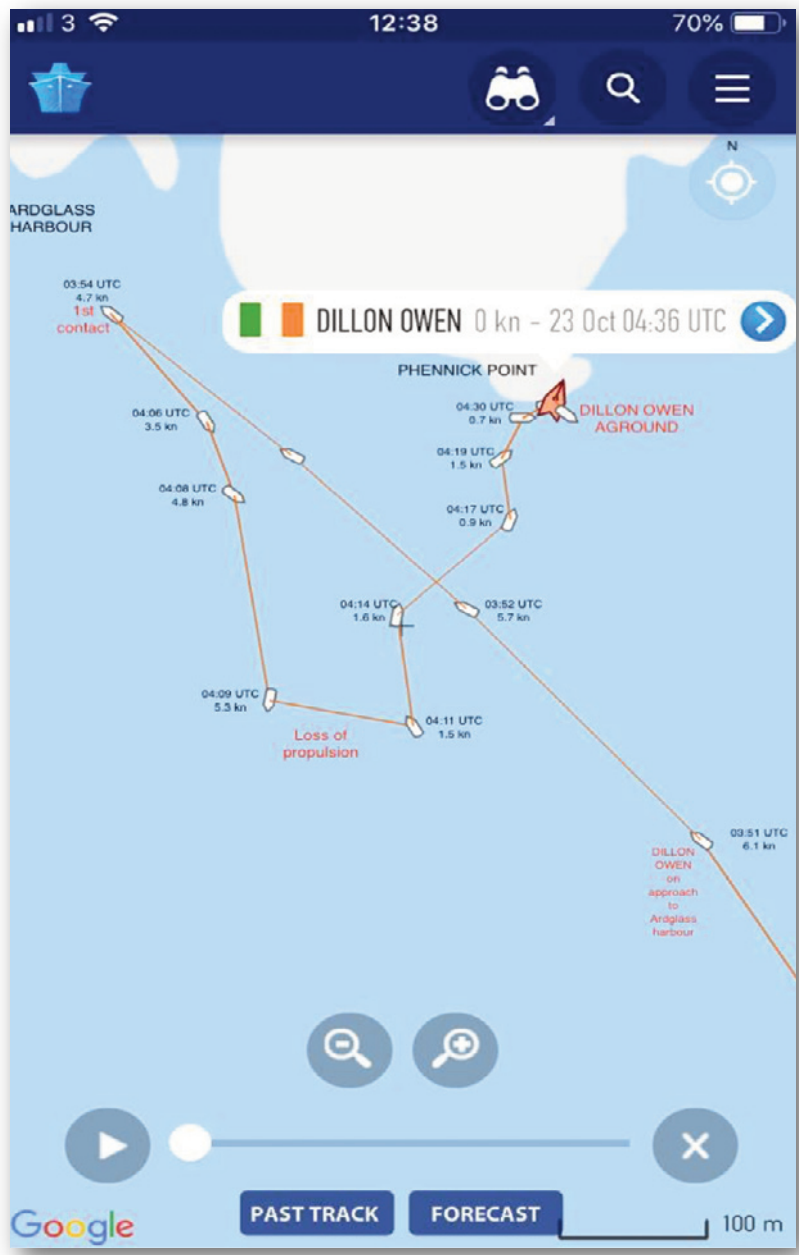
- 4.3 The draft of the '*FV Dillon Owen*' was approximately 4.8 m (Forward) to 5.2 m (Aft) in the loaded condition. If the vessel's draft was in this loaded condition it would have been safe practice to ensure the vessel's approach to Ardglass Harbour was close to the centre of the entrance channel while taking cognizance of the isophase (sectored) North Pier light. The AIS track at 03.54 hrs (UTC) shows the vessel's approach was from the south east at 4.7 kn. The Skipper stated that the vessel was to starboard of the entrance channel. He was not observing the sectored light from the North Pier and he was of the opinion the depth was sufficient to enter the harbour. If the '*FV Dillon Owen*' was indeed to starboard side of the entrance channel the vessel would be at risk of crossing the shallow water shelf south of Ardtole Beacon and grounding.

Fig.5. 'FV Dillon Owen' - AIS Track.

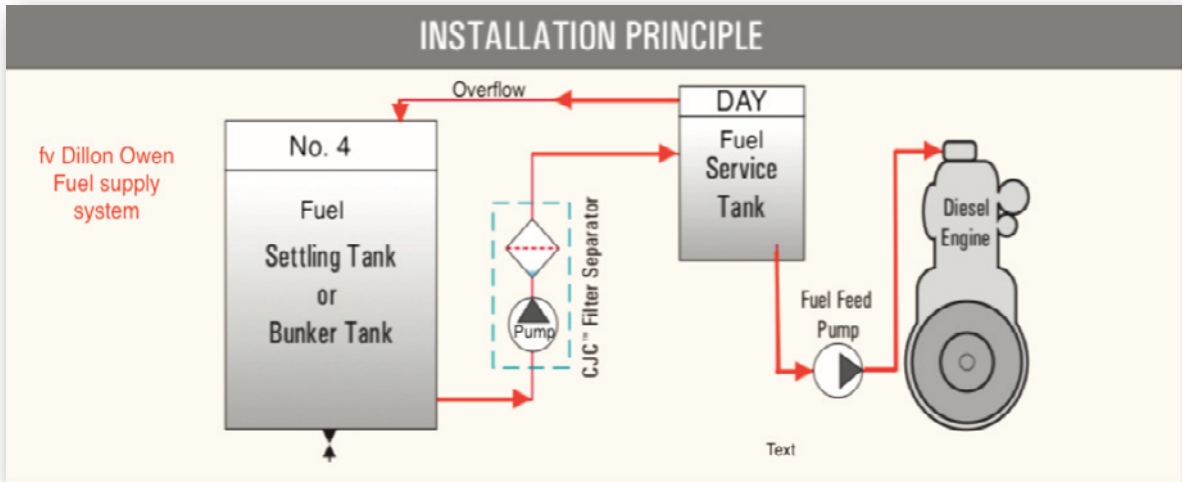
- 4.6.2 The second electrical power failure and the subsequent loss of propulsion power event suggest that the seawater flooding into No.4 fuel bunker tank and the practice of continuous recirculation of fuel from No.4 fuel tank to the Day Tank quickly resulted with inundation of seawater into the fuel pipes supplying fuel to the diesel generators and main engine. This hypothesis is supported by Crewmember No.1 who reported that there appeared to be significantly more pressure than normal in the fuel Day Tank when he opened the sampling valve to test the tank contents and he saw an amount of water issuing out of the sample valve and from the CJC filter drain valve at that time. The hydrostatic pressure of the sea quickly filled and pressurised the ruptured No.4 fuel tank while the CJC filter pump continued to operate, pumping sea water into the Day Tank (until the time of the electrical blackout). The normal overflow of diesel from the Day Tank into No.4 tank would be stopped by the hydrostatic back pressure from No.4 fuel tank. The head of pressure within the Day Tank would thereby increase to a higher head of pressure than when normally overflowing into No.4 fuel tank. Seawater entering the Day Tank would displace the diesel fuel from the lower level of the tank bottom (diesel fuel having a lower specific gravity and therefore lighter than seawater).

- 4.6.3 At 400 litre/hour pumping rate the CJC filter would pass approximately 100 ltr of seawater from the flooded No.4 fuel bunker tank into the Day Tank in the 15 minutes between the initial grounding and the vessel's electrical failure and dead ship condition. Having regard to the proximity of the fuel suction pipe supplying the generator and main engine diesel engines to the lowest level of the Day Tank the water contamination of the fuel supply system would follow shortly after water entered the bunker tank. A small quantity of water into the Day Tank would be sufficient to significantly contaminate the fuel supply lines and quickly stop the generator and main engine.

Fig.6. Fuel Supply and CJC Filter system.
