**REPORT INTO A FATAL
INCIDENT INVOLVING THE
MFV ELLIE ADHAMH
AT ROSSLARE EUROPORT
19th MAY 2019**

**REPORT NO. MCIB/292
(No.4 OF 2020)**

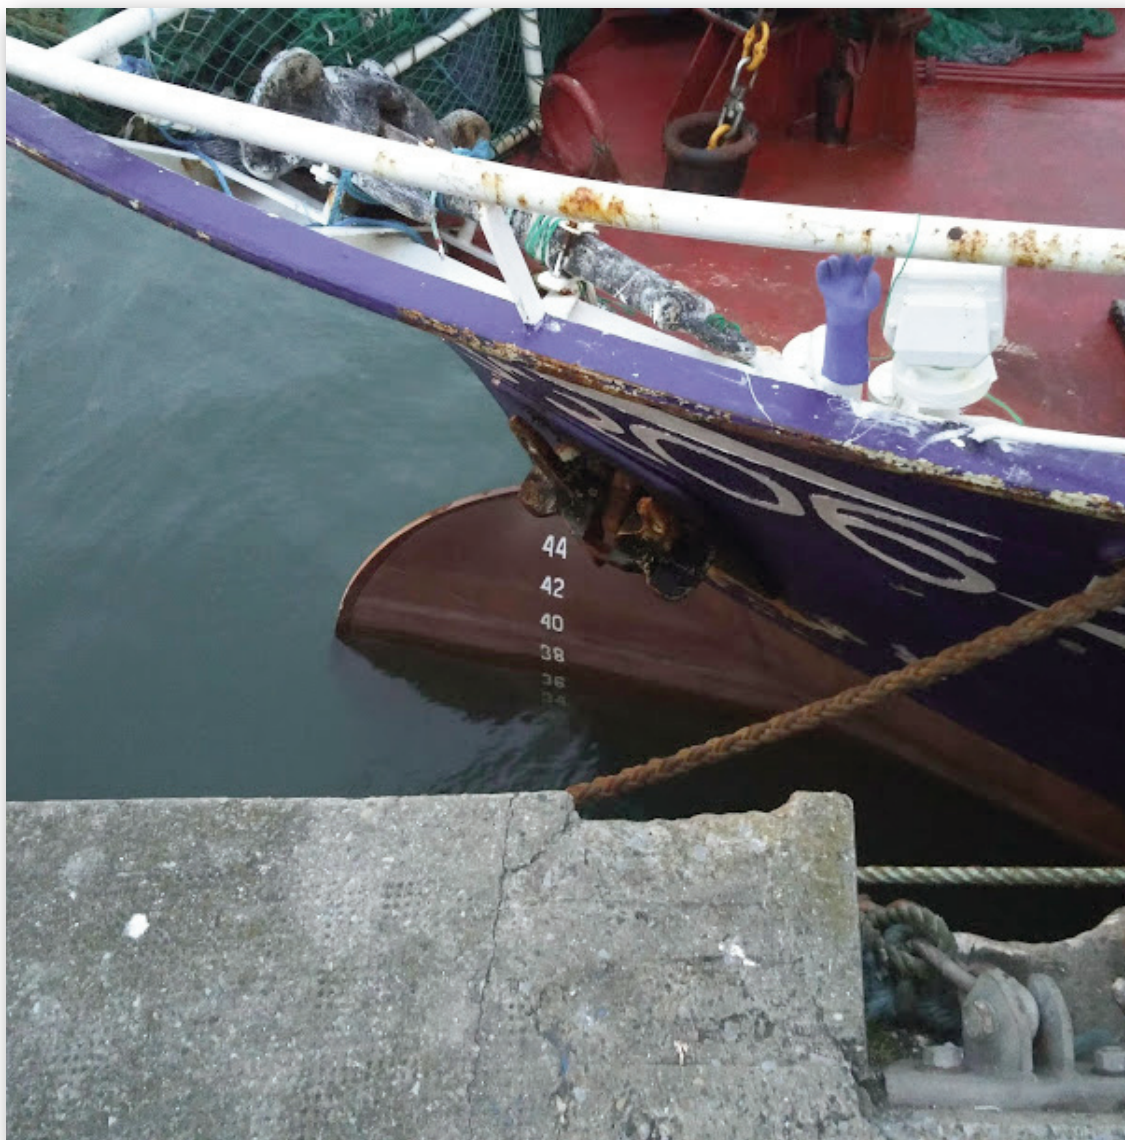
- 3.7 The mooring lines from the 'MFV Ellie Adhamh' to the quay wall would have been slackest at time of the incident (see Appendix 7.1 Photographs No. 1 and No. 2). Fixed ladders for No. 4 berth had recently been removed and were

- 4.6 The *'MFV Ellie Adhamh'* was seen to be between 1.5m and 1.8m off the quay wall shortly after the incident indicating the ropes were at their slackest at around half tide. The close proximity of the *'MV Stena Nordica'* (Gross tonnage 24,206) manoeuvring at the time of the incident most likely had an effect on the vessel being drawn out from the quay wall, caused by the large vessel displacing a considerable volume of water in a relatively shallow area and possibly the use of bow thrusters. The distance between the vessel and the quay wall together with the lack of a safe access point would have made the transit from the quay to the vessel difficult. Had the Casualty been wearing an automatic PFD it would have improved his chance of survival.

Photograph No. 2. Mooring lines from the 'MFV Ellie Adhamh' to the quay wall.

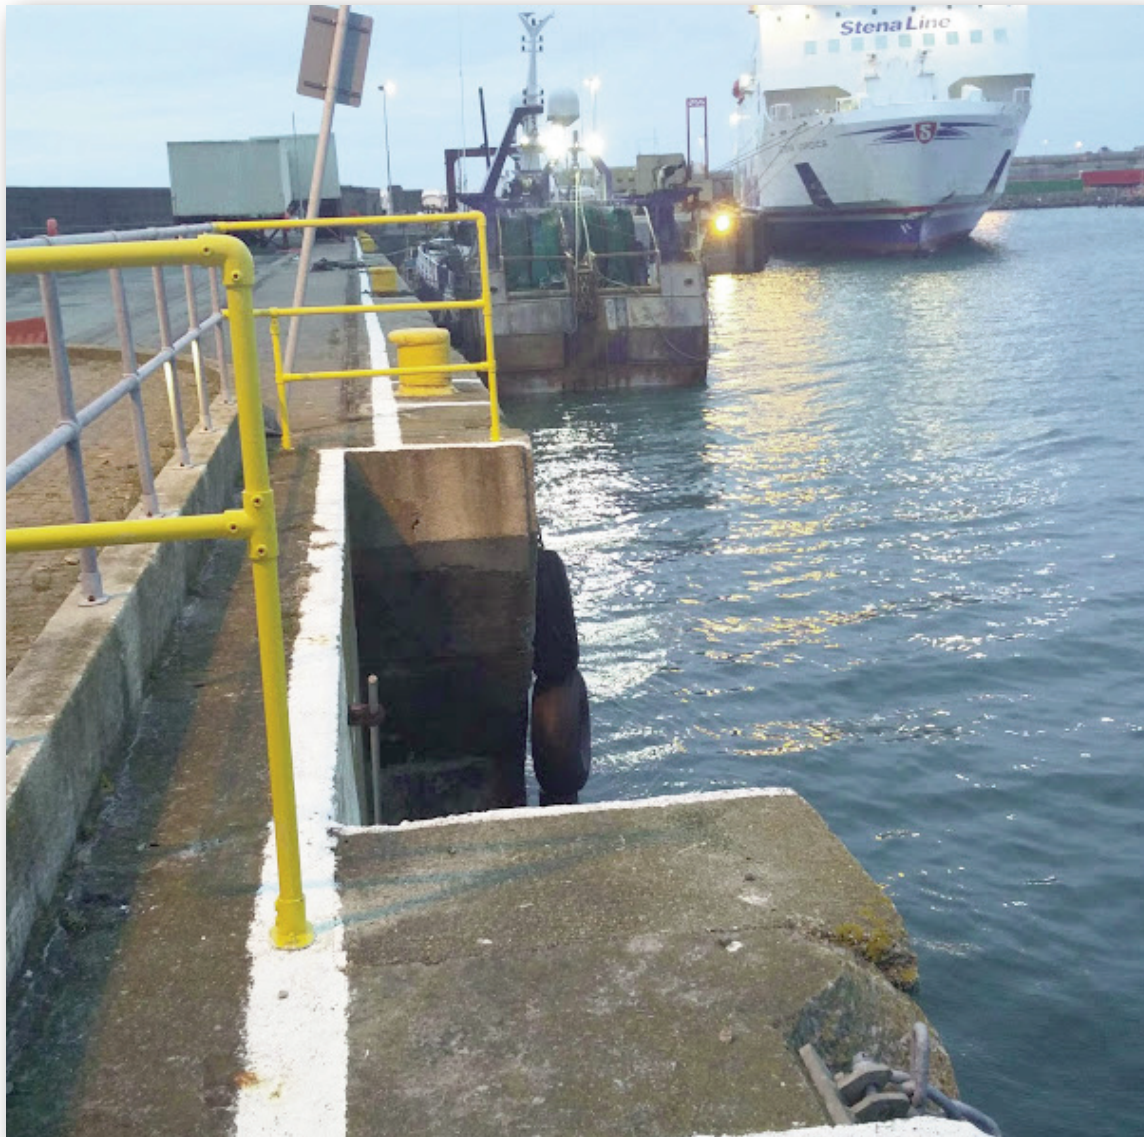
due for replacement. The *'MFV Ellie Adhamh'* has boarding ladders built in on both sides of the main hull (see Appendix 7.1 Photograph No. 3). No gangway or safety net were rigged and there is no clear designated access point between the *'MFV Ellie Adhamh'* and the quay wall (see Appendix 7.1 Photographs No. 4 and No. 5).

- 3.8 The Merchant Shipping (Safety of Fishing Vessels) (15-24 metres) Regulations 2007 require that a gangway or other suitable means providing an appropriate and safe means of boarding the vessel shall be available (Regulation 106).
- 3.9 The initial postmortem report supplied to the MCIB indicates death was caused by drowning, however, this verdict will be determined by the coroner. The toxicological analysis in the report indicated a very high level of ethanol in the Casualty's blood.

- 5.2 Safe means of access to the vessel at all states of tide was not evident.
- 5.3 No PFD was worn by the Casualty.
- 5.4 It is likely that there was considerable movement of the vessel due to manoeuvring of the *'MV Stena Nordica'* in close proximity to it. As the much larger vessel went astern into its berth it would have caused considerable water flow in the vicinity of the *'MFV Ellie Adhamh'*

Photograph No. 5. No gangway or safety net were rigged and there is no clear designated access point between the 'MFV Ellie Adhamh' and the quay wall.

- 6.2 It is recommended that the Minister for Transport, Tourism and Sport issue a Marine Notice reminding fishing vessel owners and skippers of the duty of care to provide safe means of access to vessels while in harbour.
