**REPORT INTO AN INCIDENT
INVOLVING THE
'FV DEARBHLA'
AT THE BLASKETS,
CO. KERRY
14th MAY 2020**

**REPORT NO. MCIB/301
(No.12 OF 2020)**

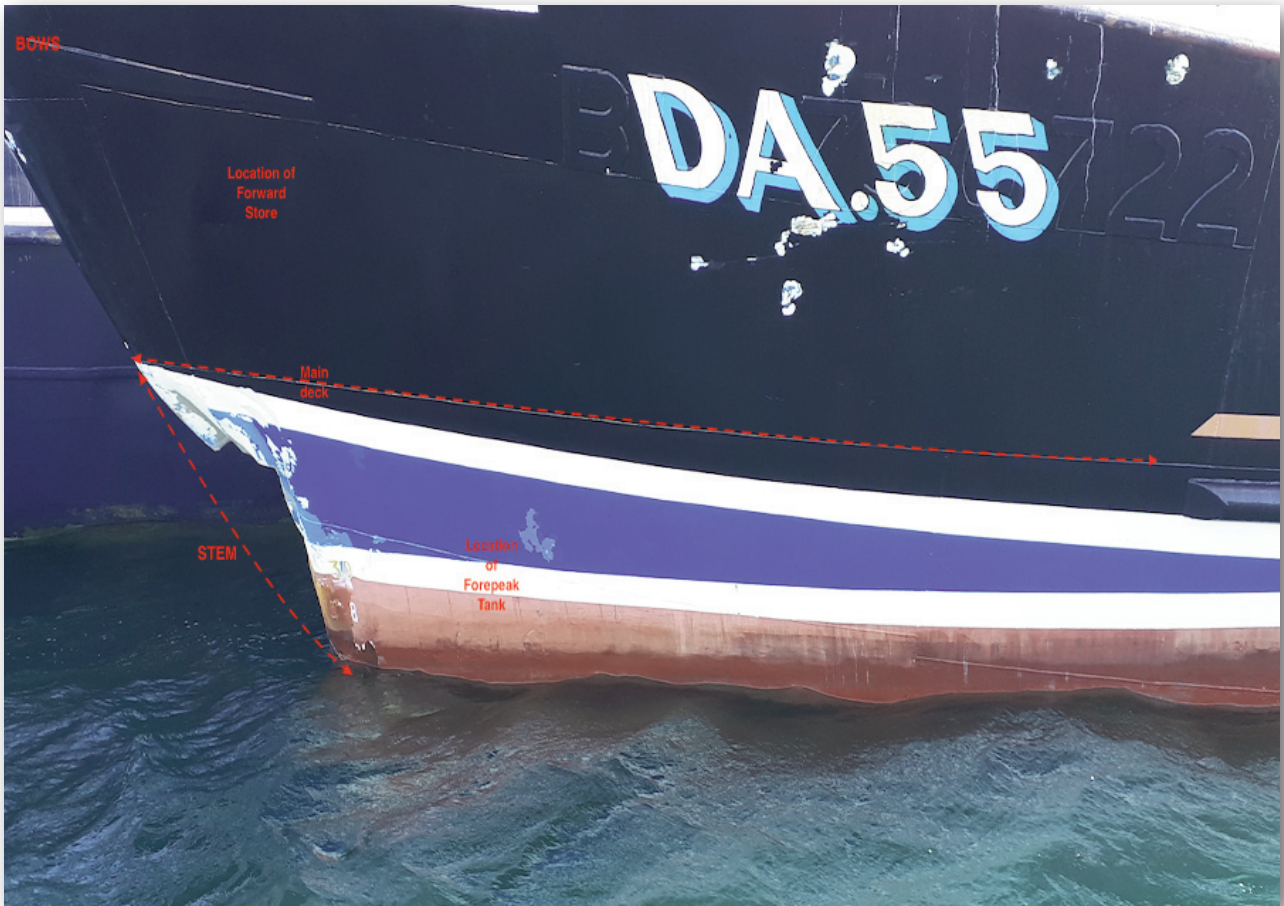
- 1.3 The vessel's owner was informed of the incident at approximately 08:00 hrs that day. The owner arranged for the vessel to proceed to Castletownbere for an inspection of the damage and repairs. The inspection revealed that the vessel had considerable contact damage to its stem at the waterline and was holed above the waterline under the bows.

Damage found to the bows and stem was extensive. The hull plating was ruptured above the waterline and internal frames, beams, brackets and floors in the forepeak tank were deformed and buckled. The deck in the forward store was buckled. There was evidence of hard contact along the starboard chine and on the leading edge of the bilge keel.

Photograph No.2 - Bow damage above the waterline.

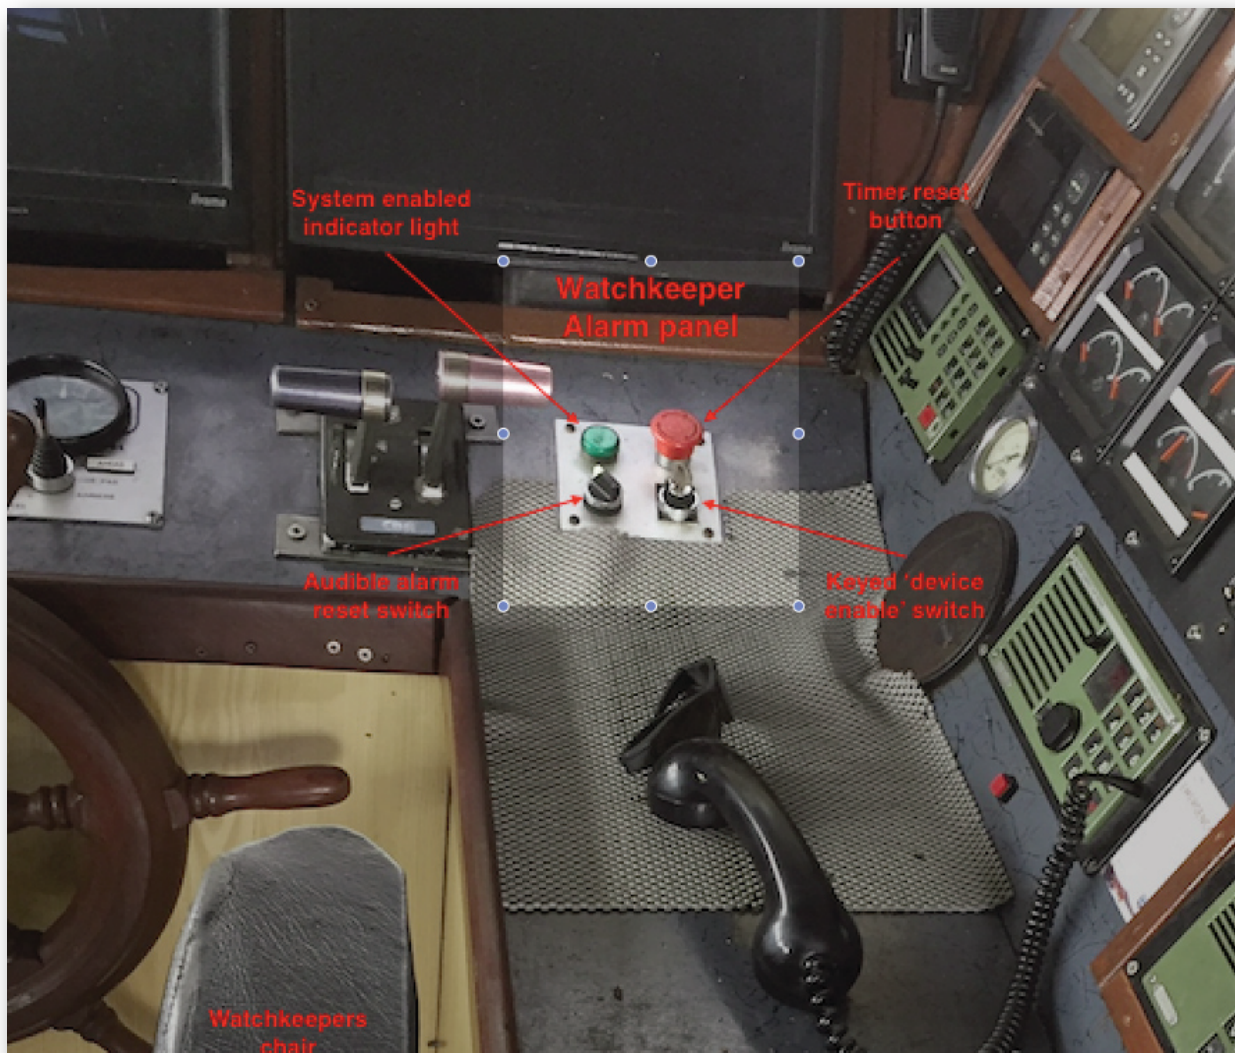
3.3 Shortly after taking over the watch Crewmember 'A' went down to the tea station in the crew mess to make a cup of tea. Before leaving the wheelhouse, Crewmember 'A' switched 'OFF' the 'Watchkeeper Alarm', a timer device designed to give an audible sound in the wheelhouse every ten minutes. The device's function is to ensure the watchkeeper remains alert and in the wheelhouse. The Watchkeeper Alarm panel is located on the main wheelhouse console to the starboard side of the helm immediately in front of the watchkeeper's chair.

Crewmember 'A' switched off the alarm so as not to awaken the crew if he was delayed in making the tea.

After making the tea Crewmember 'A' returned to the wheelhouse and resumed the watch. Crewmember 'A' stated that he forgot to switch the Watch Alarm back 'ON' after he returned to the wheelhouse.

- 4.3 The Watch Alarm panel has a keyed 'ON/OFF' switch. The key is removable and may be taken away leaving the panel either locked in the 'ON', (enabled) position or locked in the 'OFF', (disabled) position (see paragraph 3.3). It would have been good practice for a senior watchkeeper onboard the fishing

Photograph No. 3 - Watchkeeper Alarm Panel.

vessel to switch 'ON' the Watch Alarm Panel switch, remove the key and keep the key remote from the panel. By doing so the Watch Alarm system would be locked in operation, always enabled and active during the voyage.

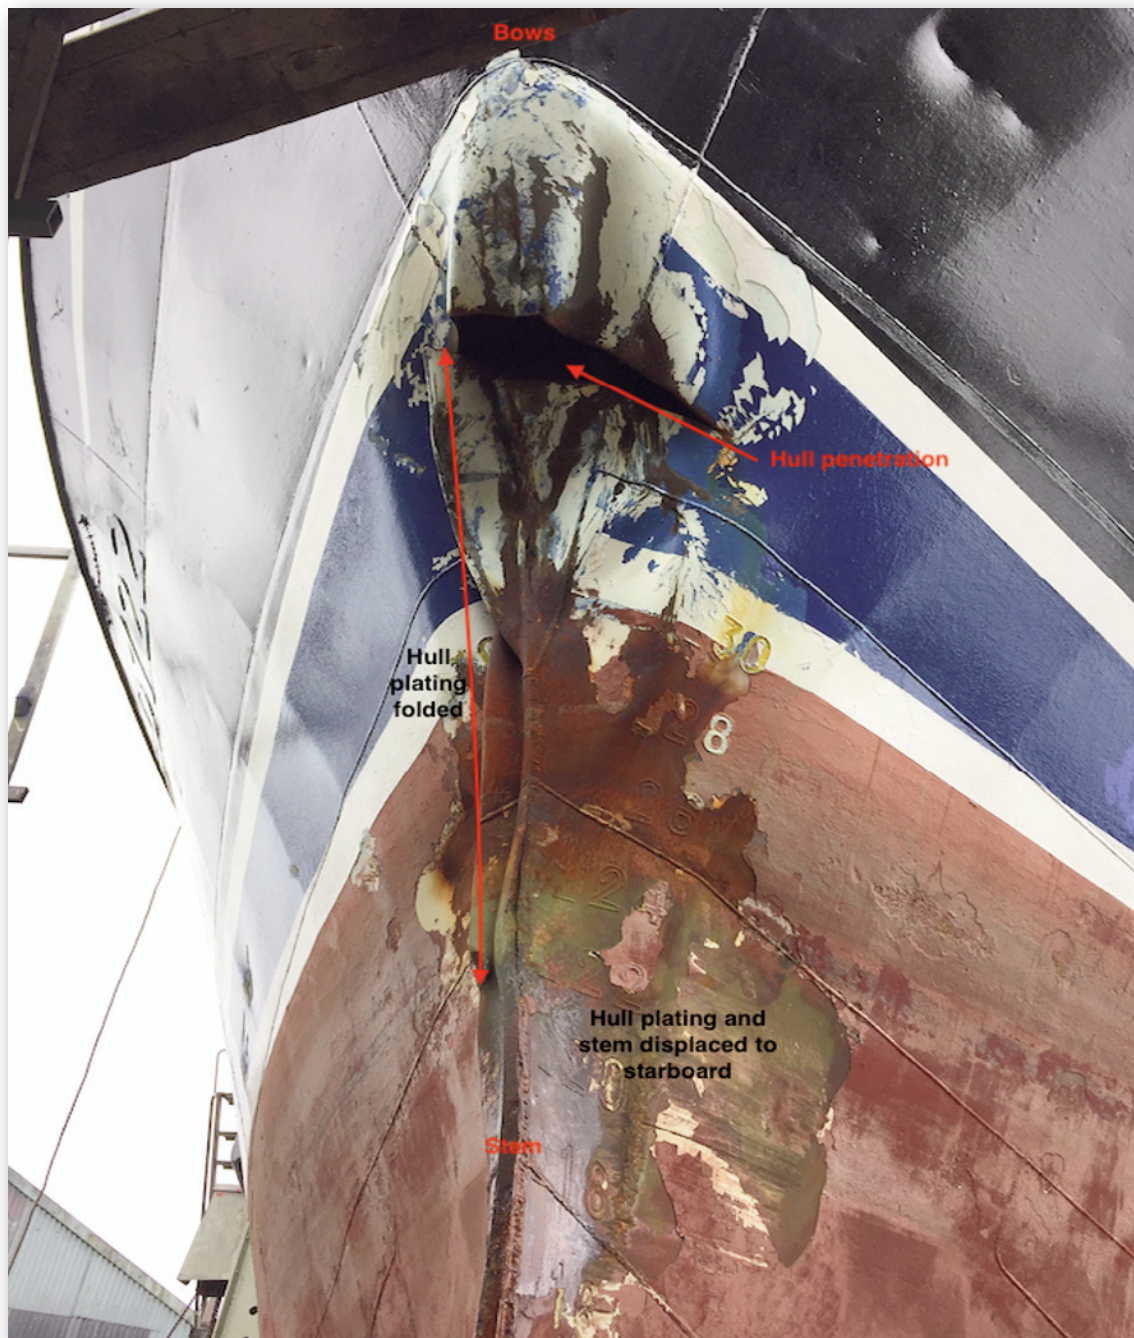
Photograph No.4 - Stem damage below the waterline.

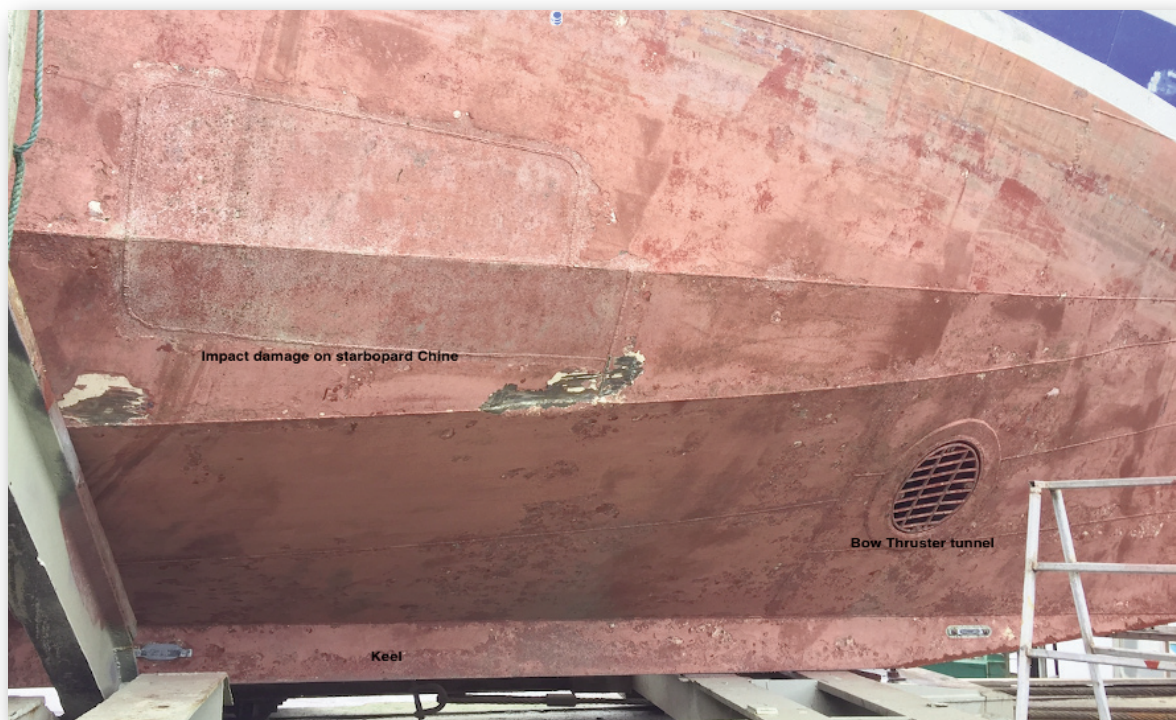
Photograph No. 5 - Starboard Chine damage below the waterline.

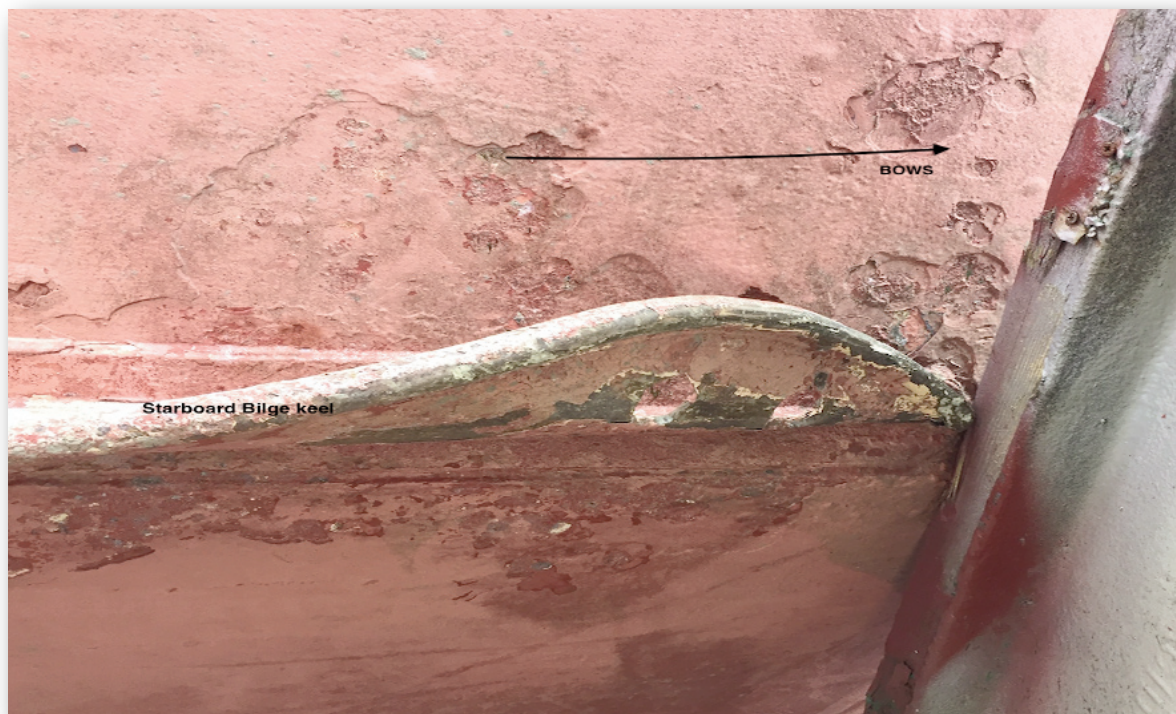
Photograph No.6 - Bilge Keel damage below the waterline.

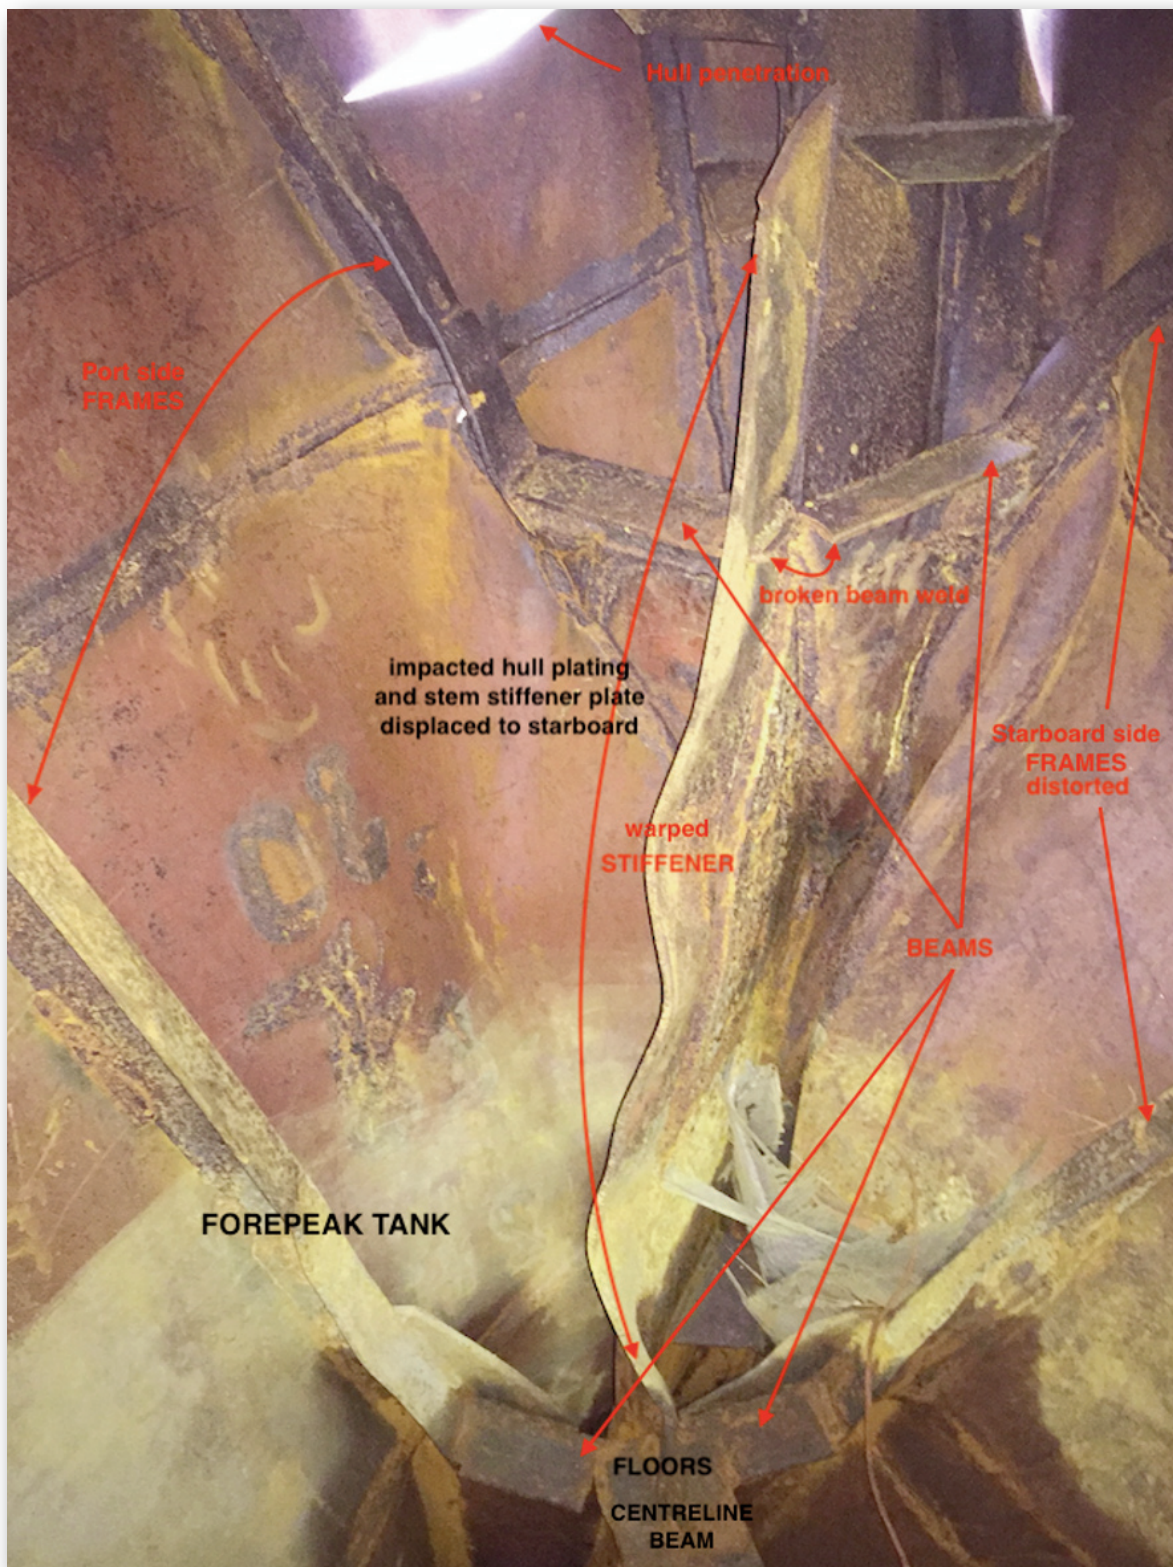
Photograph No. 7 - Forepeak Tank damage.

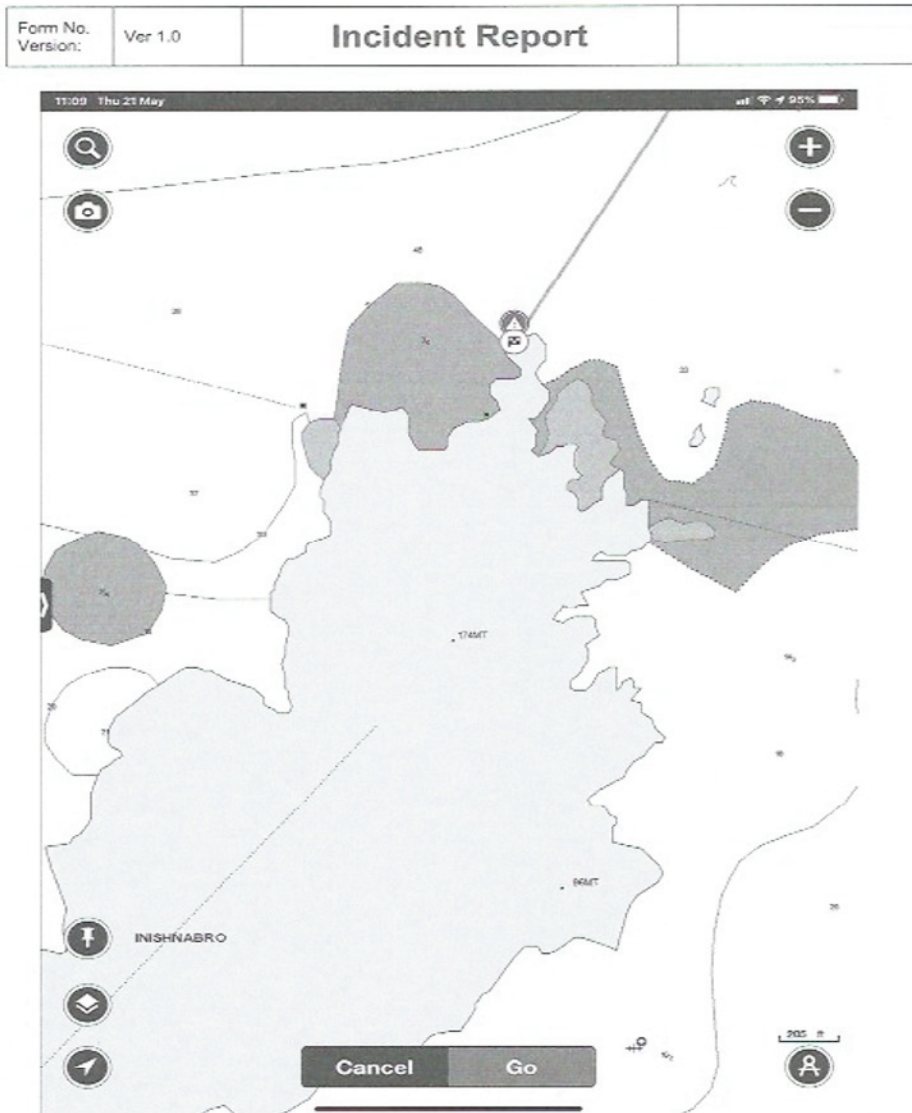
Chart No. 3. 'FV Dearbhla' Grounding Position.

At approximately 03:00 hrs the following morning, 14th May, the Skipper called Crewmember 'A' to take over the navigation watch in the wheelhouse. The Skipper instructed Crewmember 'A' to continue and proceed through Blaskets Sound. The Skipper left the wheelhouse and proceeded to his bunk for rest. At approximately 04:10 hrs the vessel grounded on rocks in approximate position Latitude 52° 03.820'N Longitude 010° 36.296'W which is on the north west peninsula of Inish na Bró island.

- 3.5 According to the vessels AIS track at 04:10:05 the vessel's speed was 8.7 kn. Sometime shortly after and according to the Skipper's incident report the fishing vessel grounded on rocks on the northwest peninsula of Inish Na Bró.

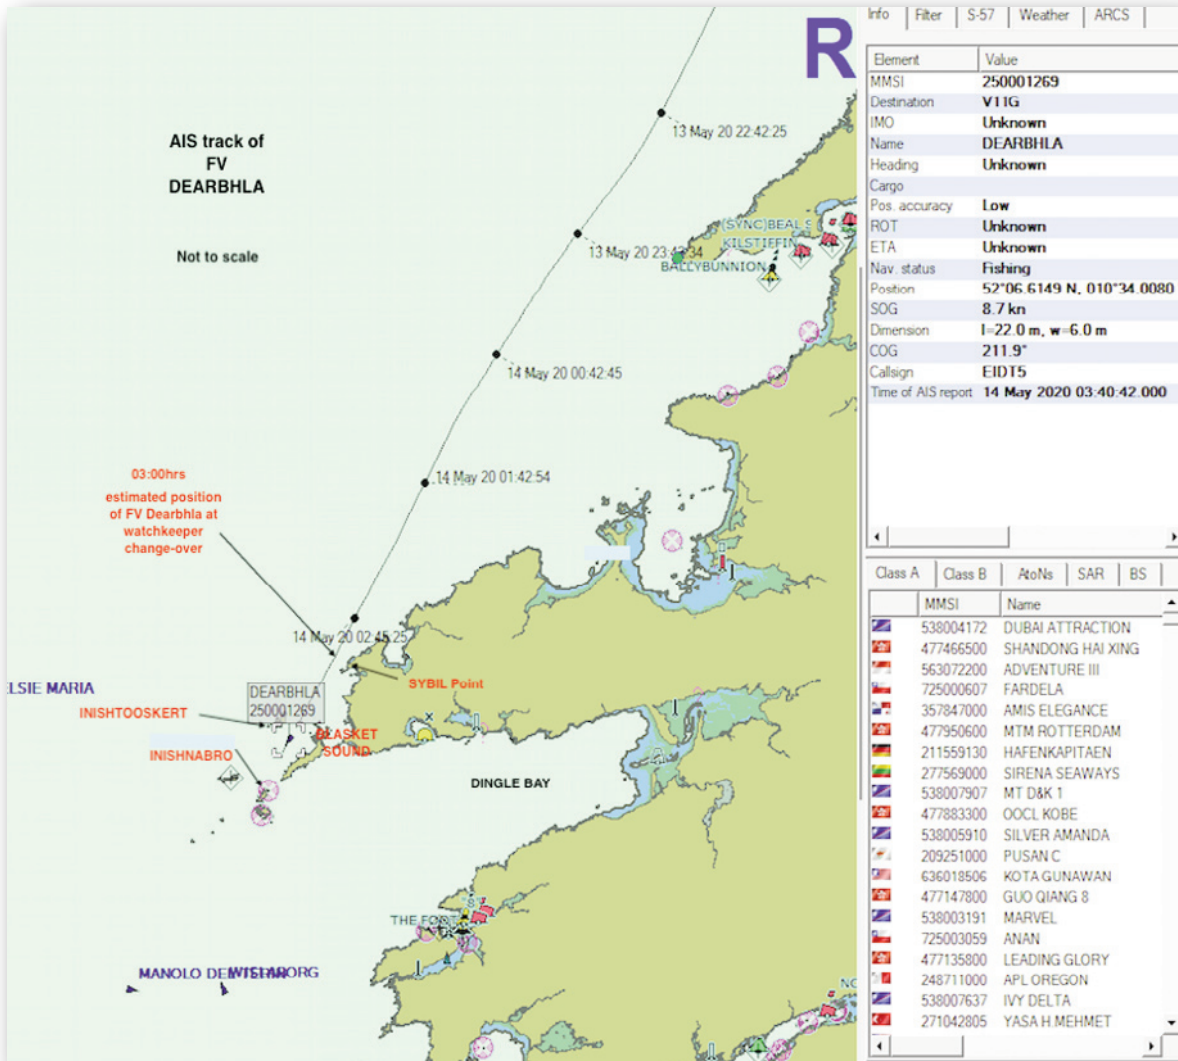
Chart No. 6. 'FV Dearbhla' AIS track to 03:40 hrs.

- 3.4 At 03:40 hrs the vessel's position was 52° 06.6149'N, 01° 0 34.008'W midway between Great Blasket Island to the southeast and Inishtooskert immediately to the north, the vessels COG 211.90, SOG 8.7 kn.

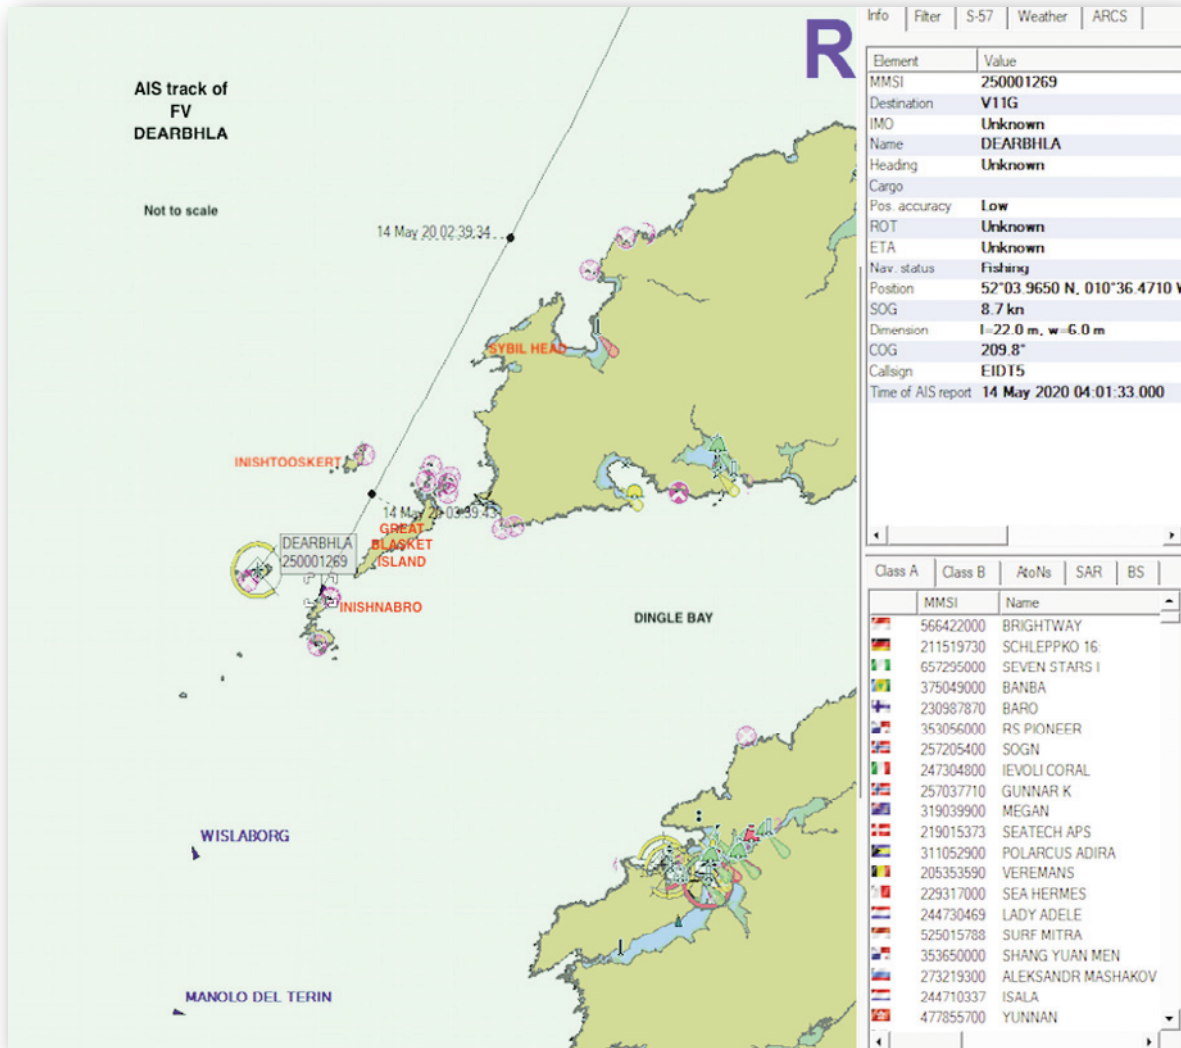
Chart No. 7. 'FV Dearbhla' AIS track to 04:01 hrs.

At 04:01 hrs the vessel's position was 52° 03.9650'N, 010° 36.4710'W in immediate proximity to Inish na Bró; the vessels COG was 209.80, SOG 8.7 kn and unless the watchkeeper made a safe course change the vessel was standing into danger of grounding on the island of Inish na Bró.
