**REPORT INTO A  
FATAL INCIDENT  
INVOLVING A KAYAKER  
ON THE ROUGHTY RIVER,  
KILGARVAN,  
CO KERRY  
4th NOVEMBER 2018**

**REPORT NO. MCIB/283  
(No.7 OF 2019)**

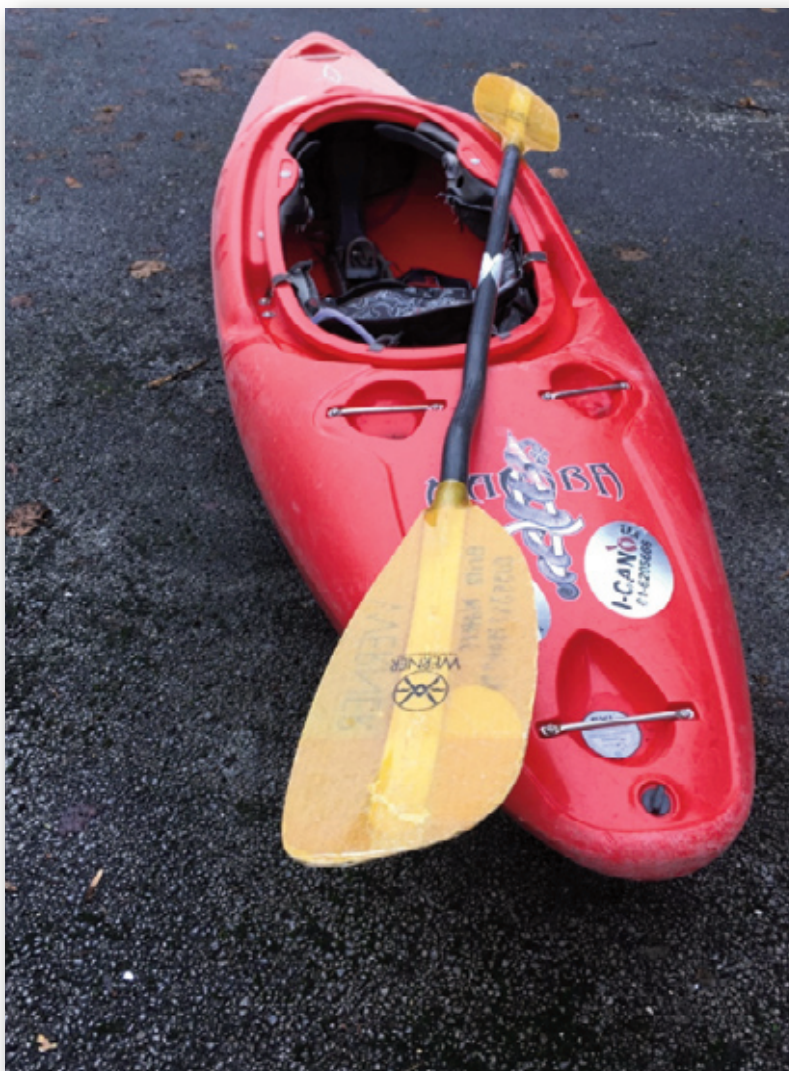
Photograph No. 1: The kayak.

Type:	MAMBA 7.6 Kayak.
Builder:	Dagger.
Length Overall (LOA):	2.31 meters (m)/7'07".
Breadth:	0.65 m/25.5".
Weight:	19 kilograms (Kg)/43 Lbs.
Volume:	242 litres (L)/64 gal.
Construction:	Roto-Moulded/Polyethylene.

The vessel was a 7.6 ft. kayak with spray deck designed for river descents. (see Appendix 7.1 Photograph No. 1).

- 3.11 A subsequent inspection of the kayak and buoyancy jacket found them to be serviceable and suitable for the activity on the day.
- 3.12 The riverbed at the drop is rock with potholes worn by pebbles. The two logs were stuck in one of these potholes (see Appendix 7.1 Photograph No. 4).

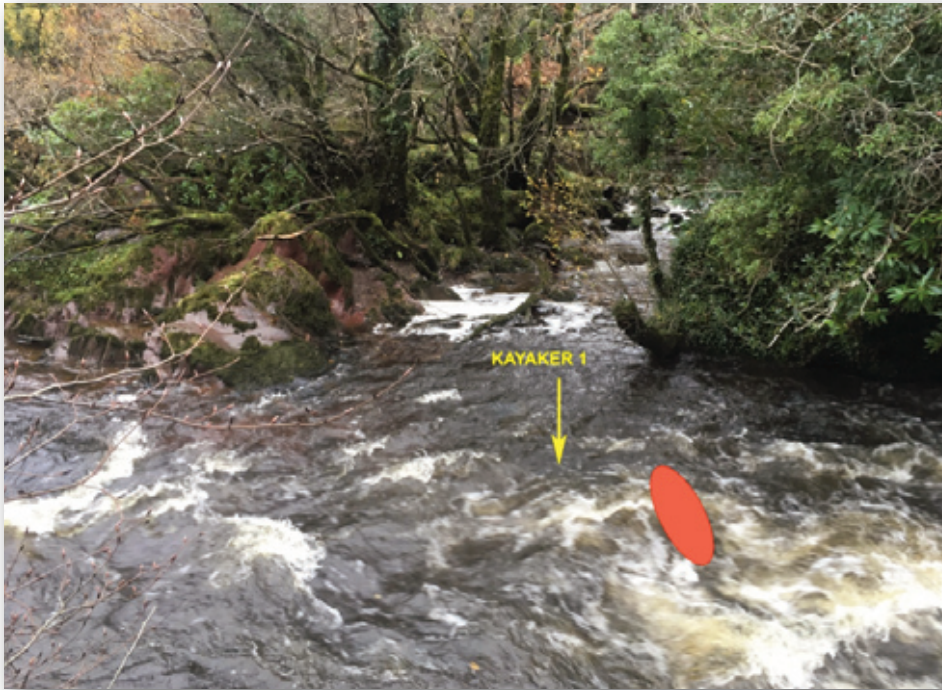
- 3.5 At about 11.45 hrs the first kayaker arrived at the take-out point and turned his kayak into the side channel and beached it. He then went into the river at the turn-in to help the rest of the party into the side channel. The water was shallow and came up to mid-calf level. Kayakers No. 2 and No. 3 followed quickly after and were beaching their boats when kayaker No. 4 approached. Kayaker No. 4 had started to turn into the side channel and was diagonally across the current when the boat contacted an underwater rock which capsized it in an upstream direction. Kayaker No. 1 caught hold of the bow and pulled it in and started to turn it upright. Kayaker No. 4 slipped out and kayaker No. 1 saw her head pop up at the other side of the boat. When kayaker No. 1 righted the boat kayaker No. 4 was at the stern in the water. She was unable to grab on the handles on the kayak and/or get on to her feet. She was washed quickly downriver over the drop obstructed by a large log and was trapped by the water flow under the log. The distance between the point of capsize and the drop was between 5 and 6 meters (see Appendix 7.1 Photographs No. 2 and No. 3).

- 4.7 The incident occurred because the Casualty's kayak touched a rock and capsized as she was turning across the current. Capsizing is a fairly normal occurrence and the trained and experienced kayaker can push themselves upright with their paddle. In this instance the kayak was in shallow water. The Casualty probably exited the boat unintentionally and was unable to hold on to the boat or get to her feet. She went out into the main flow of water and did not gain a foothold on the river bed and was washed downstream over the drop into the log obstruction. Had the log not caught the Casualty and the water flow around it pushed her down she would have arrived safely at the pool below the drop.

Photograph No. 2: Relative positions at point of capsize.

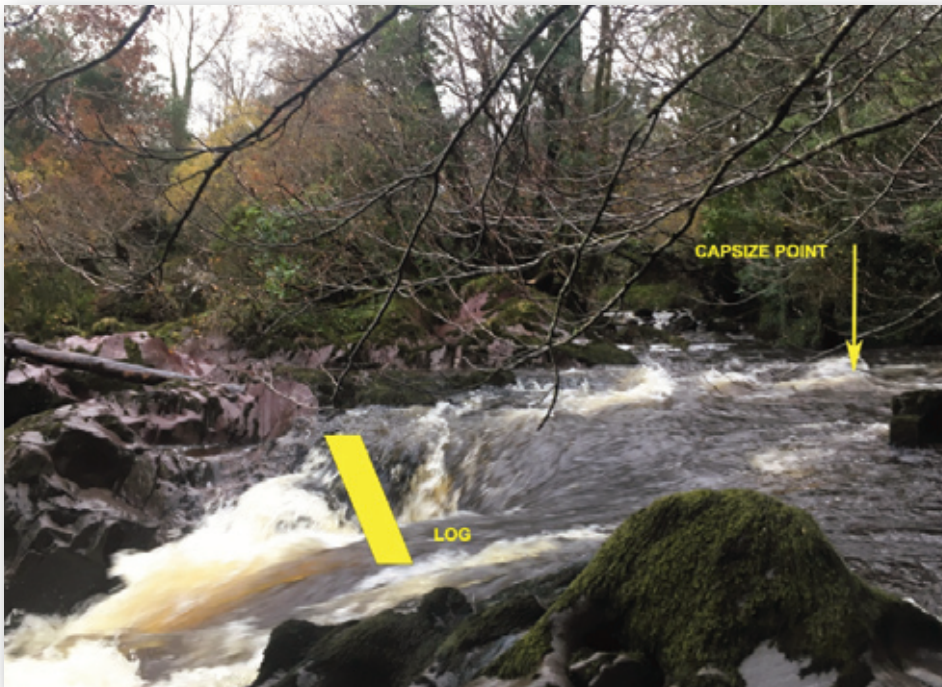
Photograph No. 3: The location of the incident.

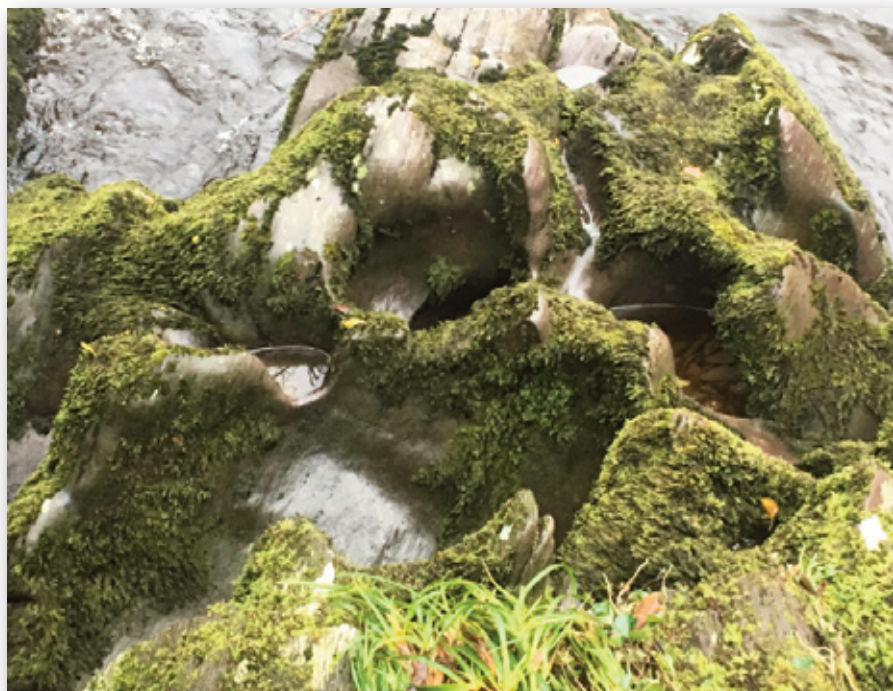
- 
- 4.8 The log was stuck in a pothole in the rock of the river bed. There was also a second more dangerous log with branches underneath the visible log and it was this one which trapped the Casualty.

Photograph No. 4: Pothole erosion of rocks - much larger in river bed.

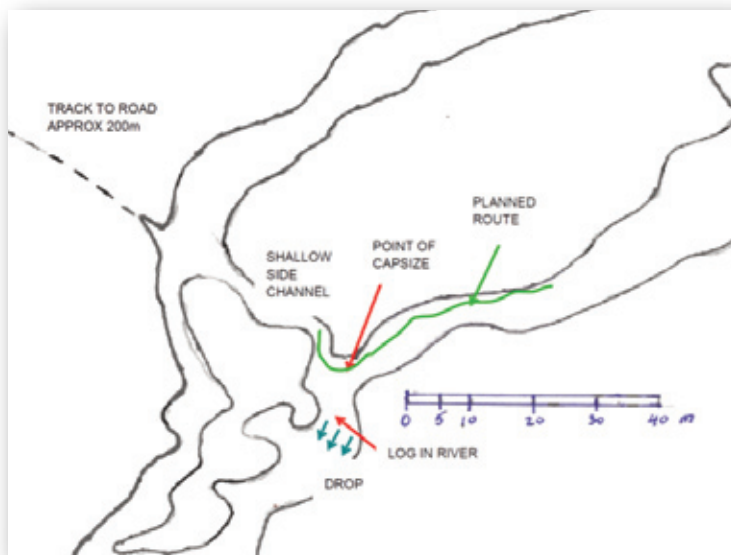
Plan of incident site.
