**REPORT INTO A
FATAL INCIDENT AT
LOUGH MASK
8th MARCH 2019**

**REPORT NO. MCIB/287
(No.6 OF 2020)**

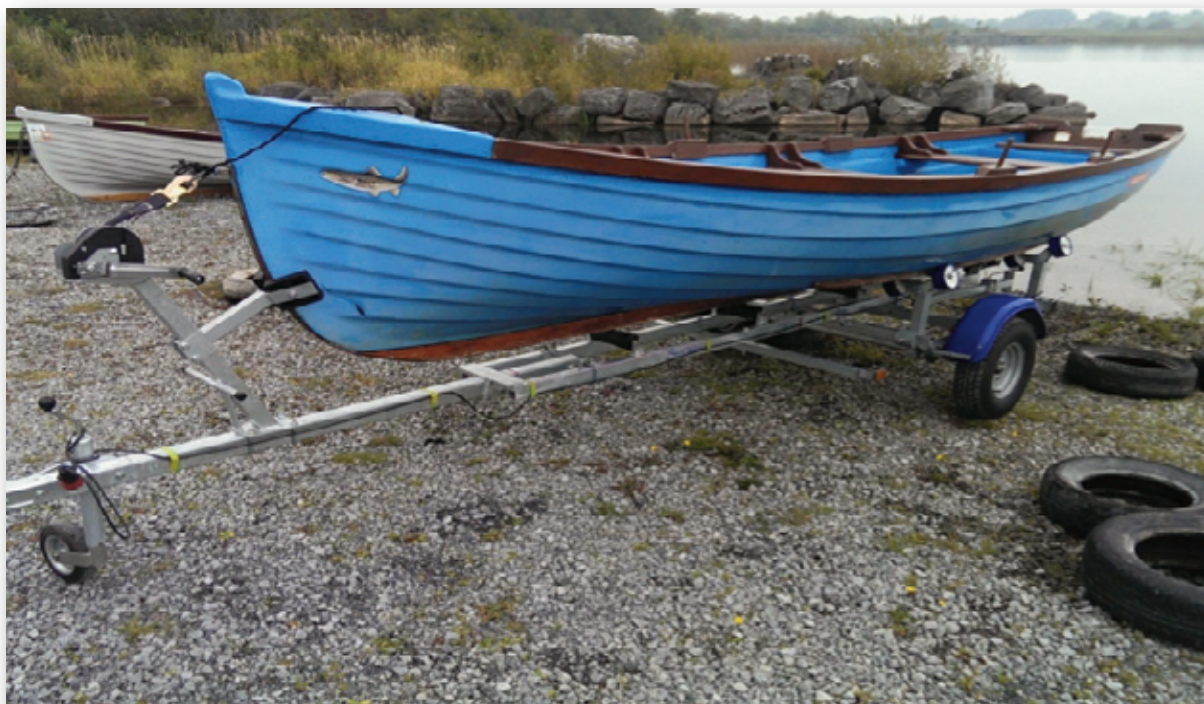
Type:	Lake Boat (see Appendix 7.1 Photo 1).
Length:	5.70 metres (m).
Beam:	1.60 m.
Maker:	Angler Fancy Boats.
Built:	2000 with the CE mark.
Boat construction:	Hull - Glass Reinforced Plastic (GRP) with built in buoyancy in the forward and aft sections. Hardwood gunwale and thwarts (seats). A keel band of 7.5cm Larch.
Engine:	15HP Yamaha outboard engine (vessel rated for a maximum horse power outboard of 9.9HP).
Engine details:	2006, 07 model, Mass 36 - 38 kg.
Fuel Type:	Petrol, with approximately 10 litres remaining in the fuel tank.

Photograph No.1 - Type of lake boat involved in the incident.

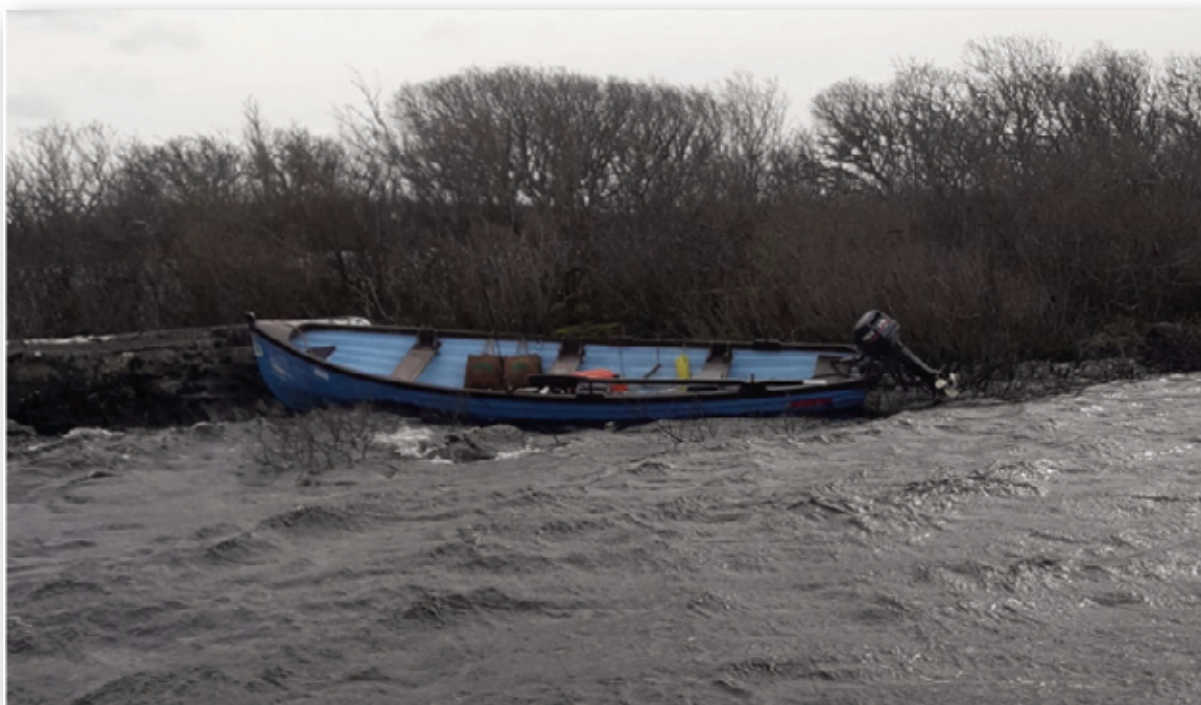
When the vessel was located it was in the upright position and in good order (see Appendix 7.1 Photograph No. 2). The outboard engine was in the lifted position and the port side oar was in the shipped position. The starboard side oar was subsequently found in the water nearby along with the angler's cap. A PFD, fishing gear, supplies and rod were in the stowed position.

- 4.1 There were no witnesses to the event which resulted in the Casualty entering the water. The Casualty was considered locally to be an experienced angler. It was reported that he had been angling on Lough Mask for many years and had entered numerous fishing competitions. The Casualty was a 78 year old male with no known medical conditions. Once in the water fully clothed and not wearing a PFD, he would have struggled to re-board the vessel.
- 4.2 The vessel was found in the upright condition with a small amount of water on-board (see Appendix 7.1 Photograph No. 2). The vessel was in reasonable order with provisions for a day of angling (see Appendix 7.1 Photograph No. 3). Once ashore the vessel's hull was inspected and there was no evidence of a collision or heavy impact.
- 4.3 The outboard engine was found in the lifted position (see Appendix 7.1 Photograph No. 2).

Photograph No.2 - The lake boat involved in the incident.

The Draft Report states the boat was recovered in good condition with equipment intact which is true. I submit that an indication of the weather conditions at the time of the incident is revealed in Photograph 2. There is considerable experience of rescue and recovery scenarios within CMSAR and more often than not a boat when

recovered is badly damaged and usually broken up by rocks or other shoreline obstacles, this was not the case in this instance. The boat, when located by CMSAR, was intact and positioned 'side on' to the prevailing wind and looked as if it had been literally lifted up and placed on the rocky shoreline. This fact, in my opinion, is an indication that the wave pattern at the time of the incident was of a sufficient height and force to carry and deposit the boat as found thus confirming the decision not to launch the D-Class inshore rescue boat in darkness was the correct one. The larger Rigid Inflatable Boat(RIB) was launched the following morning as this boat was more suitable for the prevailing weather conditions.

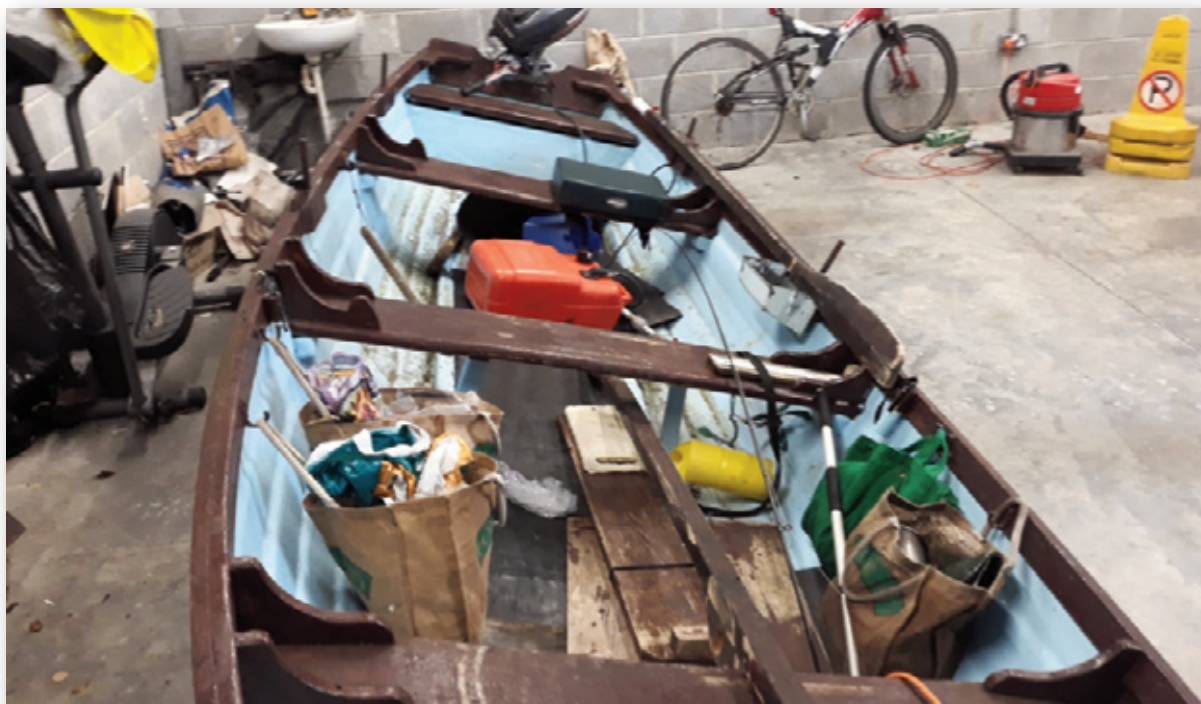
Photograph No.3 - Lake boat interior.

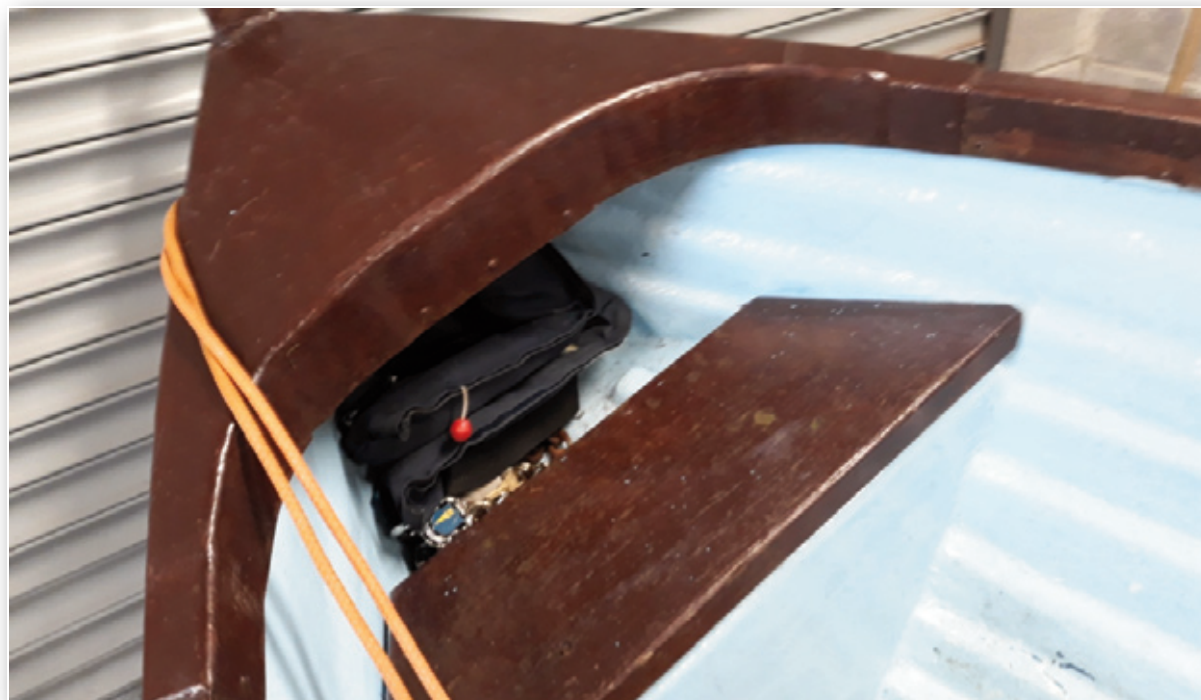
- 4.5 The Casualty was not wearing a PFD. A PFD was stowed in the forward part of the vessel (see Appendix 7.1 Photograph No. 4). The wearing of a PFD is a statutory requirement for the safe operation of recreational craft as stated in the CoP. The water temperature was 8°C and would have been cold to the human body on immersion. This would lead to the potential of cold shock for a person being suddenly immersed in the cold lake water. This along with the fact he was not wearing a PFD would have greatly reduced his chances of survival.

Photograph No.4 - PFD stowed in forward part of the lake boat under the gunwale.

- The need to be aware of the current forecast for the area.
- The requirement to wear a PFD.
- The need for a boarding ladder or other effective means of quickly re-boarding a vessel.

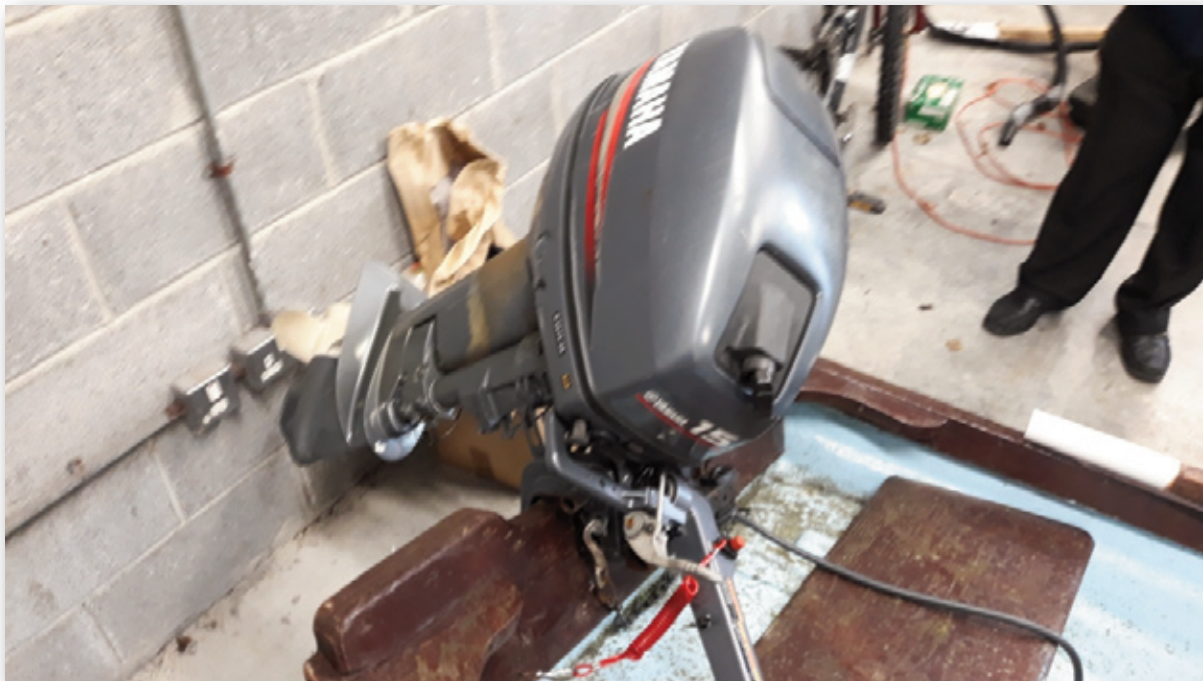
The engine was also found in gear which would not be the normal practice (see Appendix 7.1, Photograph No. 5). This suggests that the engine may have been lifted with a degree of urgency. Also, the outboard engine kill cord was not being used in the correct manner and was clipped to the transom of the vessel (see Appendix 7.1 Photograph No. 5).

Note: The 15HP outboard engine exceeded the boat manufactures recommendations.

Photograph No.5 - Outboard engine found in gear and kill cord attached to transom.

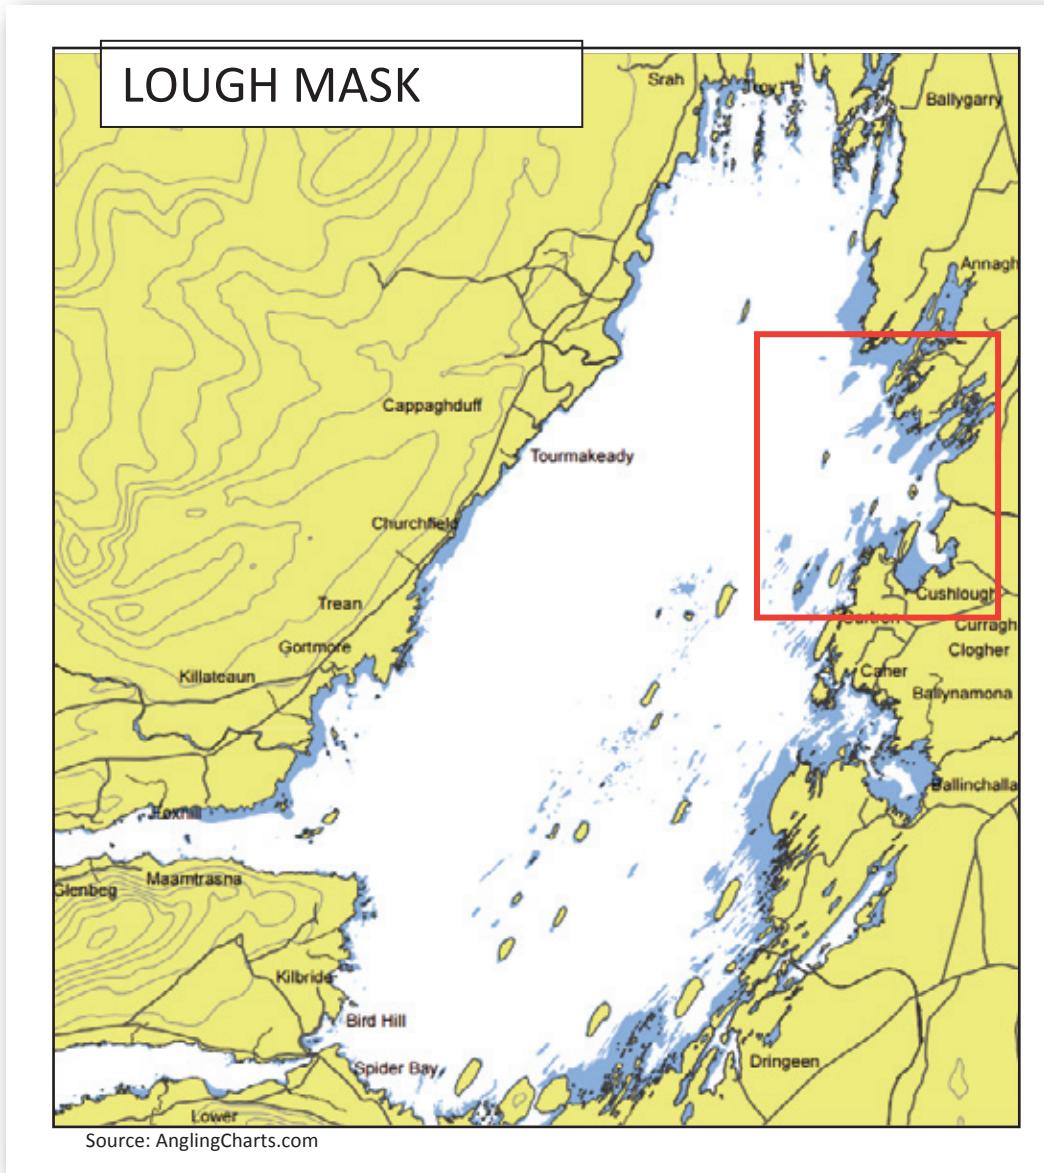
Chart 1 - Lough Mask, incident area bordered in red.

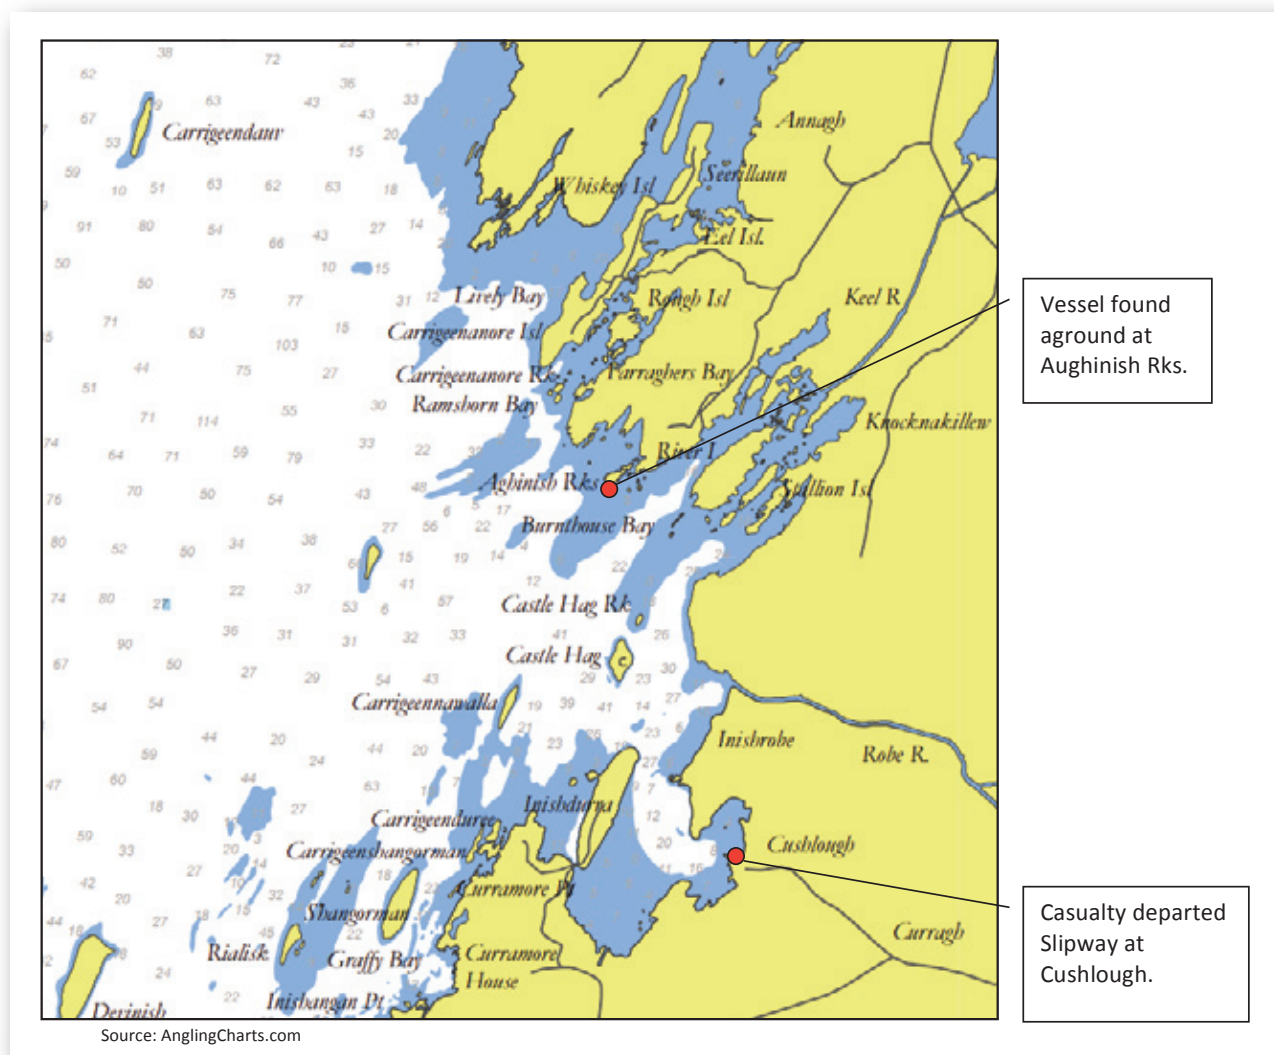
- 3.5 On the following day (9th March 2019) the search resumed at first light. Approximately 2 hrs into the search the angler's vessel was found on the eastern shore of Lough Mask, on Aghinish Rocks, approximately 1.5 nautical miles north of Cushlough slip. There was no sighting of the missing angler (see Appendix 7.1 Photograph No. 2 and Appendix 7.2 Charts 1 and 2).

Chart 2 - Location of lake boat and Casualty.
