**REPORT OF THE  
INVESTIGATION INTO  
A FATAL INCIDENT  
ON THE RIVER SUIR,  
CAHIR, CO. TIPPERARY  
11th NOVEMBER 2017**

**REPORT NO. MCIB/275  
(No.4 OF 2019)**

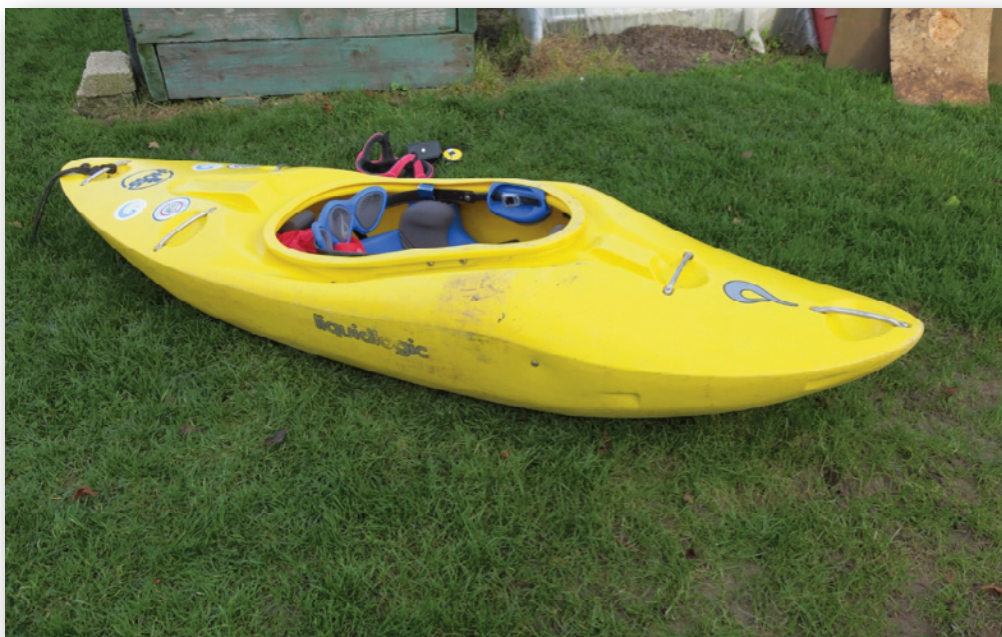
The vessel as inspected was structurally in a satisfactory condition with no breaches of the hull fabric. Various scrapes and gouges were apparent on the hull which were consistent with a vessel used for kayaking.

Photograph No. 1: General View of the kayak.

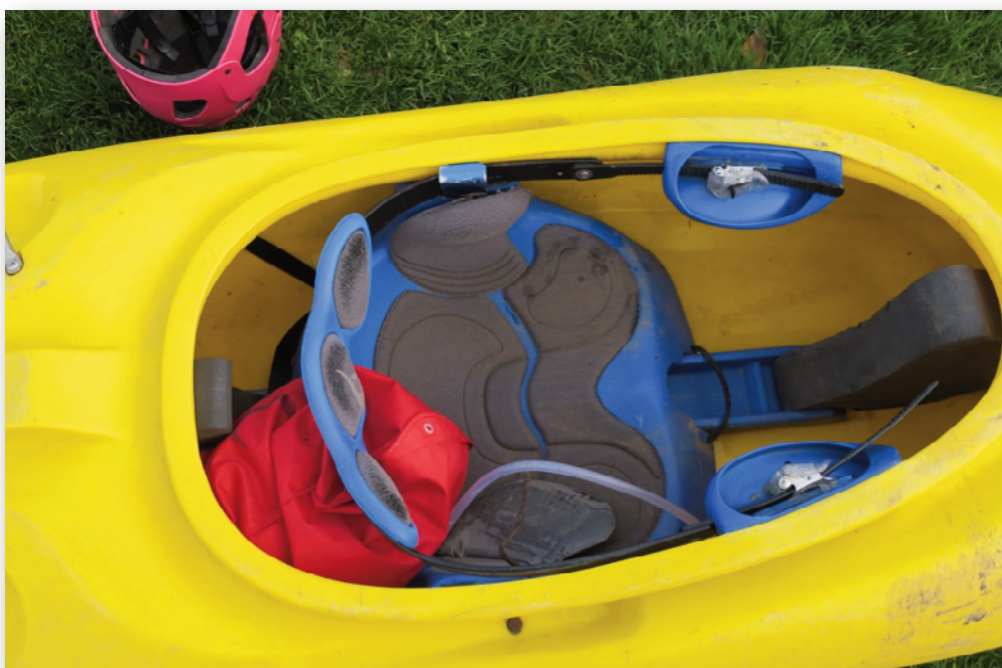
Photograph No. 2: Cockpit of the kayak.

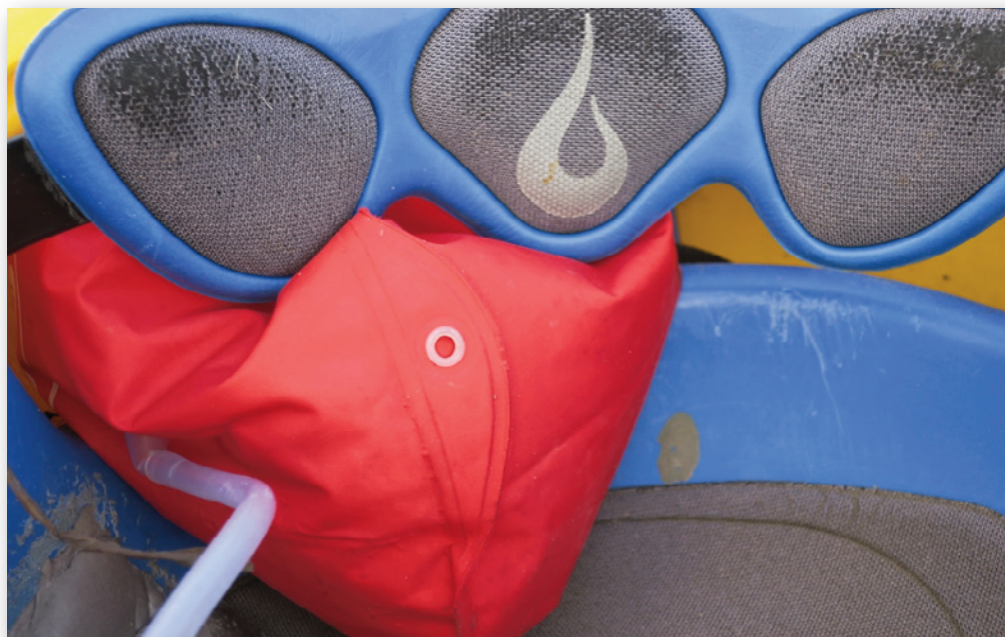
The vessel was fitted with internal foam buoyancy and two inflatable 25 litre buoyancy bags. When the vessel was recovered one of the buoyancy bags was missing.

Photograph No. 3: Buoyancy Bag.

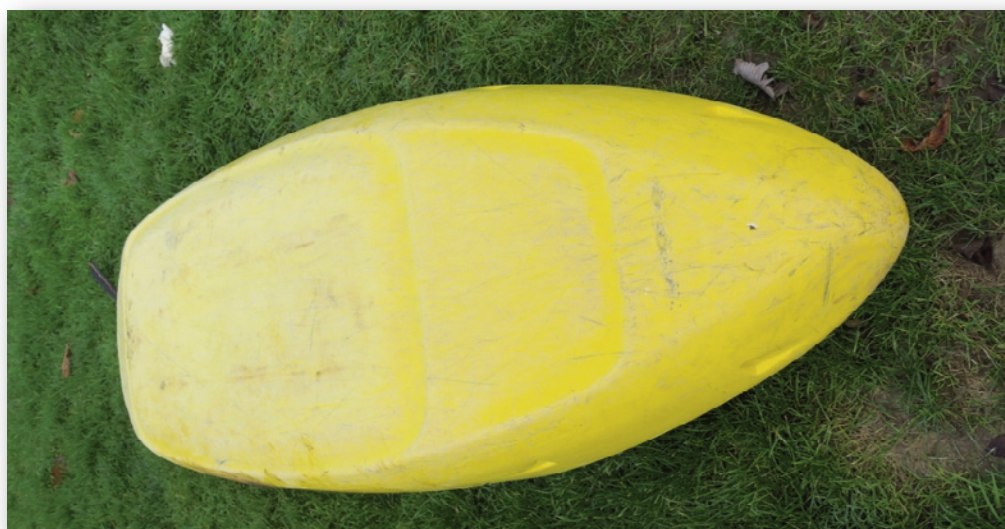
Photograph No. 4: Bottom of the kayak.

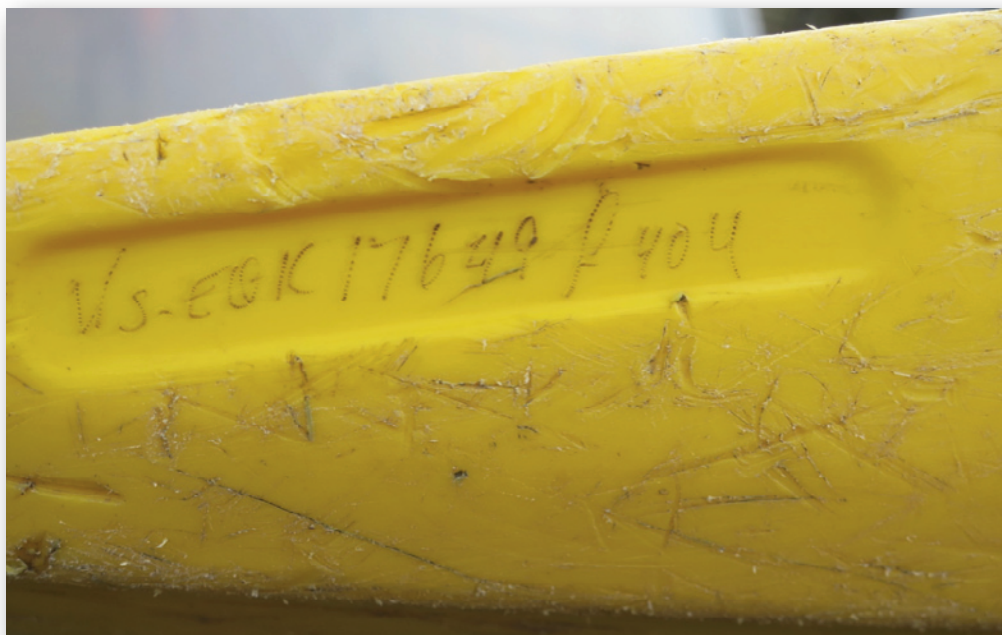
Photograph No. 5: Hull ID No. on the kayak.

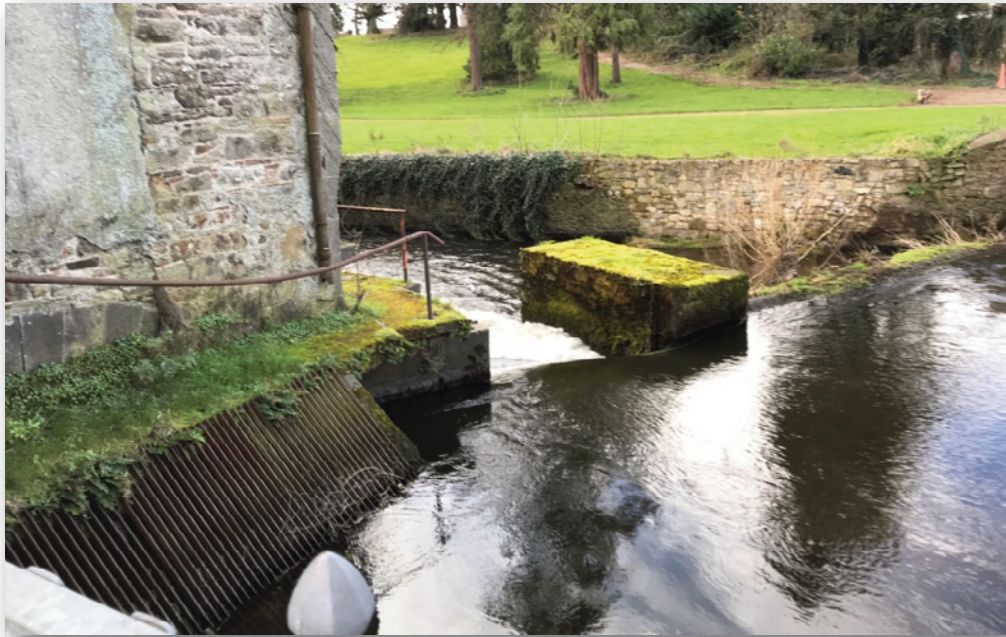
The weir area where the incident occurred would be considered a Grade 2, or on the day, a Grade 3.

Photograph No. 7: Weir where the capsizing occurred.

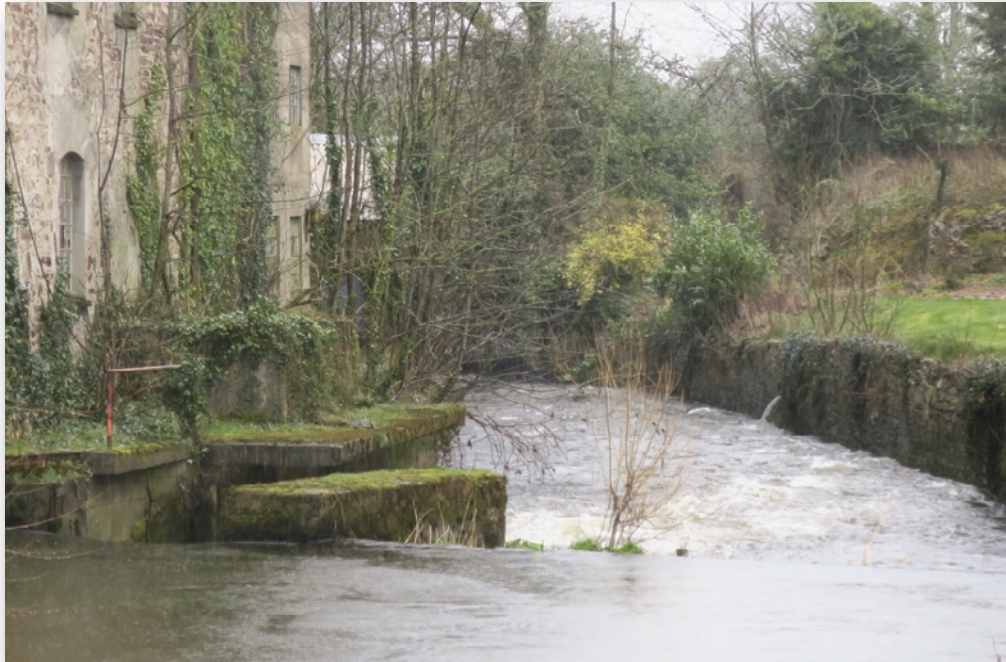
Photograph No. 8: Sluice and weir, sluice on the left-hand side of the photograph.

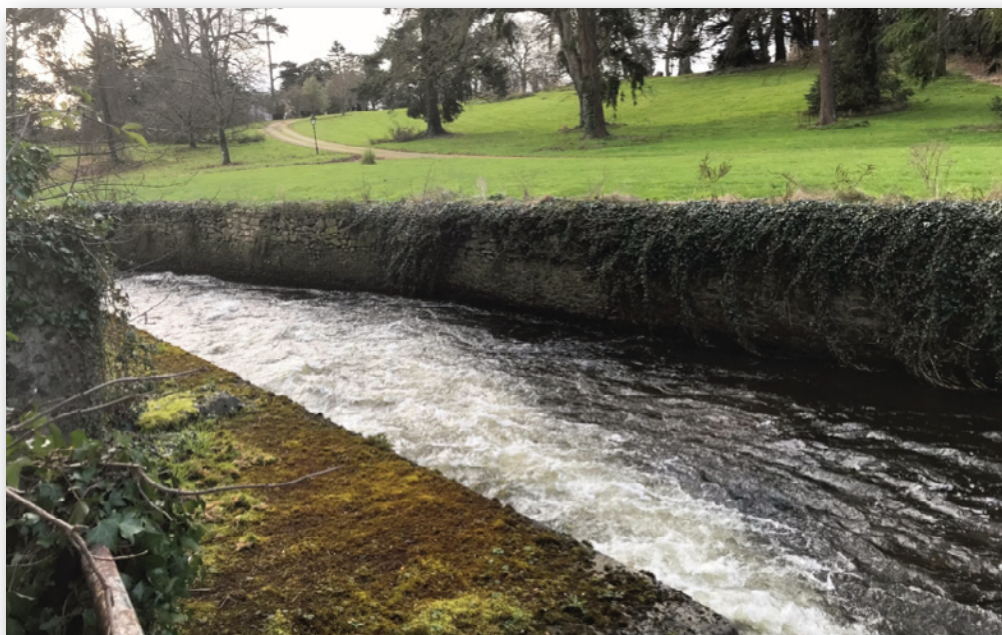
Photograph No. 9: Rapid flowing water downstream from weir.

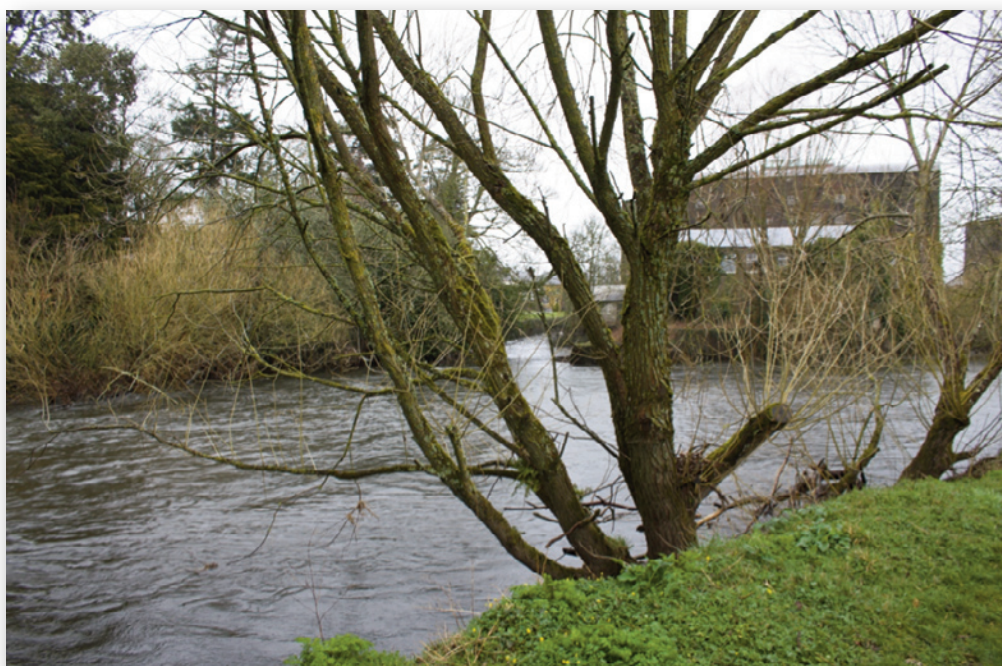
Photograph No. 10: Tributary from the weir to the main channel.

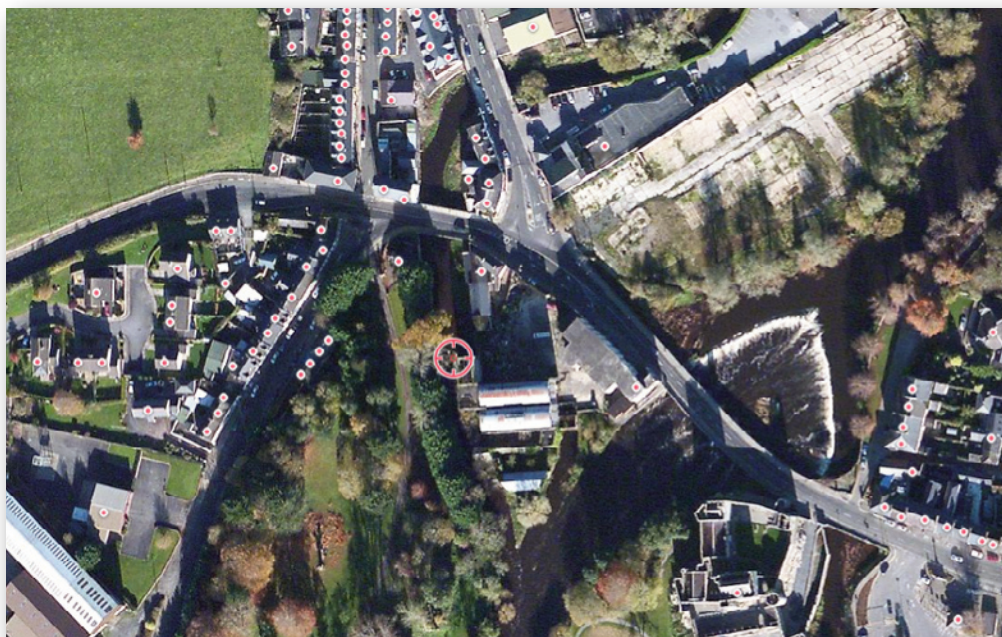
Photograph No. 13: Location of the weir.
