**REPORT OF THE INVESTIGATION
INTO FATAL INCIDENT
INVOLVING THE
'FV AISLING PATRICK'
15 NM OFF BROADHAVEN,
CO MAYO
10th APRIL 2018**

**REPORT NO. MCIB/277
(No.3 OF 2019)**

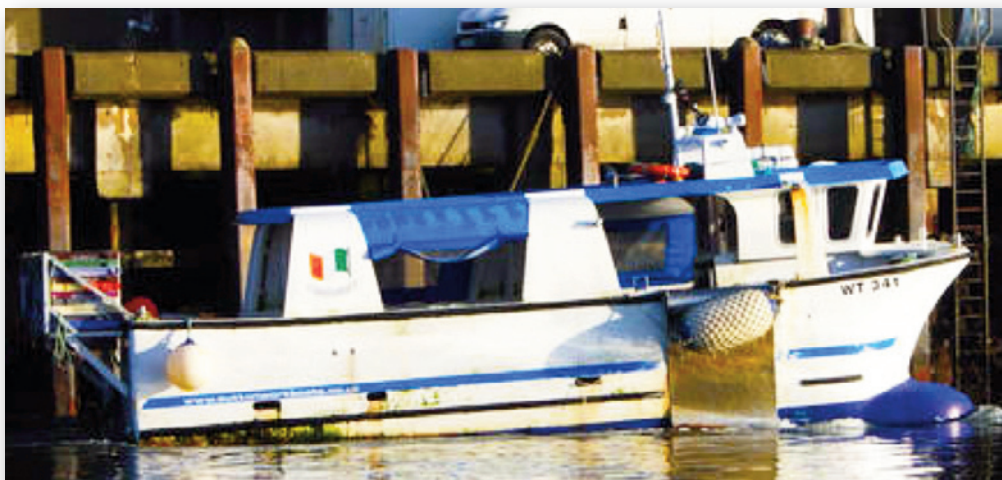
Photograph No.1 - 'FV Aisling Patrick'.

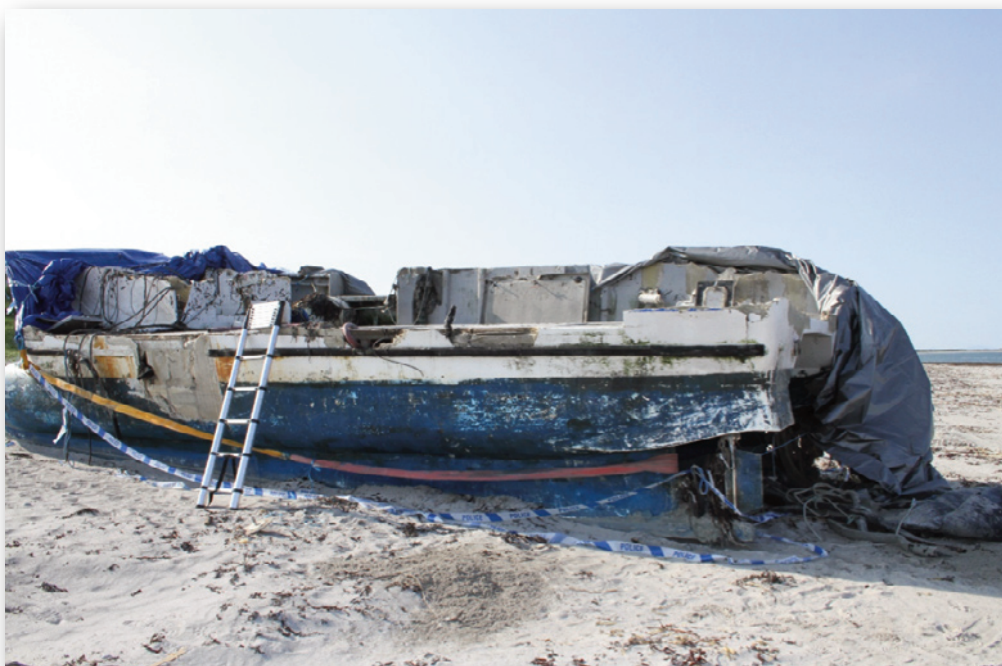
- 3.20 The vessel was dug out of the sand and turned upright and a second inspection was undertaken on the 28th May. The wheelhouse and the port and aft bulwarks had been broken off and no parts of them were found on the beach. The starboard engine hatch cover was missing and the other five hatch covers were in place. Inspection of the seals and securing arrangements found them to be in good condition. The hatch coamings and seals on the two forward and two aft hatches had been modified at the request of the surveyor during the CoP survey. There were accumulations of sand and water in all compartments and much of these had to be removed before inspection. Inspection of the starboard engine compartment found all sea cocks and attached pipework undamaged except for the connection between the oil cooler and salt water pump (see 3.21 below).

Photograph No.2 - Hull of the vessel on the 28th May.

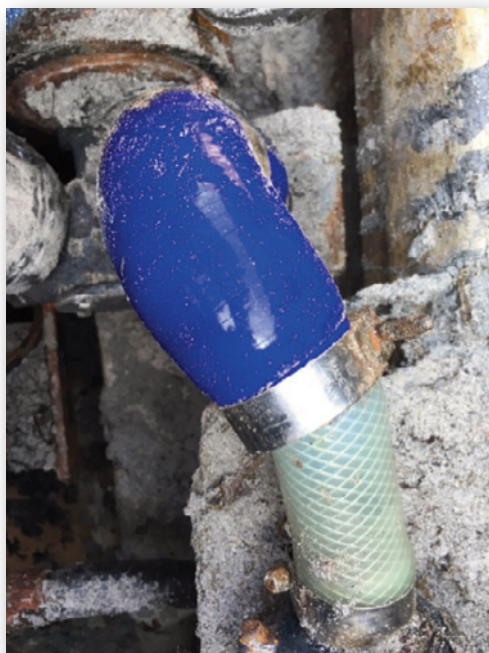
- 3.2 The vessel was surveyed by the Irish Marine Survey Office in March, 2011 and issued with a passenger boat licence for 12 passengers valid for two years. After the initial survey the inlet hose to the salt water pump was cut and a hydraulic oil cooler was inserted on the suction side of the pump. An elbow of sections of hose with stainless steel inserts was fabricated to join the oil cooler to the pump. Hoses were held by jubilee clips (see Appendix 7.1 Photograph No.3 and diagram alongside).

- 3.21 The pipework and elbow from the oil cooler to the salt water pump was connected when located but under pressure it came apart (see Appendix 7.1 Photographs No.3 and No.4). It was made up of three sections of different diameter plastic pipe. The two end pieces were 45 mm outside diameter. The centre section (see Appendix 7.1 blue in Photograph No.3) had an inside diameter of 54 mm, a difference of 9 mm. There was one stainless steel pipe inside the centre section curved slightly to make the elbow. The two sections of pipe were flexible plastic and tightening the jubilee clip between the blue section and the clear section attached to the oil cooler. The owner stated that there had been a second section of stainless pipe inside the joint to compress the two sections of pipe together. No such section of pipe was found in the engine compartment.

- 4.3 In the engine compartment (starboard centre) the elbow between the oil cooler and water pump may not have made a good watertight connection because the jubilee clip may not have fully closed the 9 mm difference in the pipe diameters as described in 3.20. The water pump drive pulley was making contact with the engine casing (see Appendix 7.1 Photograph No. 6). This could have caused vibrations which caused water to leak from the joint between the water pump and oil cooler. Evidence that water had been leaking for some time was indicated by the amount of rust staining on the forward end of the engine, which had been replaced in 2014 (see Appendix 7.1 Photograph No.5). The statements of the owner and Skipper that the oil cooler and water pump had moved apart could indicate an increase of water flow on the day of the incident. It is preferable to have the minimum number of joints in pipework and this elbow should have been one piece of stainless steel pipe with plastic pipe joints connected at each end. The joint was situated on or slightly above the waterline, however, with the pump drawing suction, water would siphon in and once the joint was lower than the outside sea level it would flow in faster than the bilge pumps could handle. Water in the compartment would have been surging around and could have shorted the exposed connection to the bilge pumps causing failure and allowing water to build up.

Photograph No.3 - Elbow between oil cooler and water pump.

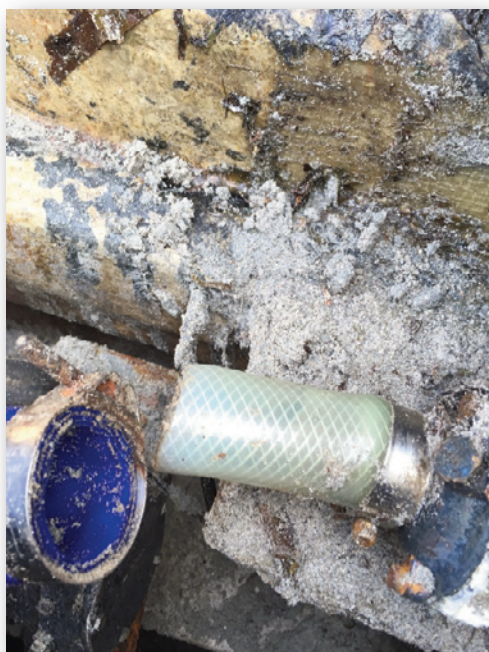
Photograph No.4 - Joints came apart with light pressure.

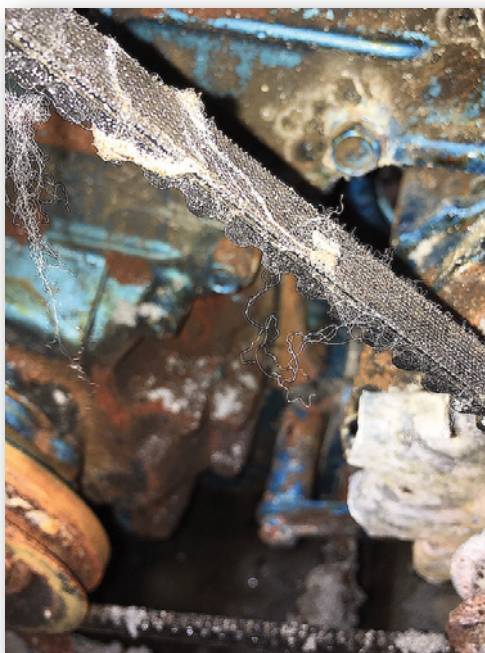
- 3.22 The water pump appeared to be misaligned and there were marks on the engine casing where the drive pulley had come in contact with it (see Appendix 7.1 Photograph No.6). When the owner and Skipper were shown photographs of the pump and oil cooler they stated that both the water pump and the oil cooler had moved apart from their normal positions. There was rust staining on the forward end of the engine (see Appendix 7.1 Photograph No.5).

Photograph No.5 - Rust on forward end of starboard engine.

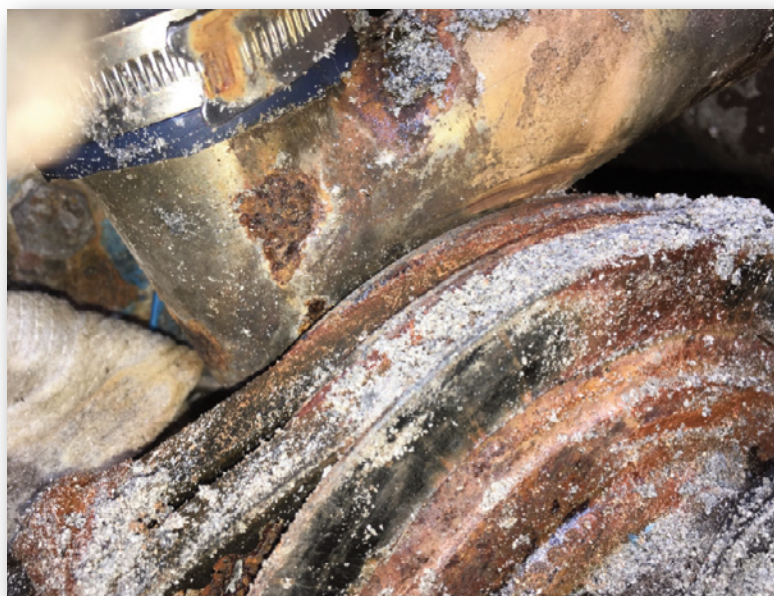
Photograph No.6 - Marks where the water pump drive pulley was in contact with the engine.

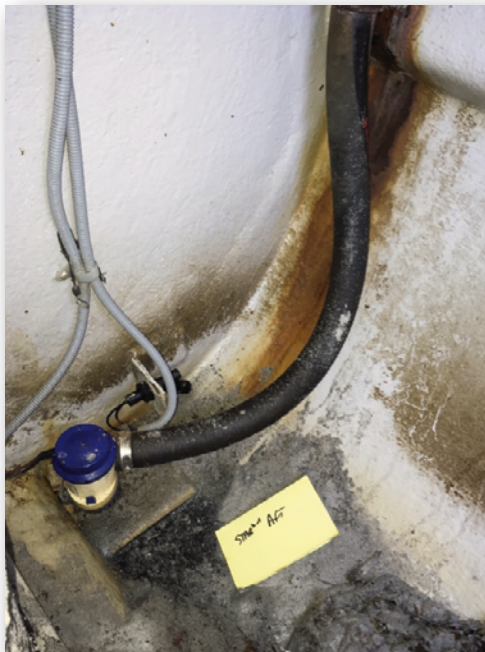
- 3.23 Inspection of the starboard aft compartment found signs of water ingress over an extended period of time in way of the point where the bilge pump outlet passed through the deck. There was also a line showing the level of water that frequently accumulated in the compartment (see Appendix 7.1 Photograph No.1). This water would have covered the bilge pump. Inspection on deck found evidence of cracking in way of the joint between the deck and the GRP duct on the bulwark side which permitted water ingress.

- 4.2 The aft starboard compartment had evidence of water lying in it which covered the bilge pump (see Appendix 7.1 Photograph No.7). It is likely that this was rainwater which seeped through the crack in the duct on deck and built up in the compartment when the boat was not in use. When the power was switched on the pump would operate and pump the water out. On the day of the incident the power had been on for over five hours so the bilge pump should have pumped all of the water out of the compartment.

Photograph No.7 - Water ingress in aft starboard compartment.

- All defects in the vessel including cracks should be repaired and the CoP complied with.
 - All watertight hatches should be secured when vessels are at sea.

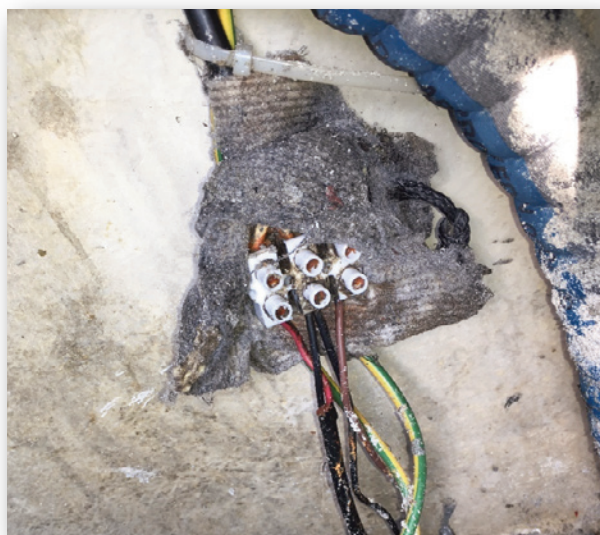
- 3.24 All bilge pumps were inspected and all were found to have clear impellers. The bilge pump from the starboard aft compartment was removed and it operated when connected to a battery. The power supply to the second bilge pump in the starboard engine compartment had been connected to the power supply to the lower bilge pump with a block connector and covered with tape. The connection was mid height on the aft bulkhead of the compartment and the tape had torn and the connector was exposed (see Appendix 7.1 Photograph No.8). Inspection of other compartments did not reveal any obvious failures, except in the port aft compartment where the exhaust hose was cracked in two places and there was staining on the sides of the compartment in way of the cracks.

Photograph No.8 - Electrical connections to the bilge pumps in starboard engine compartment.

- They must maintain their vessel in accordance with the requirements of the CoP including informing of any modifications.
 - They must ensure that bilge pumps and alarms are regularly tested as recommended in Marine Notice 35/2016 and maintained in an operational condition.
