**REPORT OF INVESTIGATION  
INTO A FATAL INCIDENT  
INVOLVING  
'FV JULIE ELEANOR'  
GALWAY BAY  
22nd NOVEMBER, 2017.**

**REPORT NO. MCIB/276  
(No.2 OF 2019)**

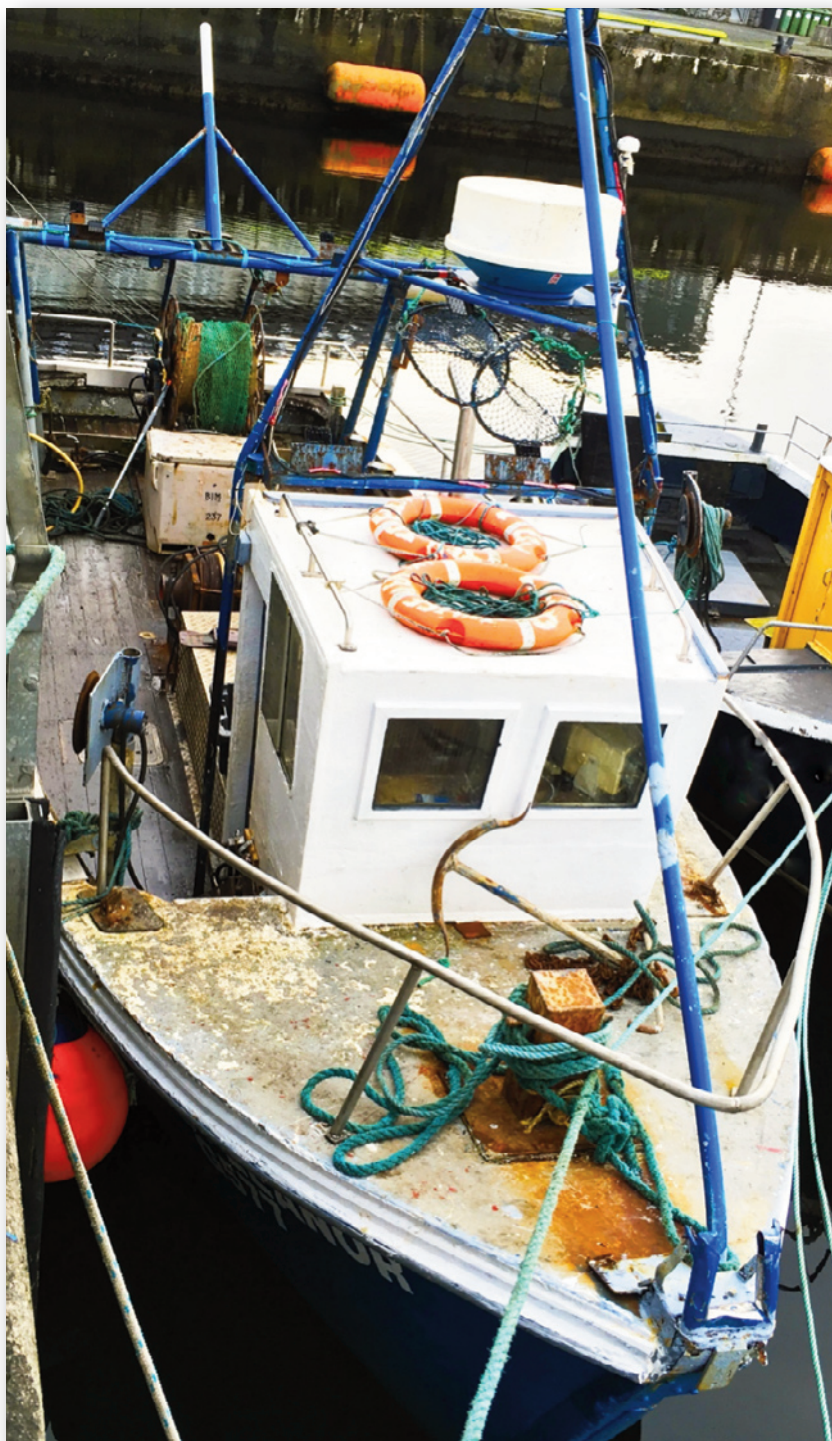
Photograph No. 1: 'FV JULIE ELEANOR'.

See Appendix 7.1 Photograph No.1.

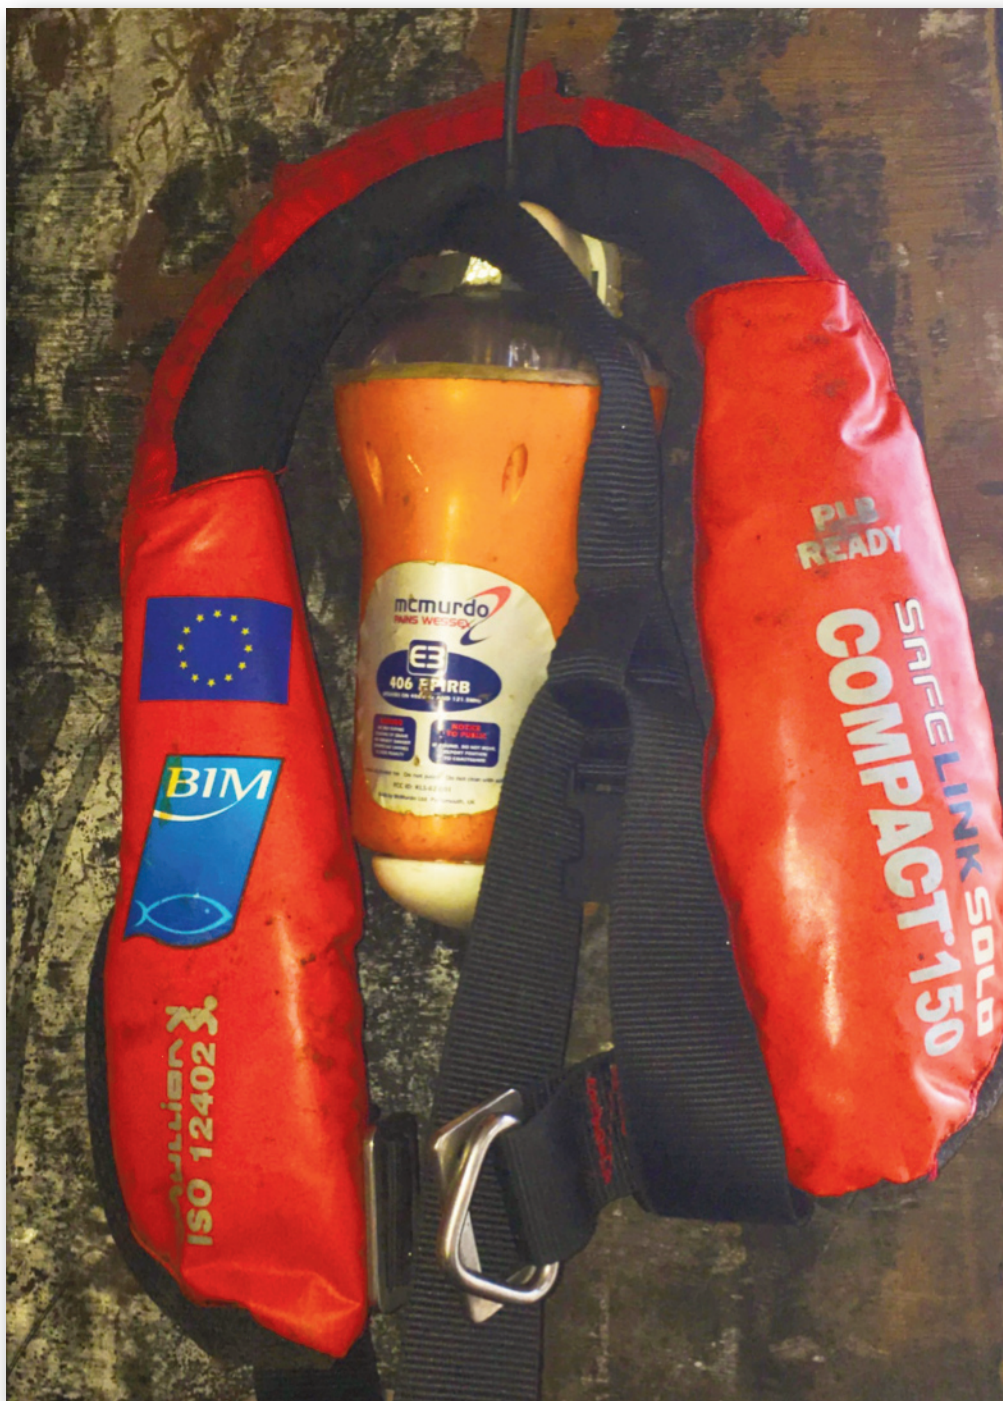
One Mullion Compact 150 inflatable PFD was found hanging in the wheelhouse. Its service date was February 2017 (see Appendix 7.1 Photograph No. 2).

- 3.10 Inspection of the vessel after the incident found that the structure of the vessel was sound with parts newly painted. The Mullion Compact 150 inflatable PFD hanging in the wheelhouse was the only one on the vessel. The PFD, EPIRB and First Aid kit all required renewal or servicing. There was no liferaft and the two life rings on the wheelhouse roof were securely tied to the handrails. There was no means of recovering a person from the water as required by the "Code of Practice" section 7.9.1 (see Appendix 7.4).

Photograph No. 2: The PFD hanging in wheelhouse.
