**REPORT OF AN INVESTIGATION
INTO THE FIRE AND LOSS OF
“FV HORIZON”
OFF THE OLD HEAD OF
KINSALE, CO. CORK
14 MAY 2021**

**REPORT NO. MCIB/309
(No.3 OF 2022)**

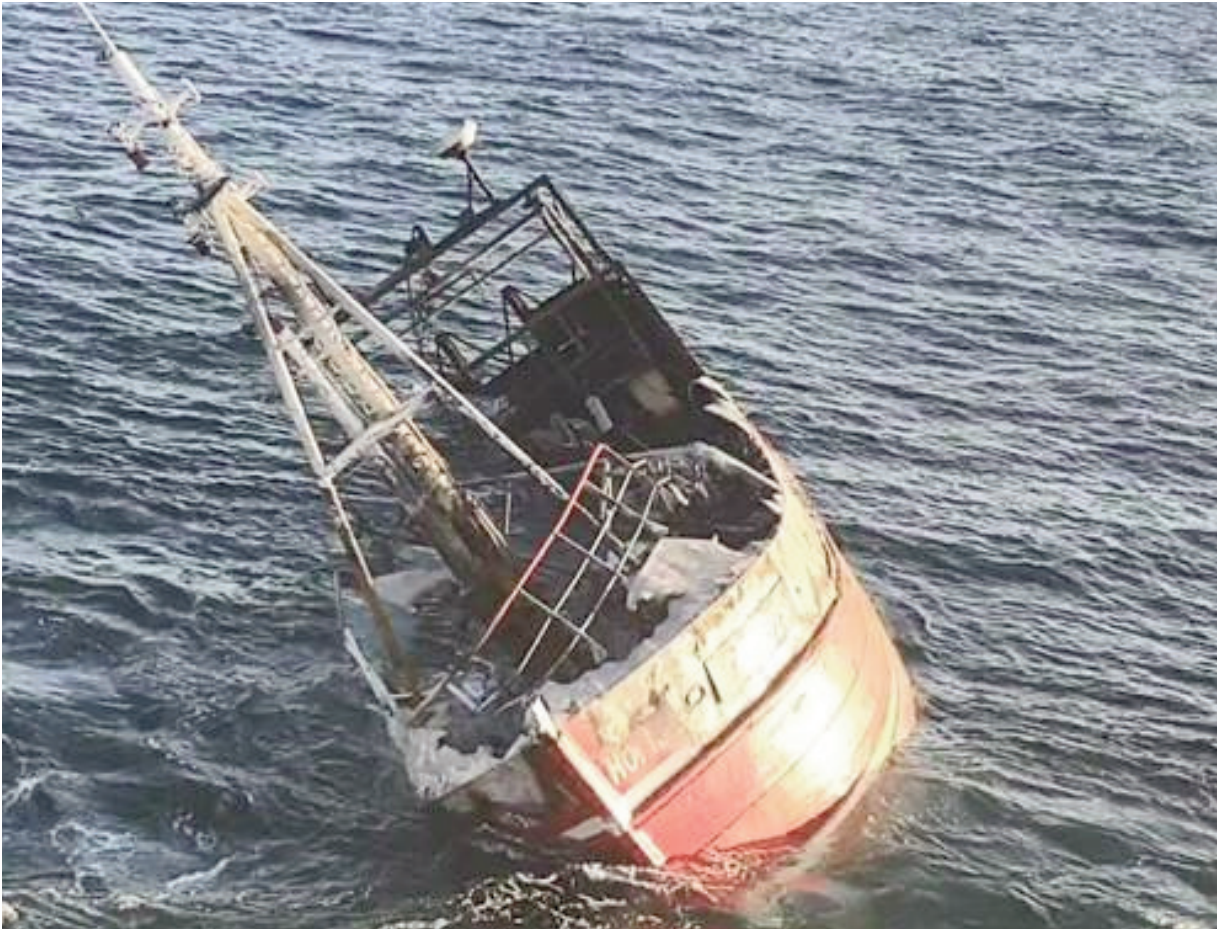
Appendix 7.14 Photograph No. 2 - "FV Horizon" Awash

- 4.6.2 The Skipper stated that the main engine and the fish hold refrigeration system were cooled each with seawater drawn directly through two separate pipe systems from the sea through the vessel's hull mounted seawater inlet valves located on the hull beneath the vessel's water line. These systems had sections of reinforced flexible plastic hoses connecting the pipework from the seawater valves to the machinery cooling systems. These hoses, when exposed to fire, melt and fail allowing an uninterrupted flow of seawater into the engine room compartment. The seawater flowing into the engine room would fill into the adjoining compartments as the bulkheads were burned through and eventually the water would fill the vessel which would sink. It can therefore be deduced that the fire was a causative factor in the sinking of the "FV Horizon" in that the intense heat of the fire melted the plastic components of the vessel's machinery cooling systems which lost their watertight integrity allowing seawater into the vessel to the extent that "FV Horizon" filled with seawater and sunk.

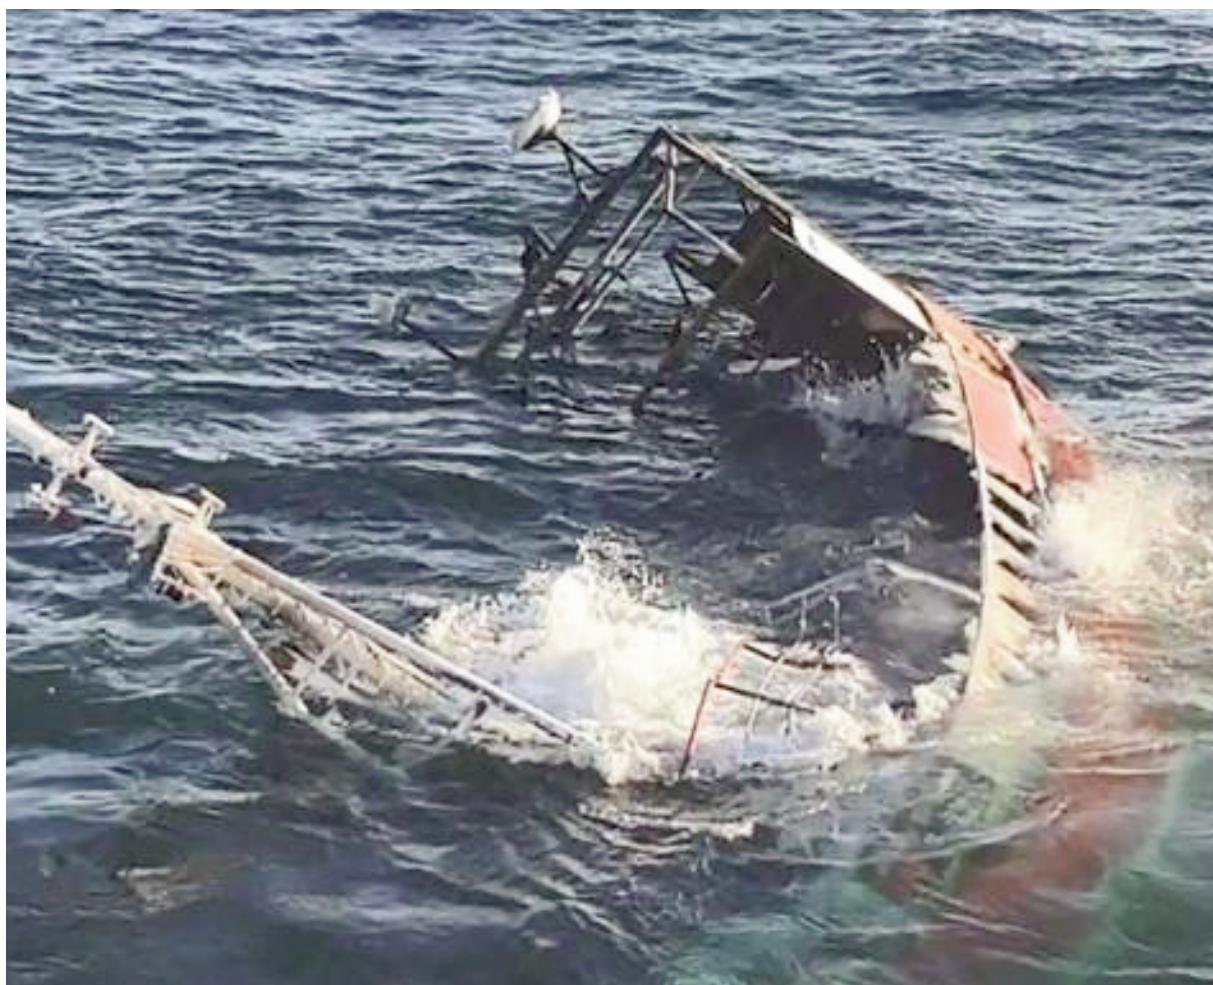
Appendix 7.15 Photograph No. 3 - "FV Horizon" Sinking

- 4.6.3 For the same reasons outlined in paragraph 4.5 it can also be deduced that the absence of fire proofing materials in the flexible hose components of the vessel's machinery cooling systems (connecting the cooling systems to the sea through the hull mounted sea valves), caused these to melt. It is deduced that, as the hoses melted, the sea was allowed to flood into the vessel through the cooling systems hull mounted sea valves and was a causative factor in the sinking of the vessel.

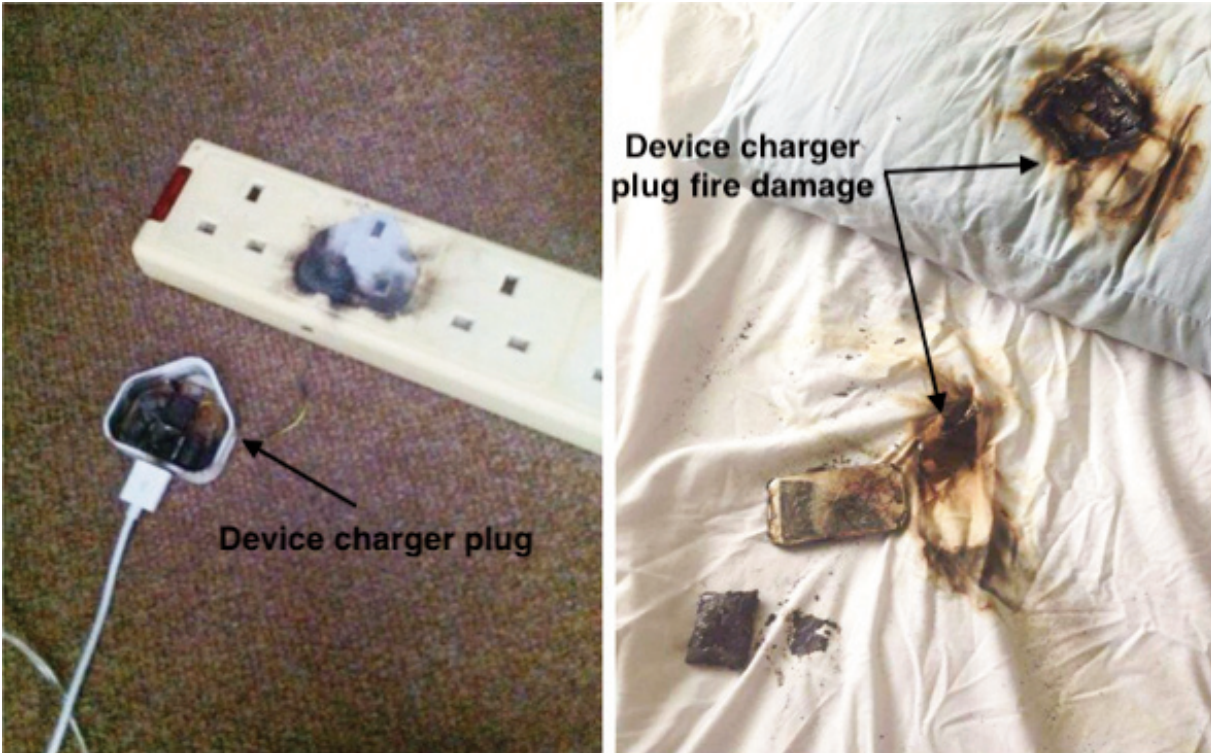
Appendix 7.16 Image No. 1 - Electronic Device Battery Charger Fire Damage

- 4.4.2 The crew each had mobile phones. These electronic devices contain lithium batteries and require re-charging, usually from a 240V AC electrical power socket and there was a 240V AC circuit in the cabin with sockets. It was probable that electronic devices were in the cabin as the vessel was 30 NM offshore (and likely out of mobile phone coverage) and therefore not in use by the crew. Lithium batteries are commonly damaged when overcharged and become prone to overheating and even igniting in some instances. Electronic device battery chargers also carry a risk of overheating and igniting and should not be operated near combustible materials or left unattended. The galley and accommodation cabin 240V AC sockets were regularly used by the crew for charging the batteries of their electronic devices. It is surmised that one or more of these devices were in the accommodation cabin and may have been plugged into the 240V AC sockets, unattended, while the crew were working on deck. It would be reasonable to deduce that an unattended mobile phone or other similar electronic device in the process of being charged and/or an electronic device battery charger may have been the source of ignition for this fire and may therefore, present a causative factor for the fire onboard the vessel.

See Appendix 7.16 Image No. 1 - Electronic Device Battery Charger Fire Damage.
See Appendix 7.17 Image No. 2 - Lithium Battery Fire Damage.
