**REPORT OF AN INVESTIGATION
INVOLVING
“FV MARLIONA”
AT GREENCASTLE CO. DONEGAL
3 FEBRUARY 2021**

**REPORT NO. MCIB/307
(No.4 OF 2022)**

- 1.1 At approximately 14.05 hours (hrs) on the afternoon of 3 February 2021, a serious marine casualty occurred on the fishing vessel (FV) “*Marliona*” while alongside Greencastle Harbour, Co Donegal. During a repair process the Skipper’s left arm became trapped by a trawl door causing severe damage to his arm.
- 1.2 First aid was administered by another crewmember and the bleeding was stopped. The ambulance was called and arrived at 14.30 hrs, and the Casualty was transferred to the nearest hospital where he was treated for his injuries. The hospital treated the Casualty and managed to save his arm. He was released the same day but continued to receive treatment and only returned to work in May 2021.

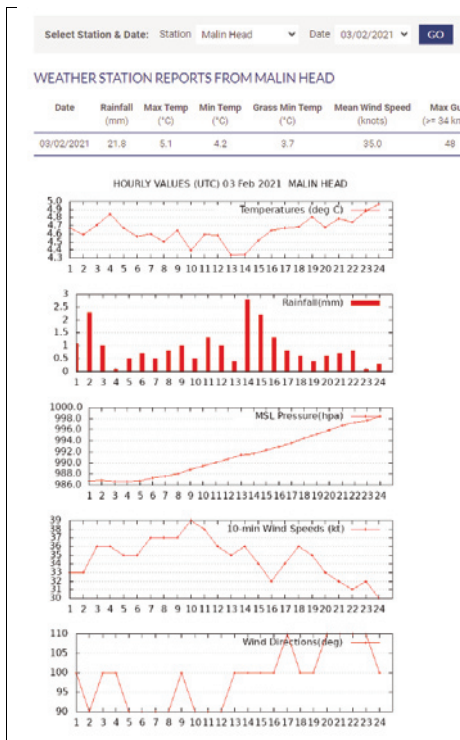
3-Feb-2021 Observations from nearest (land based) Meteorological Station including Windrose.
Station: Malin Head (approximately 30 km to the northwest of the incident location)
