**REPORT OF AN INVESTIGATION
INTO AN INCIDENT INVOLVING
KAYAKERS ON MULROY BAY,
CO. DONEGAL
19 MARCH 2022**

**REPORT NO. MCIB/318
(No.4 OF 2023)**

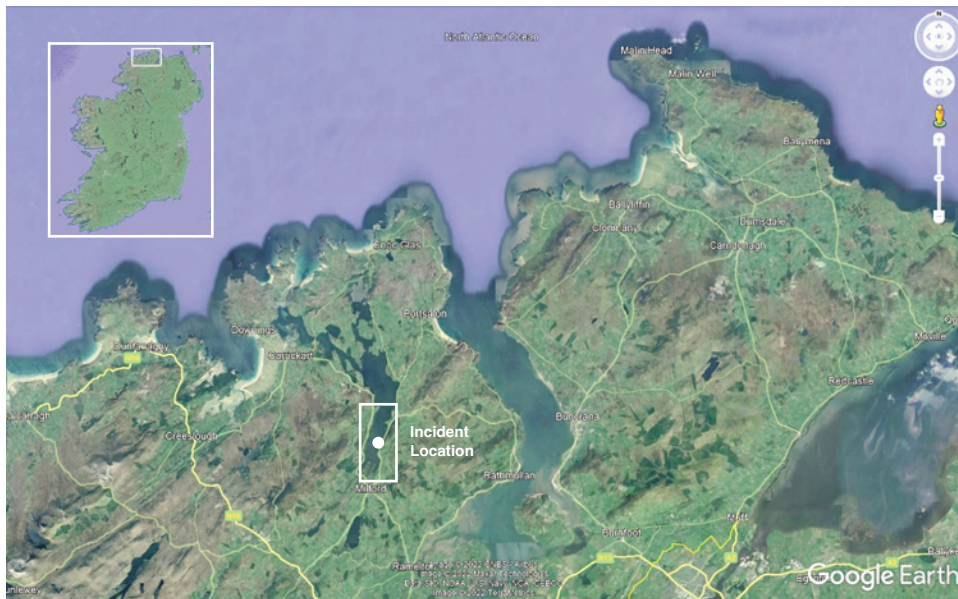
Figure 1: Aerial overview of north Co. Donegal, annotated to highlight the area in which this marine casualty event occurred. Image Source: Google Earth.

2.1.1 The trip was a commercial, guided kayaking tour on Mulroy Bay sea lough in north Co. Donegal. The group consisted of six persons, comprising the Trip Organiser and five clients who were novice or first-time kayakers. The trip was intended to be approximately 3 km/1.5 NM in overall length. The trip included a crossing of the sea lough, which is approximately 1 km/0.5 NM in width. The trip's point of departure (and its intended return point) was the public pier on east shore along the R246 Millford - Kerrykeel road. See Figures 1 and 2.

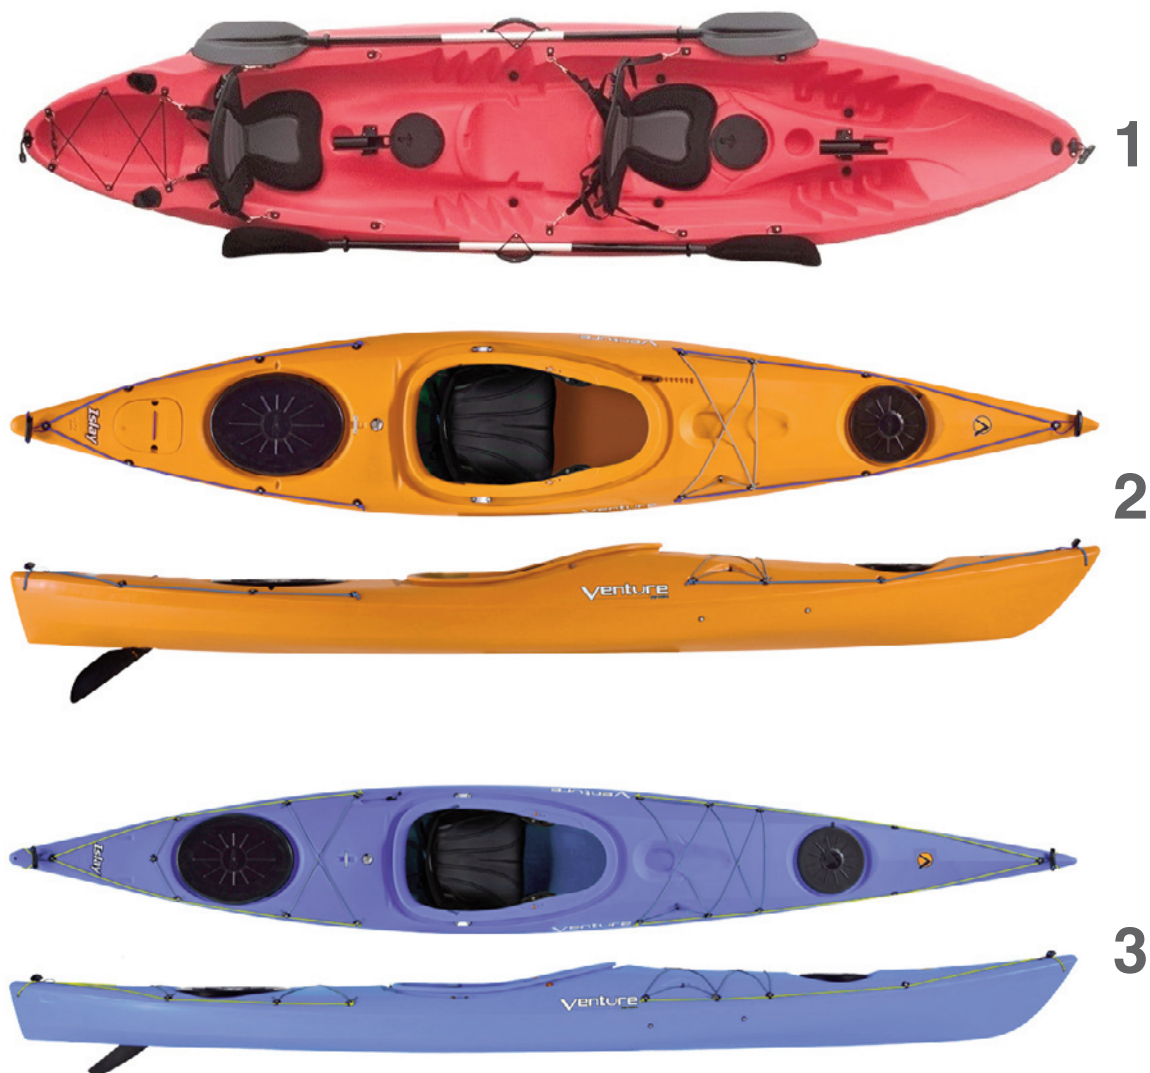
2.2.2 This kayaking group used three different types of kayaks, which this report refers to as Type 1, Type 2 and Type 3 kayaks. See Figures 3 and 4. The Trip Organiser had purchased these kayaks new in 2019.

Figure 3: The three types of kayaks in use on this trip, highlighting (1) the double kayak, (2) the 12-foot single kayak, (3) the 14-foot single kayak.

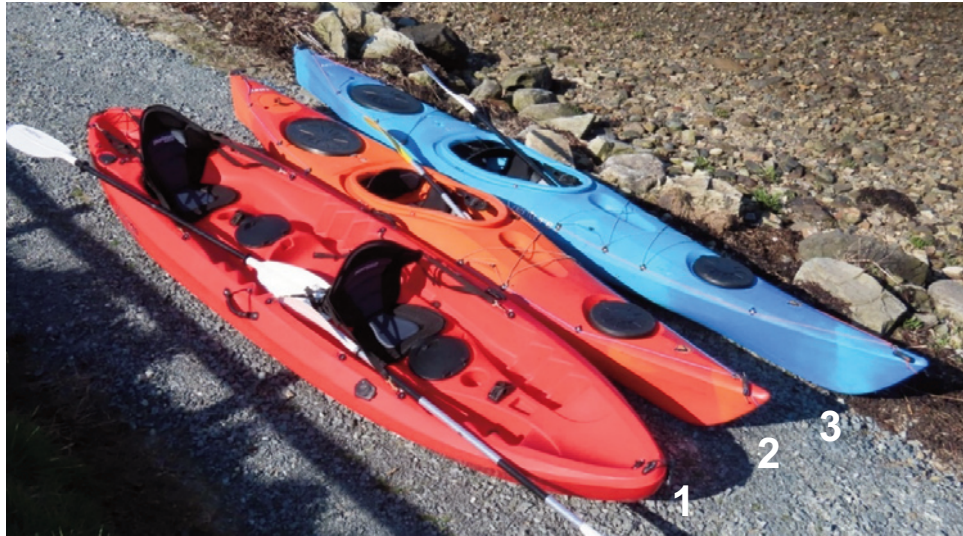
Figure 4: The three types of kayaks in use on this trip, highlighting (1) the double kayak, (2) the 12-foot single kayak, (3) the 14-foot single kayak.
Source: www.venturekayaks.com and www.horizonkayaks.com

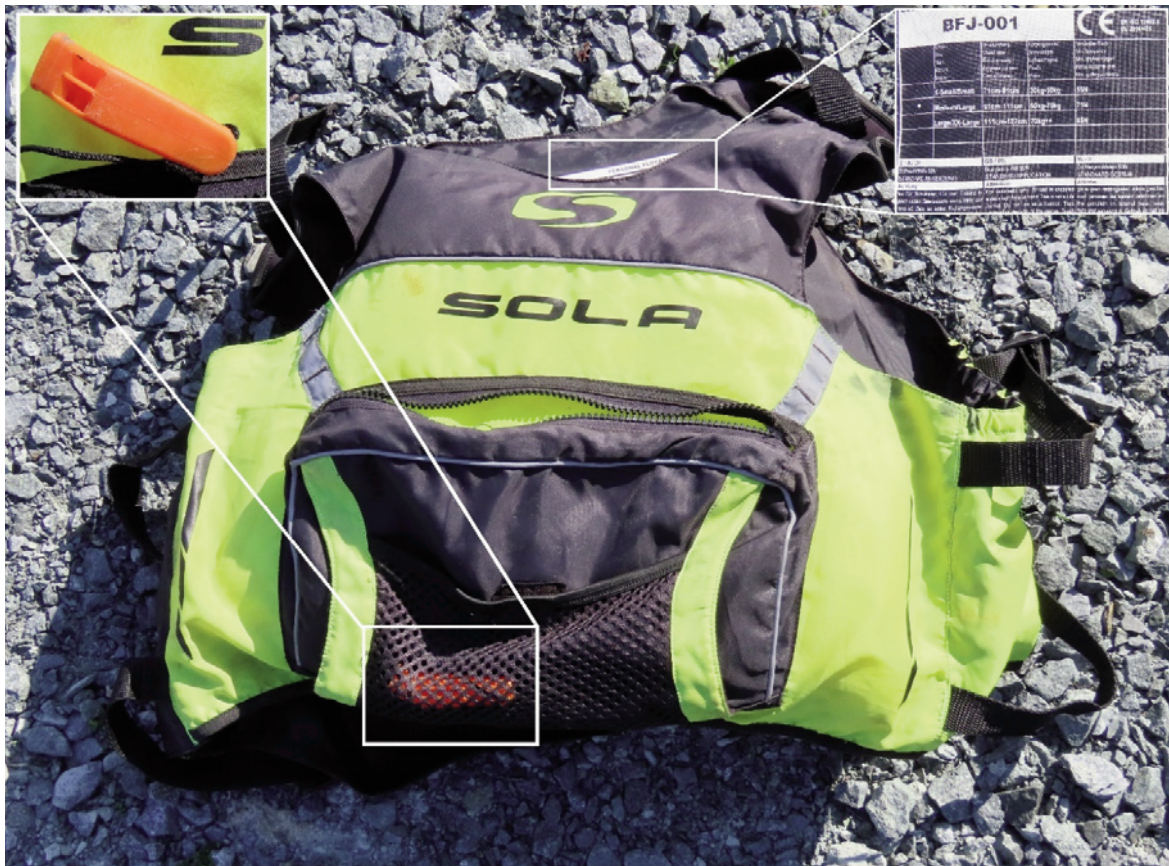
2.11.2 The buoyancy aids were correctly provided with a whistle, located within a chest pocket and attached by string. The buoyancy aids include the CE mark and identify how this product was designed in accordance with the standard EN ISO 12402-5 published by the EU and the International Organisation for Standardisation (ISO).

Figure 5: The type of buoyancy aid used by the kayaking group, highlighting the provision of a whistle and this product's compliance with the European Standard for PFDs, EN ISO 12402-5.

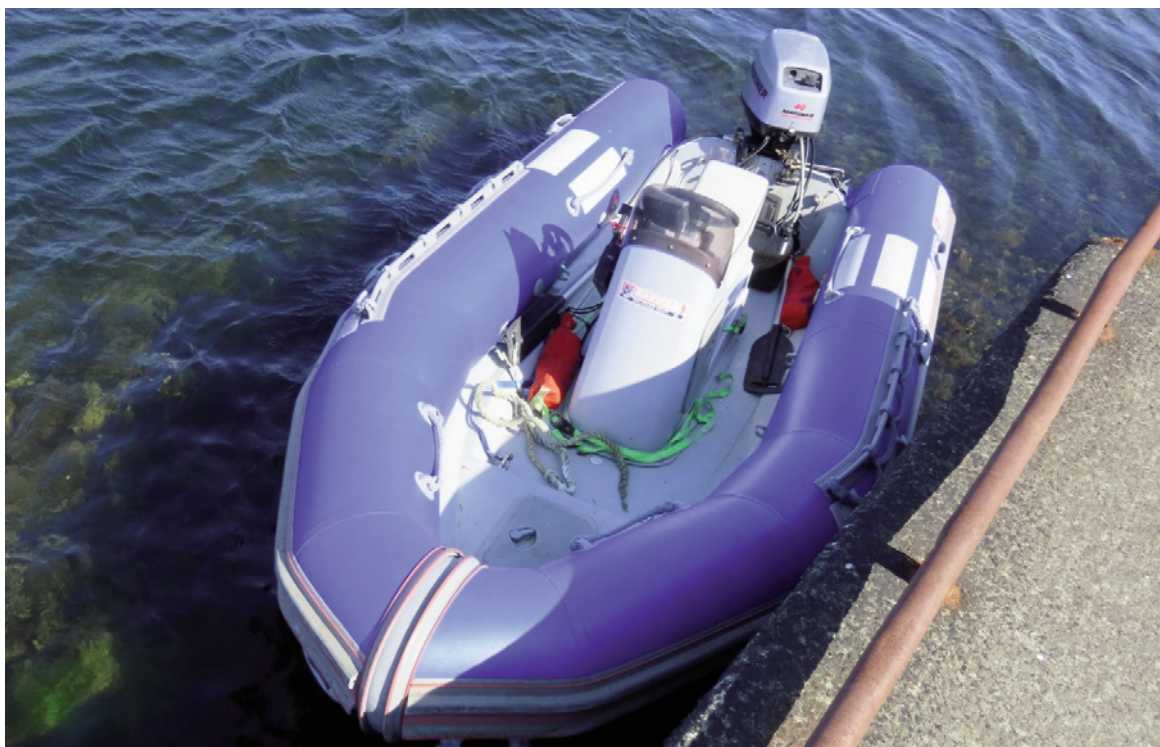
Figure 6: The rescue boat the Trip Organiser opted not to use on this trip.

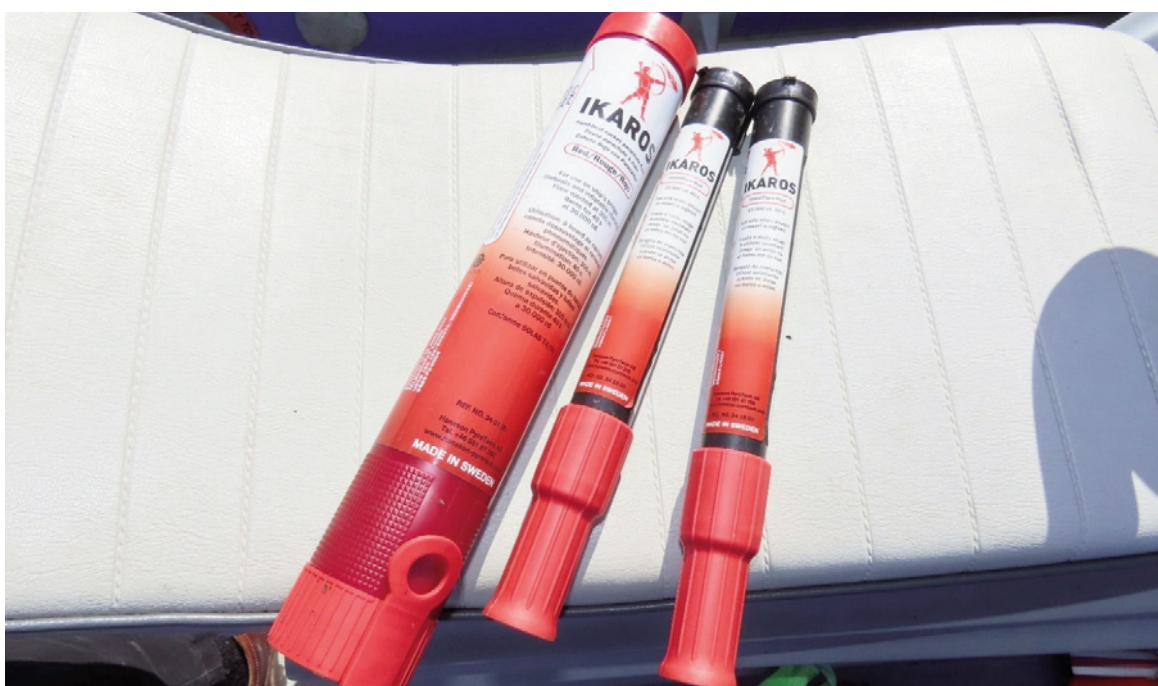
Figure 7: The signalling flares stored on the rescue boat that was not in use on this trip.

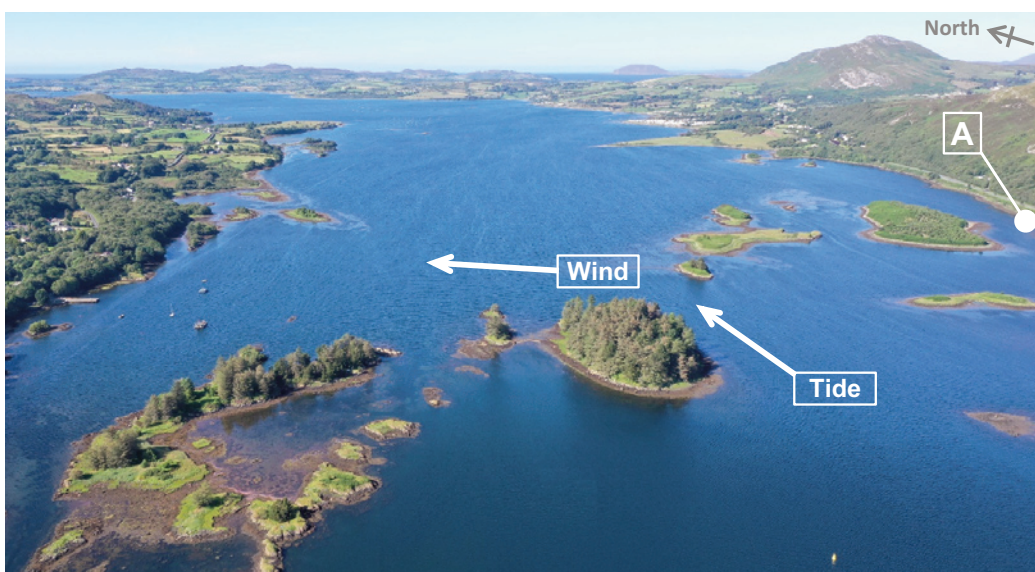
4.1.2 The wind direction was across the lough (travelling from the southeast) and the tidal stream was along the length of the lough's shores (travelling towards the northeast). See Figure 9. The topography of the land along the east shore is steeply sloping, with the result that a person standing on the shore at this kayaking trip's start point (A) is likely to experience wind conditions that are more benign than those away from the shore, out on the lough, on days when the wind is from the southeast. This is likely to have been the situation on the day of this marine casualty event.

Figure 9: Aerial overview, annotated to highlight the approximate direction of wind and tide. Image Source: Geraldine Hennigan.

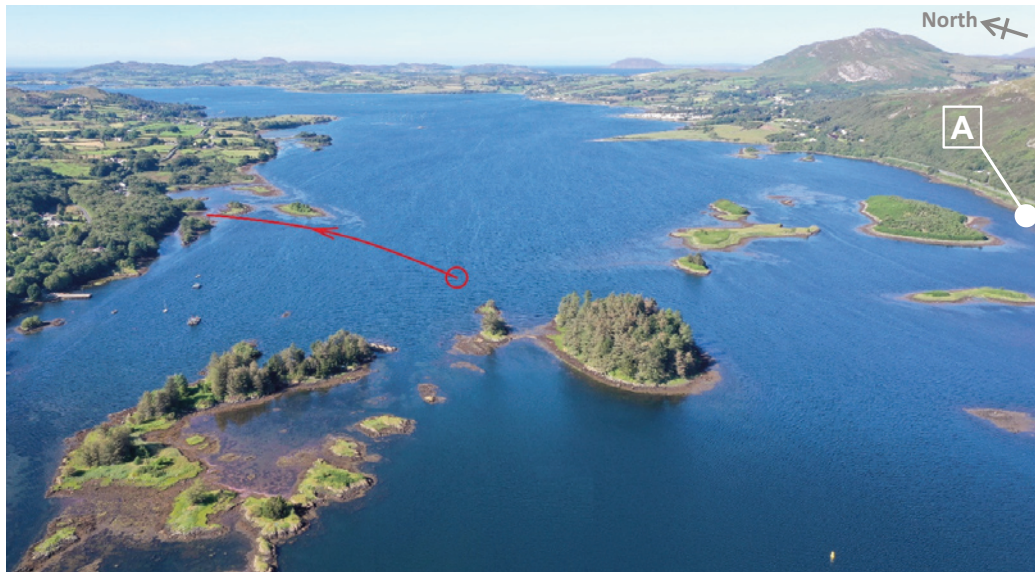
- 4.1.3 After the capsizes commenced, Clients 1 and 2 in the double kayak made their way to the west shore. See Figure 10.

Figure 10: Aerial overview, annotated to highlight the approximate route taken by Clients 1 and 2 after their double kayak capsized. Image Source: Geraldine Hennigan.

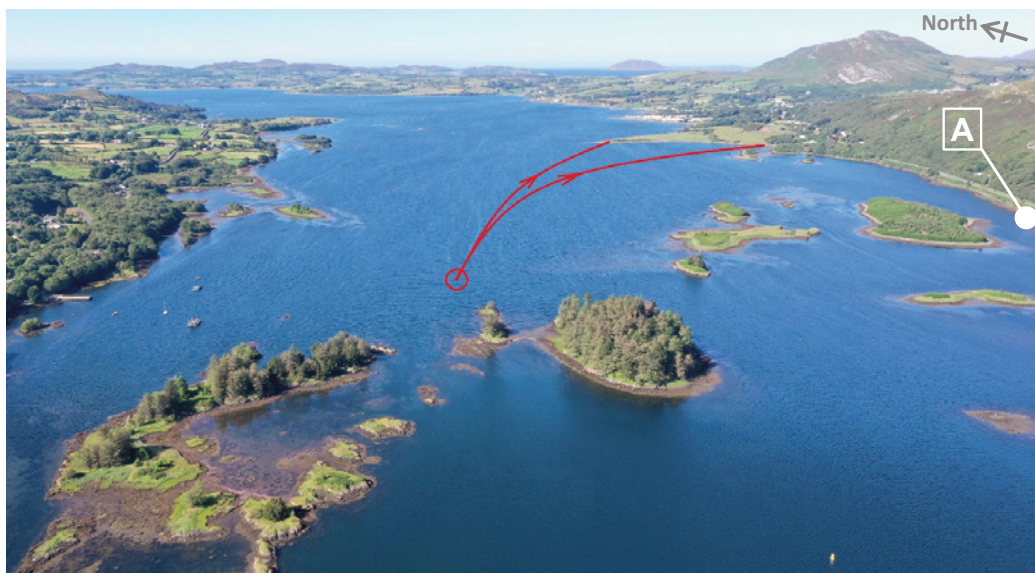
- 4.1.4 After the capsizes commenced, Clients 3 and 4 in single kayaks separately made their own way to the east shore. See Figure 11.

Figure 11: Aerial overview, annotated to highlight the approximate route taken by Clients 3 and 4 who separately made their own way to the east shore. Image Source: Geraldine Hennigan.

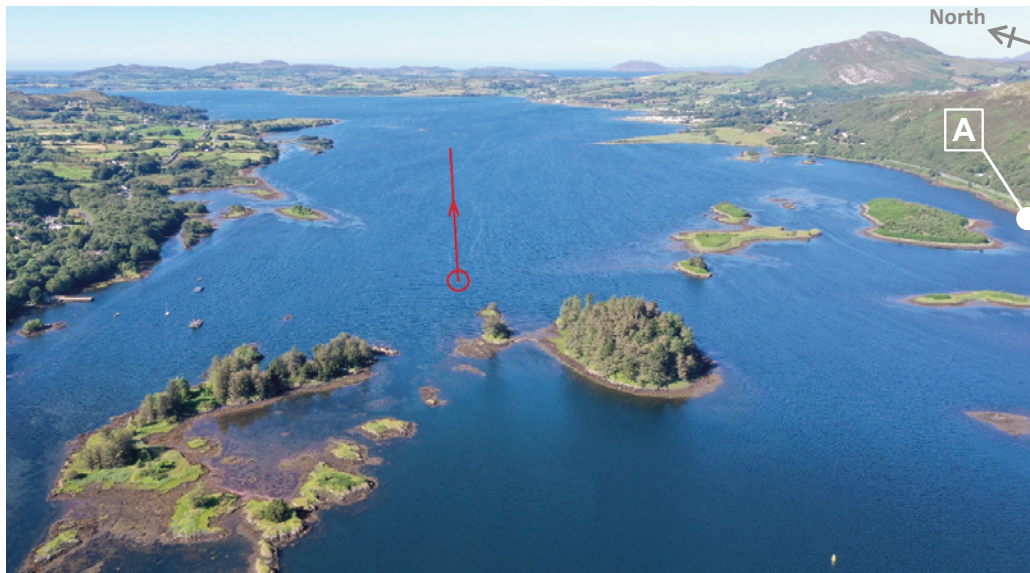
- 4.1.5 Client 5 and the Trip Organiser both capsized and separated from their single seat kayaks. They drifted in the water for approximately one hour and ten minutes, being carried by the tidal stream, until they were rescued from the water by the Coast Guard at a position off Ranny Point headland. See Figure 12.

Figure 12: Aerial overview, annotated to highlight the approximate drift of Client 5 and the Trip Organiser after they capsized and separated from their kayaks, until being rescued by the Coast Guard. Image Source: Geraldine Hennigan.

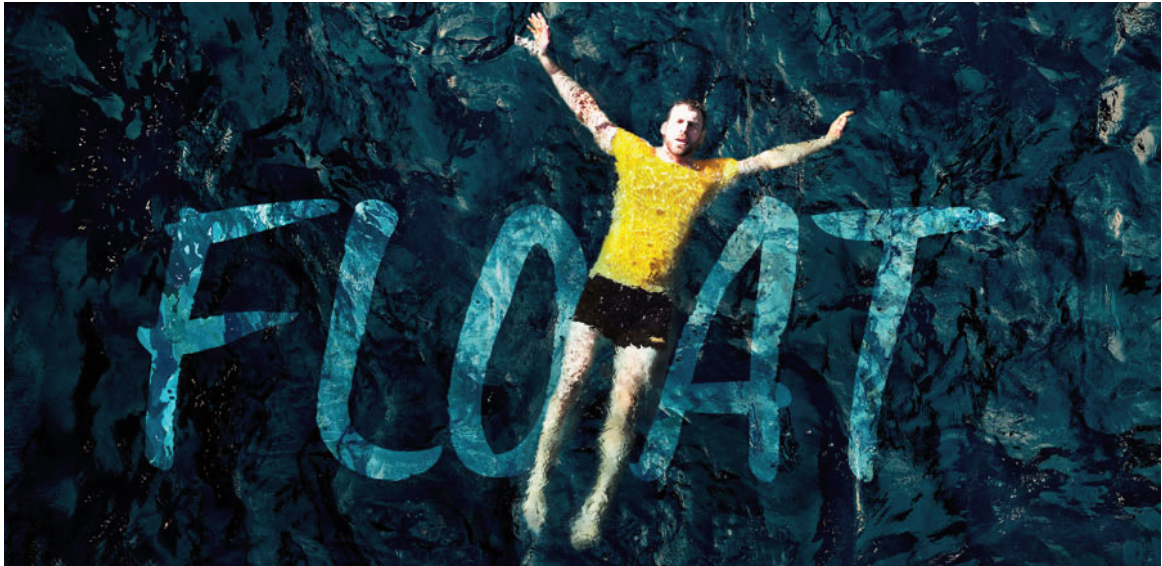
Two of the casualties who found themselves submerged in the water during this incident were unaware of the importance of trying to simply float in the water; they incorrectly tried to maximise their movement instead of minimising it.

Figure 13: RNLI’s recommended posture if struggling in the water.
Source: <https://rnli.org/safety/float>

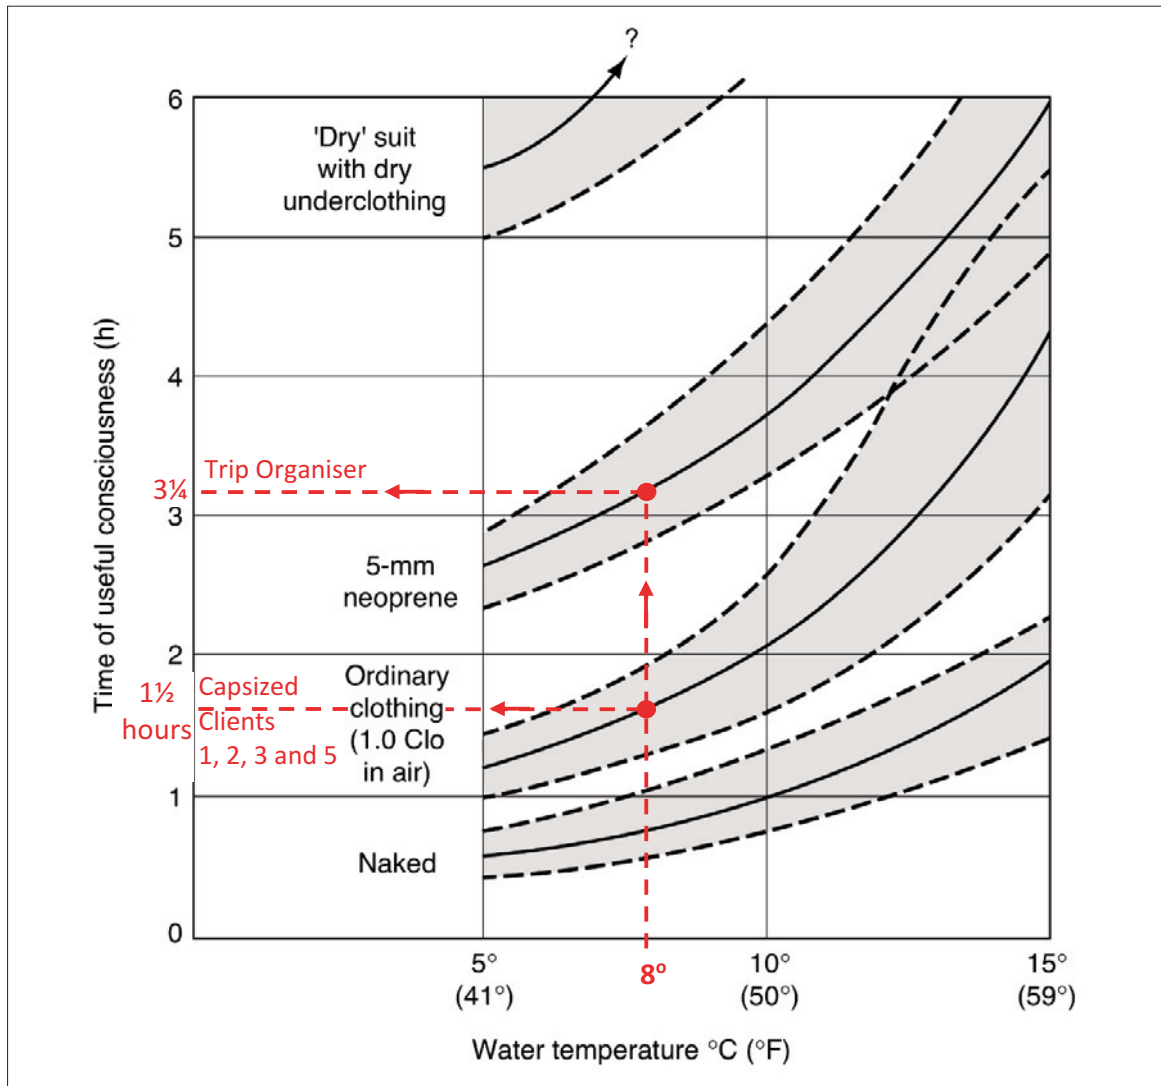
4.5.2 Figure 14 is a graph reproduced from *Essentials of Sea Survival* that illustrates the significant difference in outcomes following exposure to cold water, depending on the type of clothing worn. Sea water temperature in Ireland typically varies from a low of 8-10°C in spring to a high of 15-16°C in late summer (Source: www.met.ie/science/marine-meteorology/marine-climatology). For the 8°C water temperature that occurred during this incident, the graph shows how the average ‘time of useful consciousness’ was likely to have been considerably better (approximately 3¼ hours instead of 1½ hours) for the trip participants who wore a wetsuit (the Trip Organiser and Client 4) compared to those who wore only ordinary clothing (Clients 1, 2, 3 and 5).

Figure 14: The ‘times of useful consciousness’ of individuals immersed in cold water in different clothing under laboratory conditions, highlighting the effects of 8°C cold water. Source: Fig 7.5, *Essentials of Sea Survival*, Golden & Tipton, 2002.

4.5.3 The MCIB’s analysis indicates that the omission of protective clothing contributed to this marine casualty event.

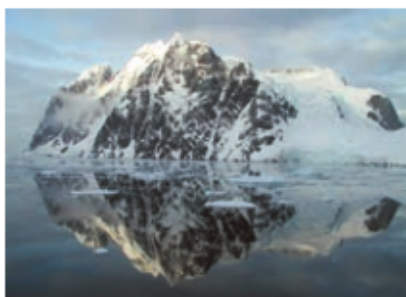
Beaufort Force 0

Wind speed (knots): Under 1
Wind description: Calm
Sea state:
 Sea is mirrorlike.

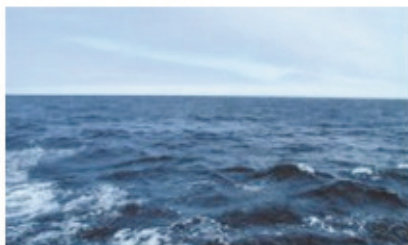
Beaufort Force 3

Wind speed (knots): 7-10
Wind description: Gentle Breeze
Sea state: Large wavelets, crests beginning to break, scattered whitecaps.

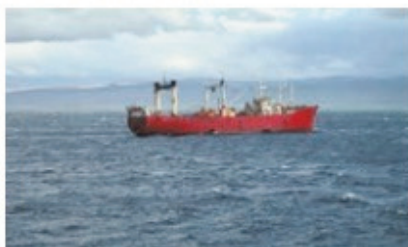
Beaufort Force 4

Wind speed (knots): 11-16
Wind description: Moderate Breeze
Sea state: Small waves, becoming longer, numerous whitecaps.

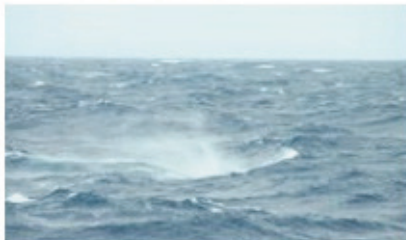
Beaufort Force 5

Wind speed (knots): 17-21
Wind description: Fresh Breeze

Sea state:
 Moderate waves, taking longer form, many whitecaps, some spray.

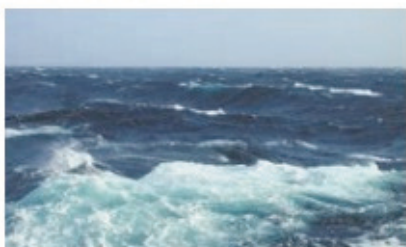
Beaufort Force 6

Wind speed (knots): 22-27
Wind description: Strong Breeze

Sea state:
 Larger waves forming, whitecaps everywhere, much spray.

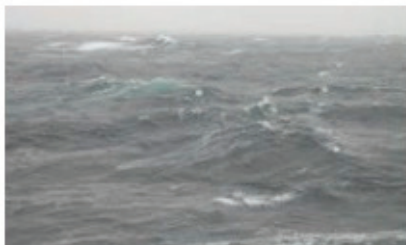
Beaufort Force 7

Wind speed (knots): 28-33
Wind description: Near Gale

Sea state:
 Sea heaps up, white foam from breaking waves begin to be blown in streaks.

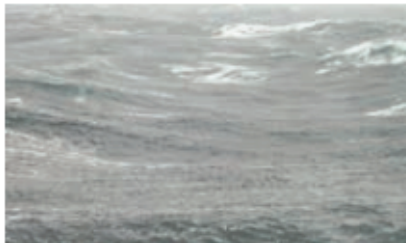
Beaufort Force 9

Wind speed (knots): 41-47
Wind description: Strong Gale

Sea state:
 High waves, sea begins to roll, dense streaks of foam, spray begins to reduce visibility.

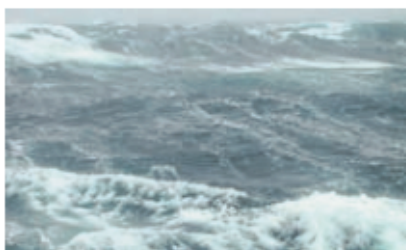
Beaufort Force 10

Wind speed (knots): 48-55
Wind description: Storm

Sea state:
 Very high waves with overhanging crests, sea takes on white appearance, foam blown in dense streaks, rolling is heavy, visibility reduced.
