The development of a Fibre Bragg Grating river scour sensor utilizing vortex flow

ABSTRACT: The ability to effectively manage the deterioration of a network wide bridge stock condition from year on year is vital for the effective use of finite resources while maintaining public safety. The leading cause of bridge failure and deterioration globally is as a result of scouring. This research looks at the development of a Fibre Bragg Grating (FBG) scour sensor utilizing vortex flow effects, which can inform decision making within an existing road bridge management system (BMS). This paper will briefly review the current types of scour sensors available before outlining the initial development of a novel FBG sensor setup and associated prototype development. The findings of initial field trials are presented before outlining future research opportunities on the concept of incorporating real time data from targeted representative structures with on-site sensors to inform and update the scour risk rating.

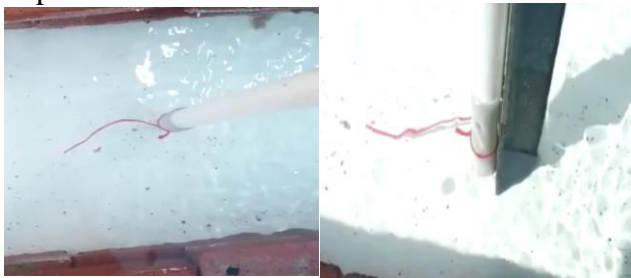
Figure 2 - Flume tank and red string tests

As the capacity of the available pump produced, a low flow rate in the flume a lightweight indicator was required to ensure motion could be visually detected initially. A

length of red cord attached to a cylindrical rod was placed into the flume Figure 2. Motion was noted in the cord and without significant debris being introduced oscillated back and forth. Bricks were then added to the sides of the flume which constrained the flow and caused an increased movement in the cord.

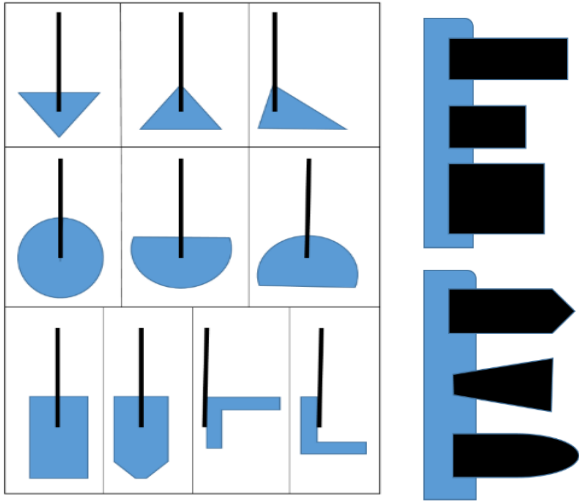
Figure 3 - Various bluff body profiles viewed in plan and various fin profiles viewed side on, used in the initial tests

The next stage was to investigate the effects of various profiles acting as the bluff body Figure 3, and observe the effects on the red cord. This red cord was then replaced by a thin piece of black rubber.

Although all shapes tested induced movement in the string and rubber, those with a flat face perpendicular to the flow displayed more movement. Objects which were offset to one side of the string, displayed greater movement again.

The next stage was to investigate bluff body profiles and the fin arrangements. The initial tests consisted of dummy prototypes of various profiles and a standard rectangular fin arrangement. These ranged from rectangular, circular, angular and offset. These tests showed that in river flow all prototypes exhibited movement with a range of flow conditions. Profiles with flat faces perpendicular to the oncoming flow caused more movement than those with rounded or streamlined profiles Figure 3. The prototypes were placed in various locations within a river site with varying flow characteristics. In areas of minimal flow the fins displayed movement and as the flow rate increased the rhythmical movement of the fins increased.

Variations on the fin shape were also tested with the ‘fish tale’ style fin that has a narrow width at the support and widens as it extends out, being the most responsive to the flow conditions Figure 3.

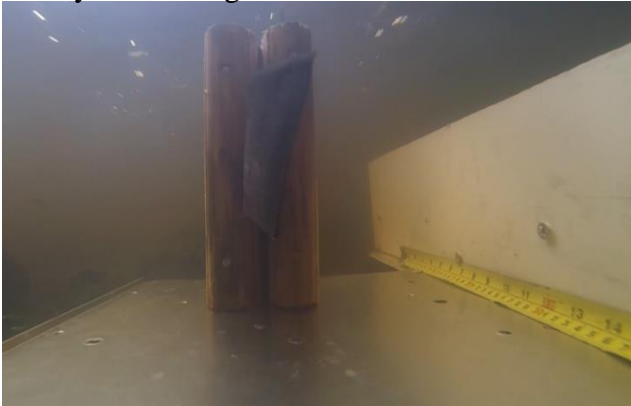
Figure 4 - River fin test

The next phase explored the effects of the fin shape on the movement. Initially rectangular fins were tested with varying lengths and widths considered. Longer narrower fins moved more readily in flow Figure 4.

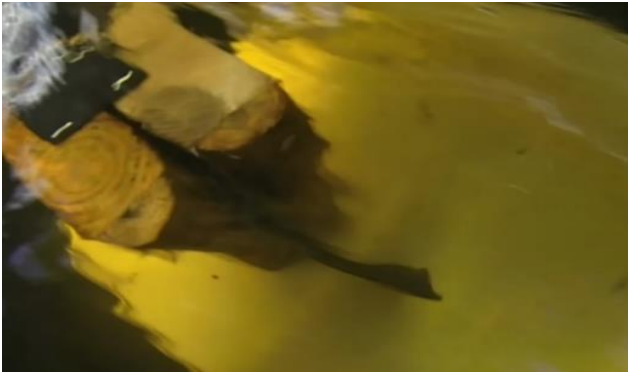
Figure 6 - 'Dummy' prototype river test

A 'dummy' prototype was fabricated, to scale, to test all the assumptions made on the earlier trials. This test was conducted in a river environment at various points and video footage recorded of the movement of the fin Figure 6. Debris was introduced including floating vegetation and branches and the tests showed that the fin continued to move.

This test confirmed the assumptions and informed a refinement of the fabrication detailed drawings.

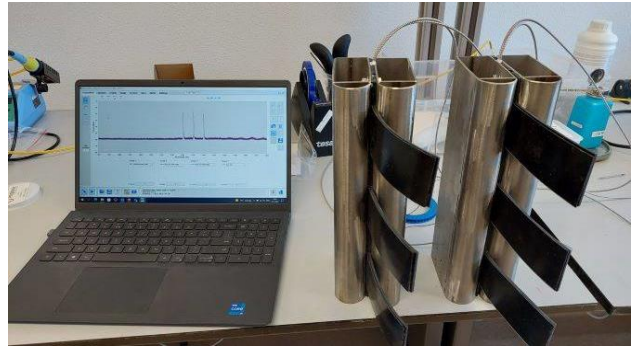
Figure 7 - Two functional prototypes

and none buried and scenarios of partially buried fins. This would allow for the tracking of a scour and infilling event during our trials. Detailed fabrication drawing were developed and two operational prototypes were fabricated by Somni Technologies Lt Denmark and shipped to N.Ireland Figure 7. This consisted of stainless steel hollow sections welded and bolted together with FBGs bonded to rubber fins. One sensor was to be tested in a river environment while the other in Lab conditions.

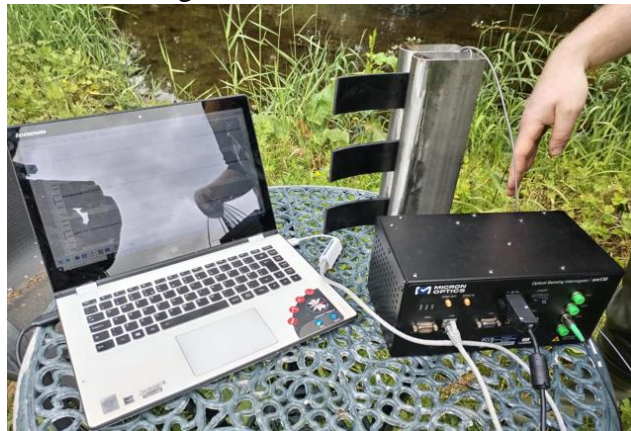
Figure 8 - Equipment setup

These prototypes were connected to a Micron Optics Optical Sensing Interrogator sm130 and the fins manually agitated back and forth to check the fins registered a response to movement Figure 8.

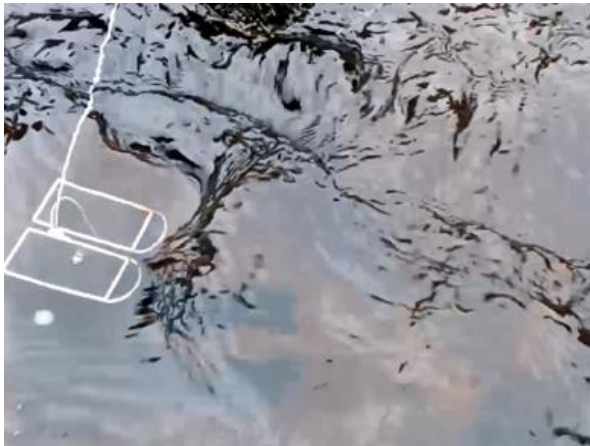
Figure 10 - Prototype river test

A test site within a private garden beside the River Bann in Lawrencetown, Northern Ireland was selected with good access to the river, in a semi-rural location with convenient access to a mains power supply. One of the prototypes was fixed to a steel base plate and placed onto the riverbed in a relatively shallow part of the river Figure 10.

This demonstrated that in relatively low flow conditions a discernible trace was recorded from each fin sensor. When boards were used to funnel the flow towards the sensors the trace varied more indicating greater movement in the fins, and this was clearly visible on the fins. Having established this the next stage was to find

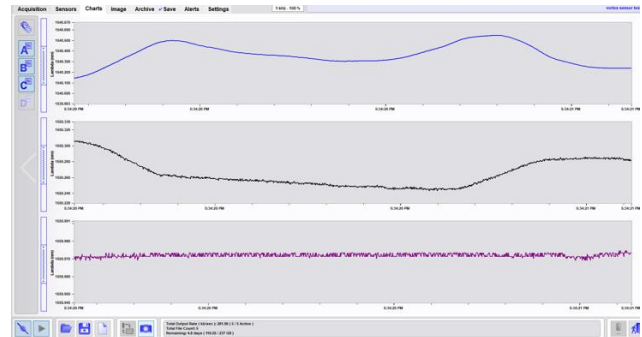
Figure 11 - Sensor trace when bottom fin buried in river test

a natural depression in the riverbed and move rocks to simulate a bridge pier. Natural riverbed material from the riverbanks was moved less than 10m from the test site and deposited around the sensor. This had the effect of burying the bottom fin. This translated to the trace for this fin levelling out, Figure 11 and in effect indicating that the fin was no longer moving and therefore buried.

This was a very basic test but proved the concept of this sensor. Attempts to bury the next two fins proved difficult due to the flow in the river washing the material away before it could be fully buried. A temporary barrier was constructed around the sensor in order to build up the infilling around the sensor and then released to wash away the material. The material around the bottom fin was then allowed to wash away and once again this registered on the trace indicating movement in the fin.
