# Recent developments and ongoing challenges in the implementation of UAS assisted bridge inspections

**ABSTRACT:** In the past decade, the use of drones, or unmanned aircraft systems (UAS), to supplement engineering activities such as structural inspections has increased considerably due to the advances in the associated technology in terms of UAS positioning, operation, control, and payload capacity. High-resolution imagery of structures obtained using drones fitted with digital cameras can be post-processed using computer vision and photogrammetry techniques to potentially provide more reliable structure geometry and inventory, structure condition, and structural performance (SHM) data, in less time and possibly at a lower cost than current methods. This approach can aid Principal Inspections for bridge structures, particularly where access is difficult, obviating the need for expensive under-bridge equipment and/or lane closures. However, challenges remain for the widespread implementation of drones for bridge inspections, primarily relating to measurement accuracy and stabilisation of images recorded during drone flight, while issues around safety and regulation can also limi

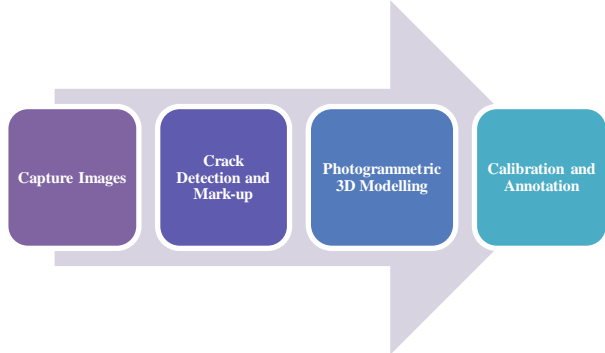
Figure 1: Annotated 3D model generation workflow.

As 3D photogrammetric models are generated from high quality images, the generated models are large files in the form of point clouds that makes analysis of these models for defects a challenging task for any automated computer algorithm. In this paper, crack defect annotation in 2D images prior to generation of 3D models is explored. The proposed pipeline is shown in Figure 1 below.

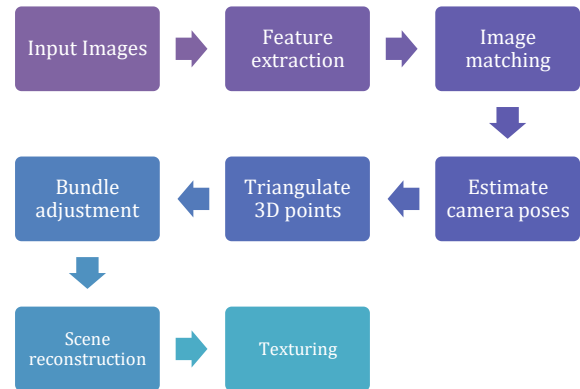
Figure 3: Structure from motion pipeline

One of the main algorithms and approaches used to reconstruct the 3D geometry of an object or a scene from 2D images in photogrammetry is structure from motion (SfM). The SfM algorithm aims to derive the 3D scene points and all the camera relative poses from correspondence feature points in multiple overlapping 2D images.

Scale ambiguity remains thus the reconstructed scene needs to be scaled to the correct scale after the reconstruction process. When all the camera poses and 3D points and camera poses have been determined, a mesh of the scene is created and textured to create the full 3D model as represented in the 2D images. The full SfM pipeline is summarised in Figure 4 below. In this study, Autodesk Recap Photo was used to create the 3D models.

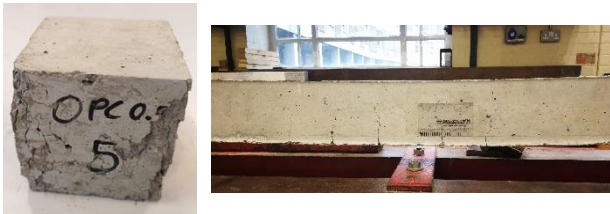
Figure 4: Test specimens used in this study (a) concrete cube (b) concrete beam

A 100x100x100 mm crushed concrete cube and a 65x100x1800 mm cracked concrete beam were used as representative specimens in this study. The concrete cube was used to generate a complete 3D model using images captured by the DJI Mavic 2 Pro while only the beam face was studied using images obtained from the DJI Spark drone. The concrete cube and beam are shown in Figure 5 below. A total of 62 overlapping photos were used for the concrete cube and 39 for the concrete beam.

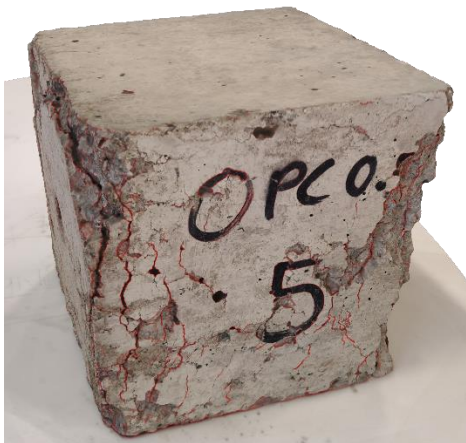
Figure 5: Concrete cube 3D model with crack locations marked on the model

Figure 5 below shows the results of the approach employed in this study for crack detection and annotation on the concrete beam cube. Figures 6 and 7 show the comparison between the approach employed in this study to enhance the output of the Canny edge detector and the Canny edge detection without any enhancement. Note that in both cases the same thresholds were used during hysteresis thresholding (Gonzalez and Woods, 2007).

As can be seen from the figures the geometry of the concrete specimens is faithfully reproduced. Furthermore, the crack detection algorithm is able to correctly locate all of the cracks in the concrete beam and many of the cracks in the concrete cube despite the cube having a very noisy texture. The minimum crack width on the concrete beam was measured with a crack gauge to be 0.3 mm.

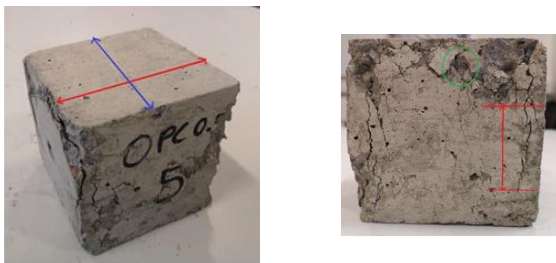
Figure 8: (a) Calibrating the concrete cube dimensions (b) Crack measurements

Prior to taking measurements of cracks on the concrete cube, the 3D model was calibrated. As noted in section 3, during modelling there is a scale ambiguity that is not recovered. To correctly scale the model, a scale object such as a ruler is usually fixed on the object to assist with scaling. In this case, the known size of the cube was used to scale and calibrate the dimensions of the 3D model in Autodesk ReCap Photo. Figure 8(a) shows concrete cube with dimension lines marked in ReCap. After calibration, the dimensions of the lines are measured as 98.231 mm.

Figure 8(b) shows the location used for sample measurement of crack length. Table 2 provides a comparison of measurements obtained in ReCap Photo.

Feature Measured	Actual Measurement (mm)	ReCap Photo Measurement (mm)	Error (mm)
Dimension	98	98.231	0.231
Crack Length	44	44.097	0.97

very accurate results are obtained with an error of less than 1 mm despite reducing the image resolution by half.
