***RAMPART ROADS IN THE PEAT LANDS OF  
IRELAND: GENESIS, DEVELOPMENT AND  
CURRENT PERFORMANCE***

**JUAN PABLO OSORIO, ERIC FARRELL,  
BRENDAN O'KELLY & TOM CASEY**

*First International Conference in Transportation Geotechnics.  
University of Nottingham, UK. 25 – 27 August, 2008.*

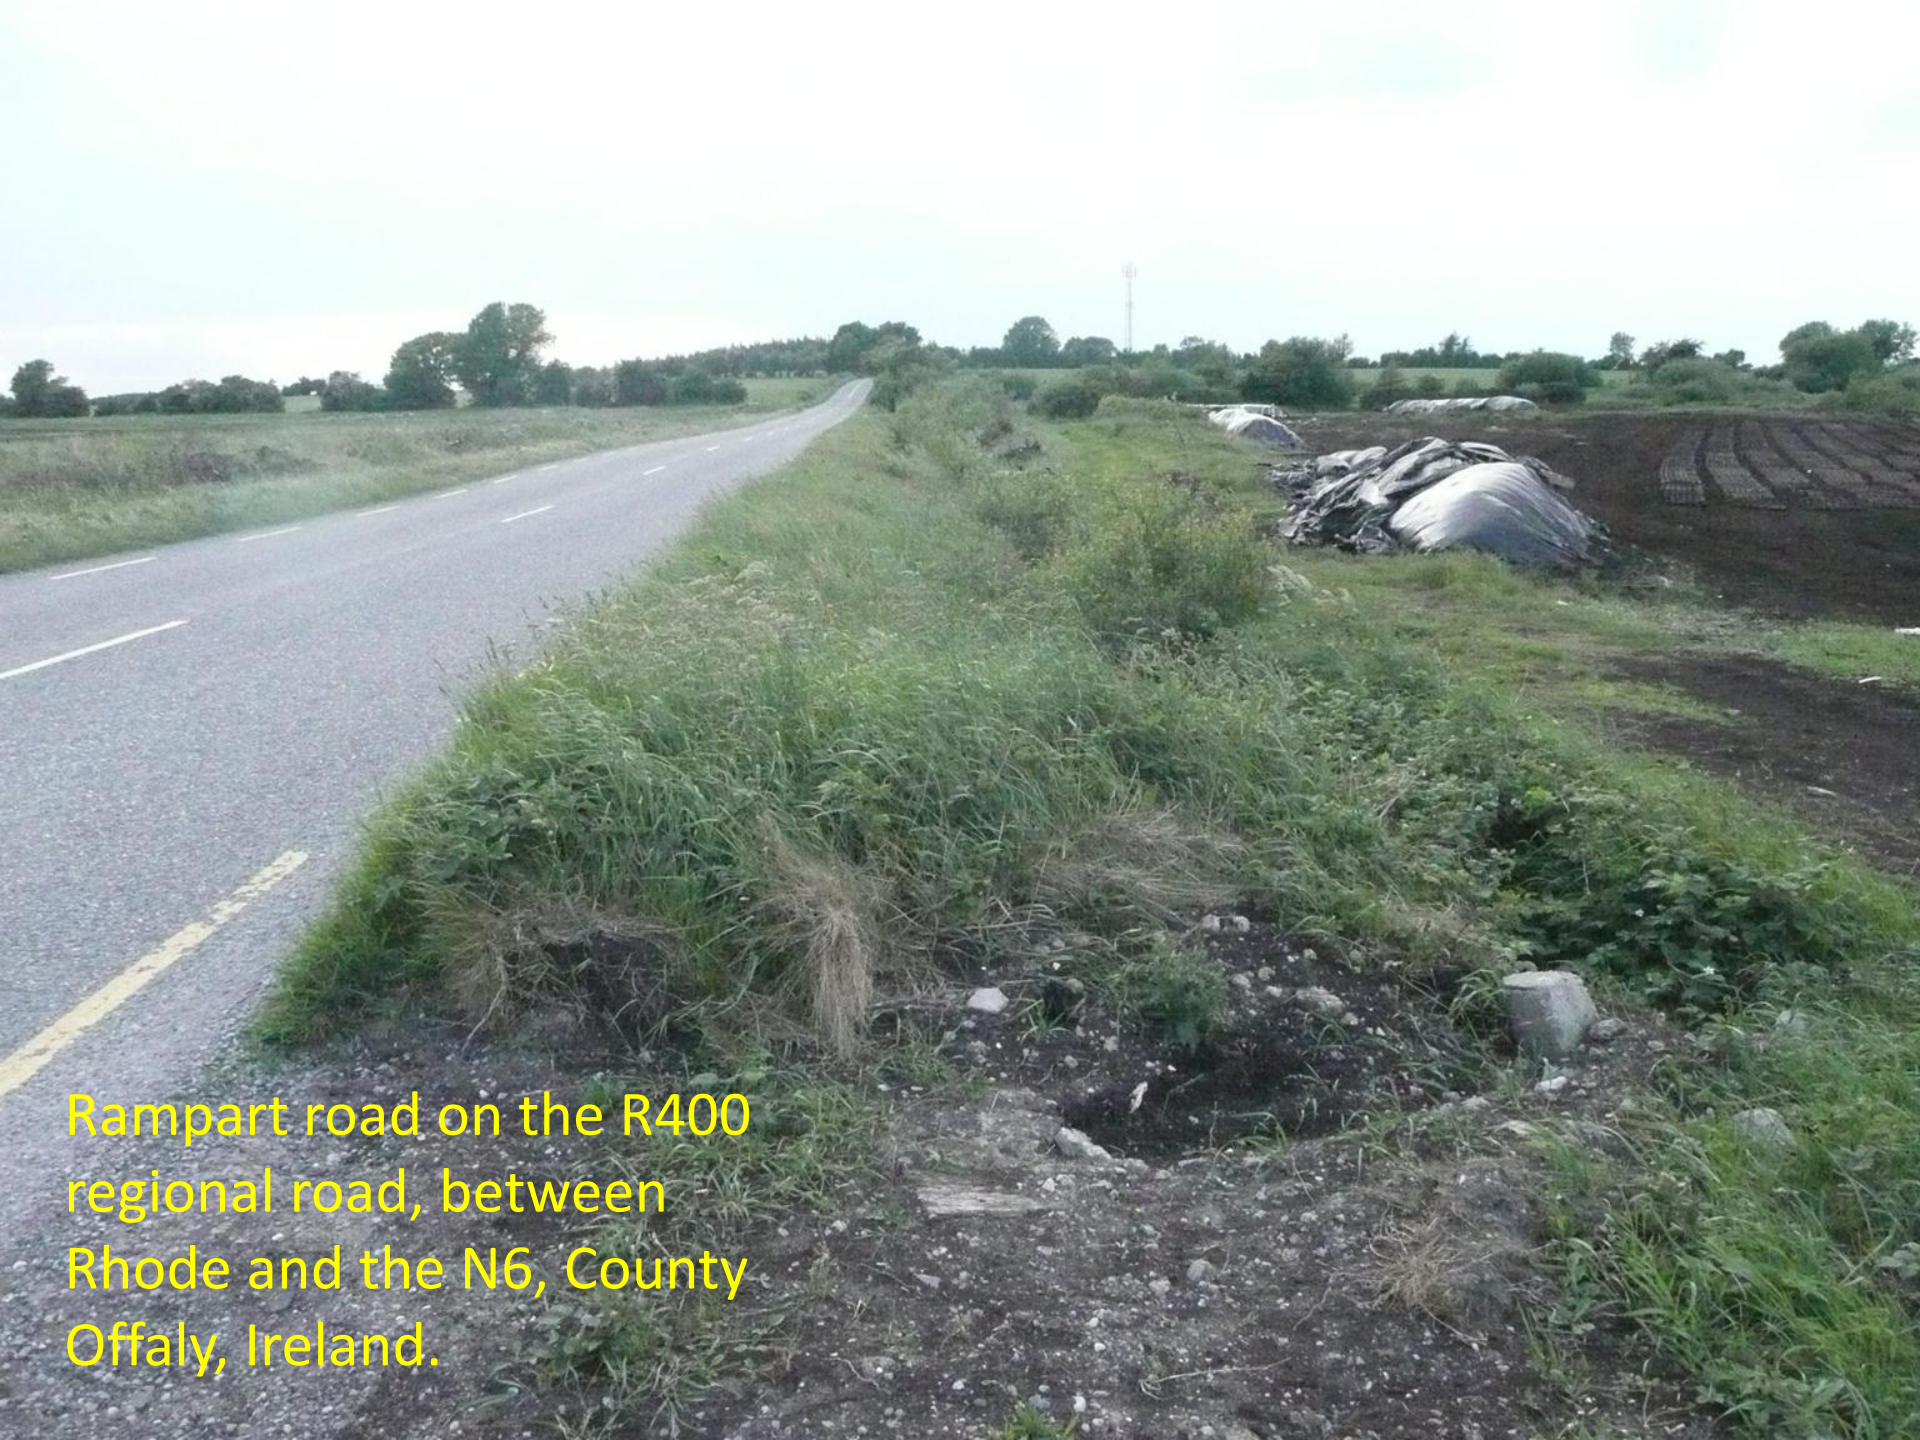
Rampart road on the R400 regional road, between Rhode and the N6, County Offaly, Ireland.

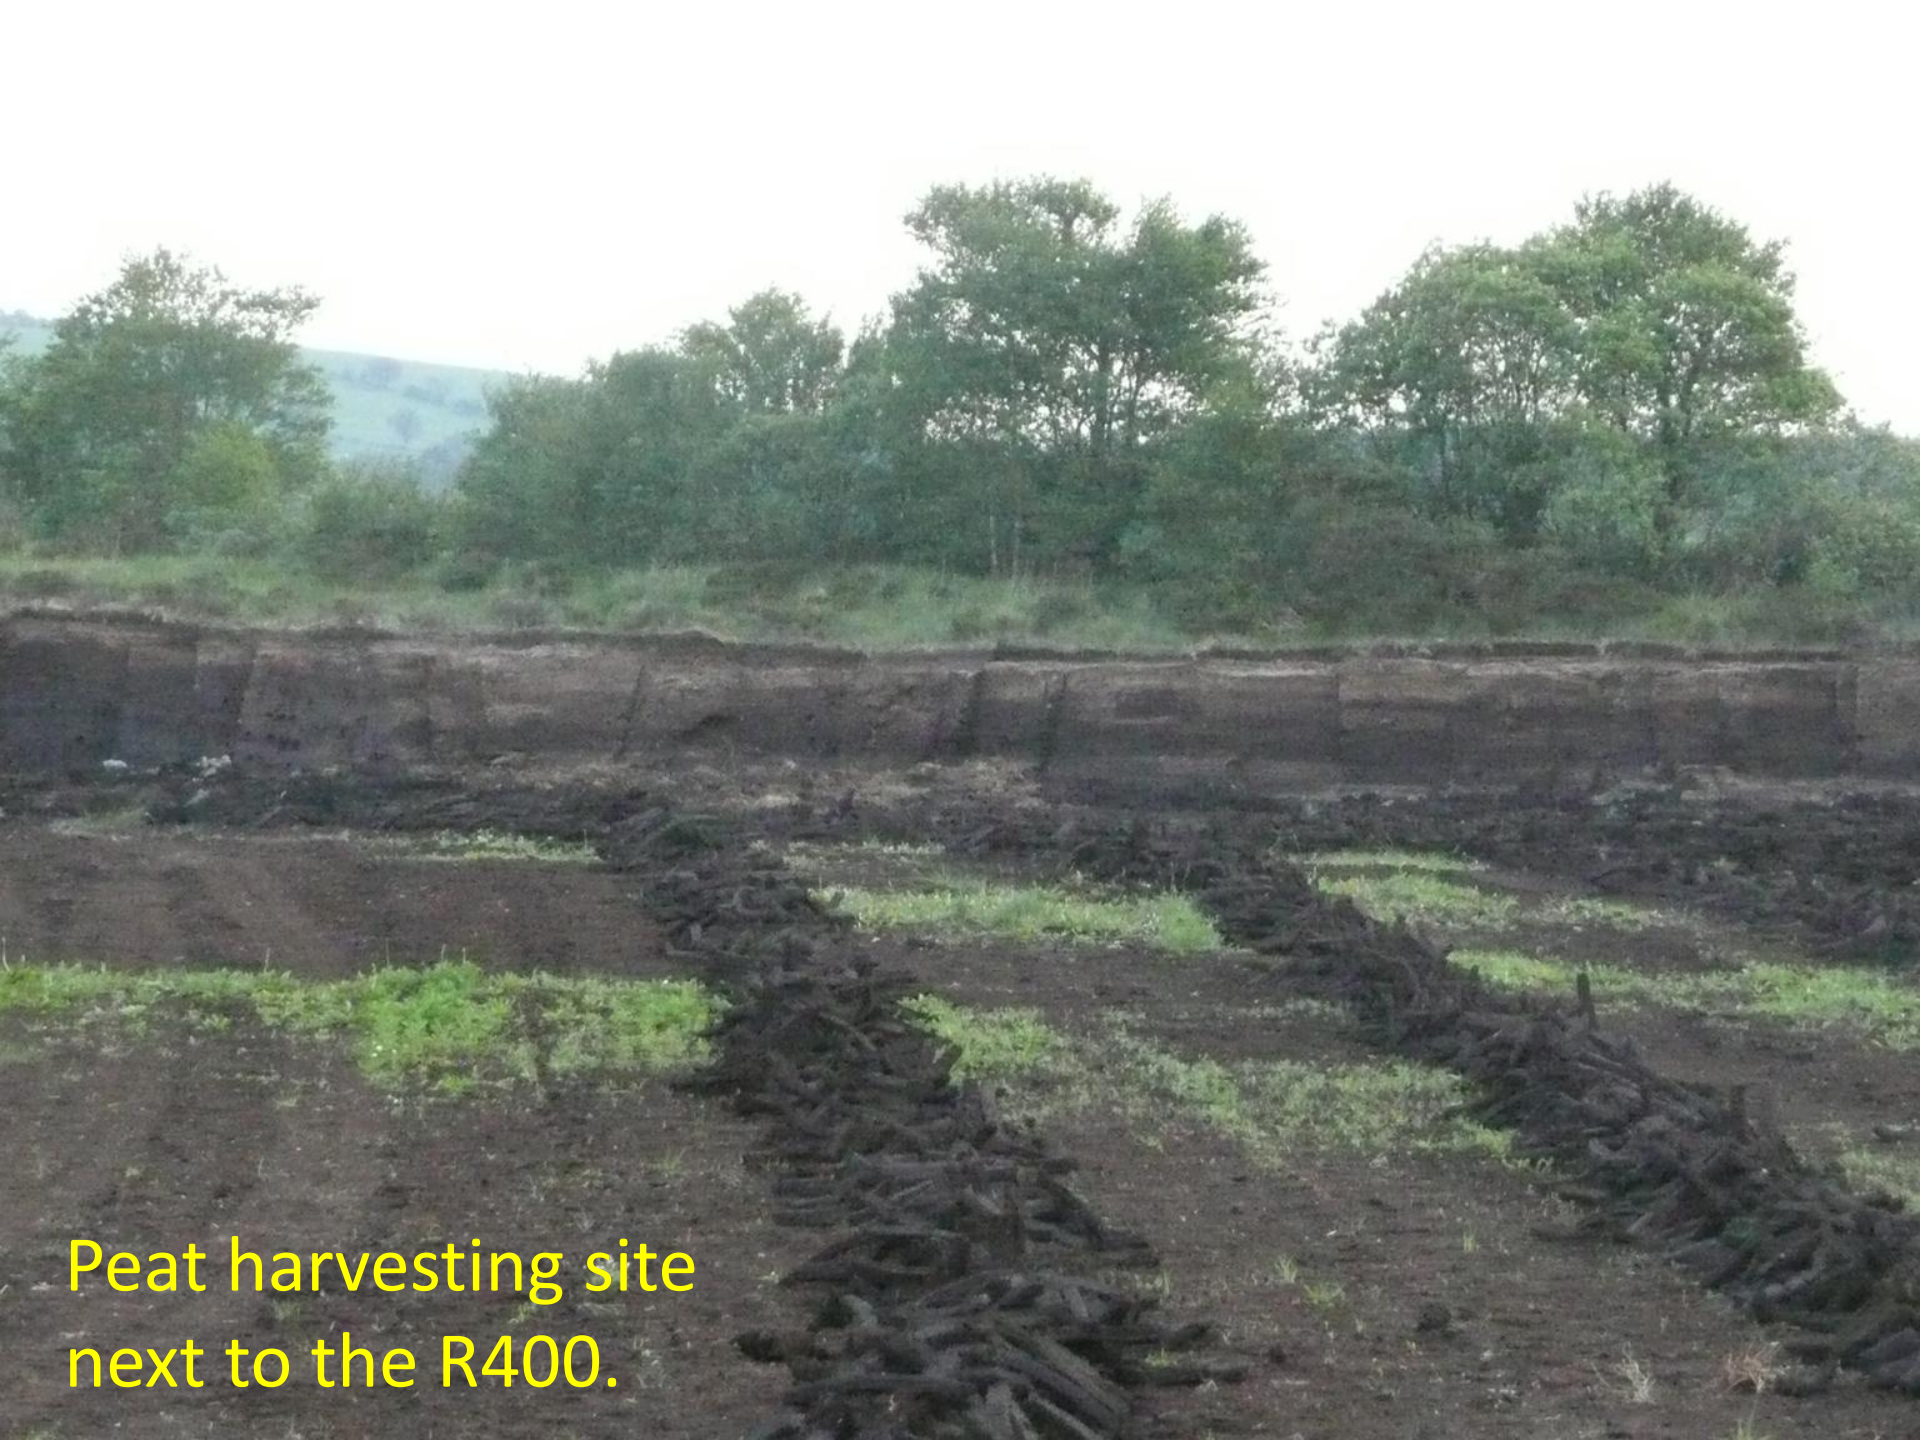
Peat harvesting site  
next to the R400.

- Peat harvesting for fuel in the vicinity of the bog roads has been a common practice in Ireland and has led to the creation of elevated roads, referred to as rampart roads.
- References in the Old Irish law texts trace peat harvesting back to the seventh and eighth centuries (Feehan & O'Donovan, 1996).

- The improved roads across the peat lands provided better access and made peat harvesting easier.
- The rapid cut away of the peat material in the vicinity of the roadsides resulted in an elevated road surface that in some cases was many meters above the surrounding ground.

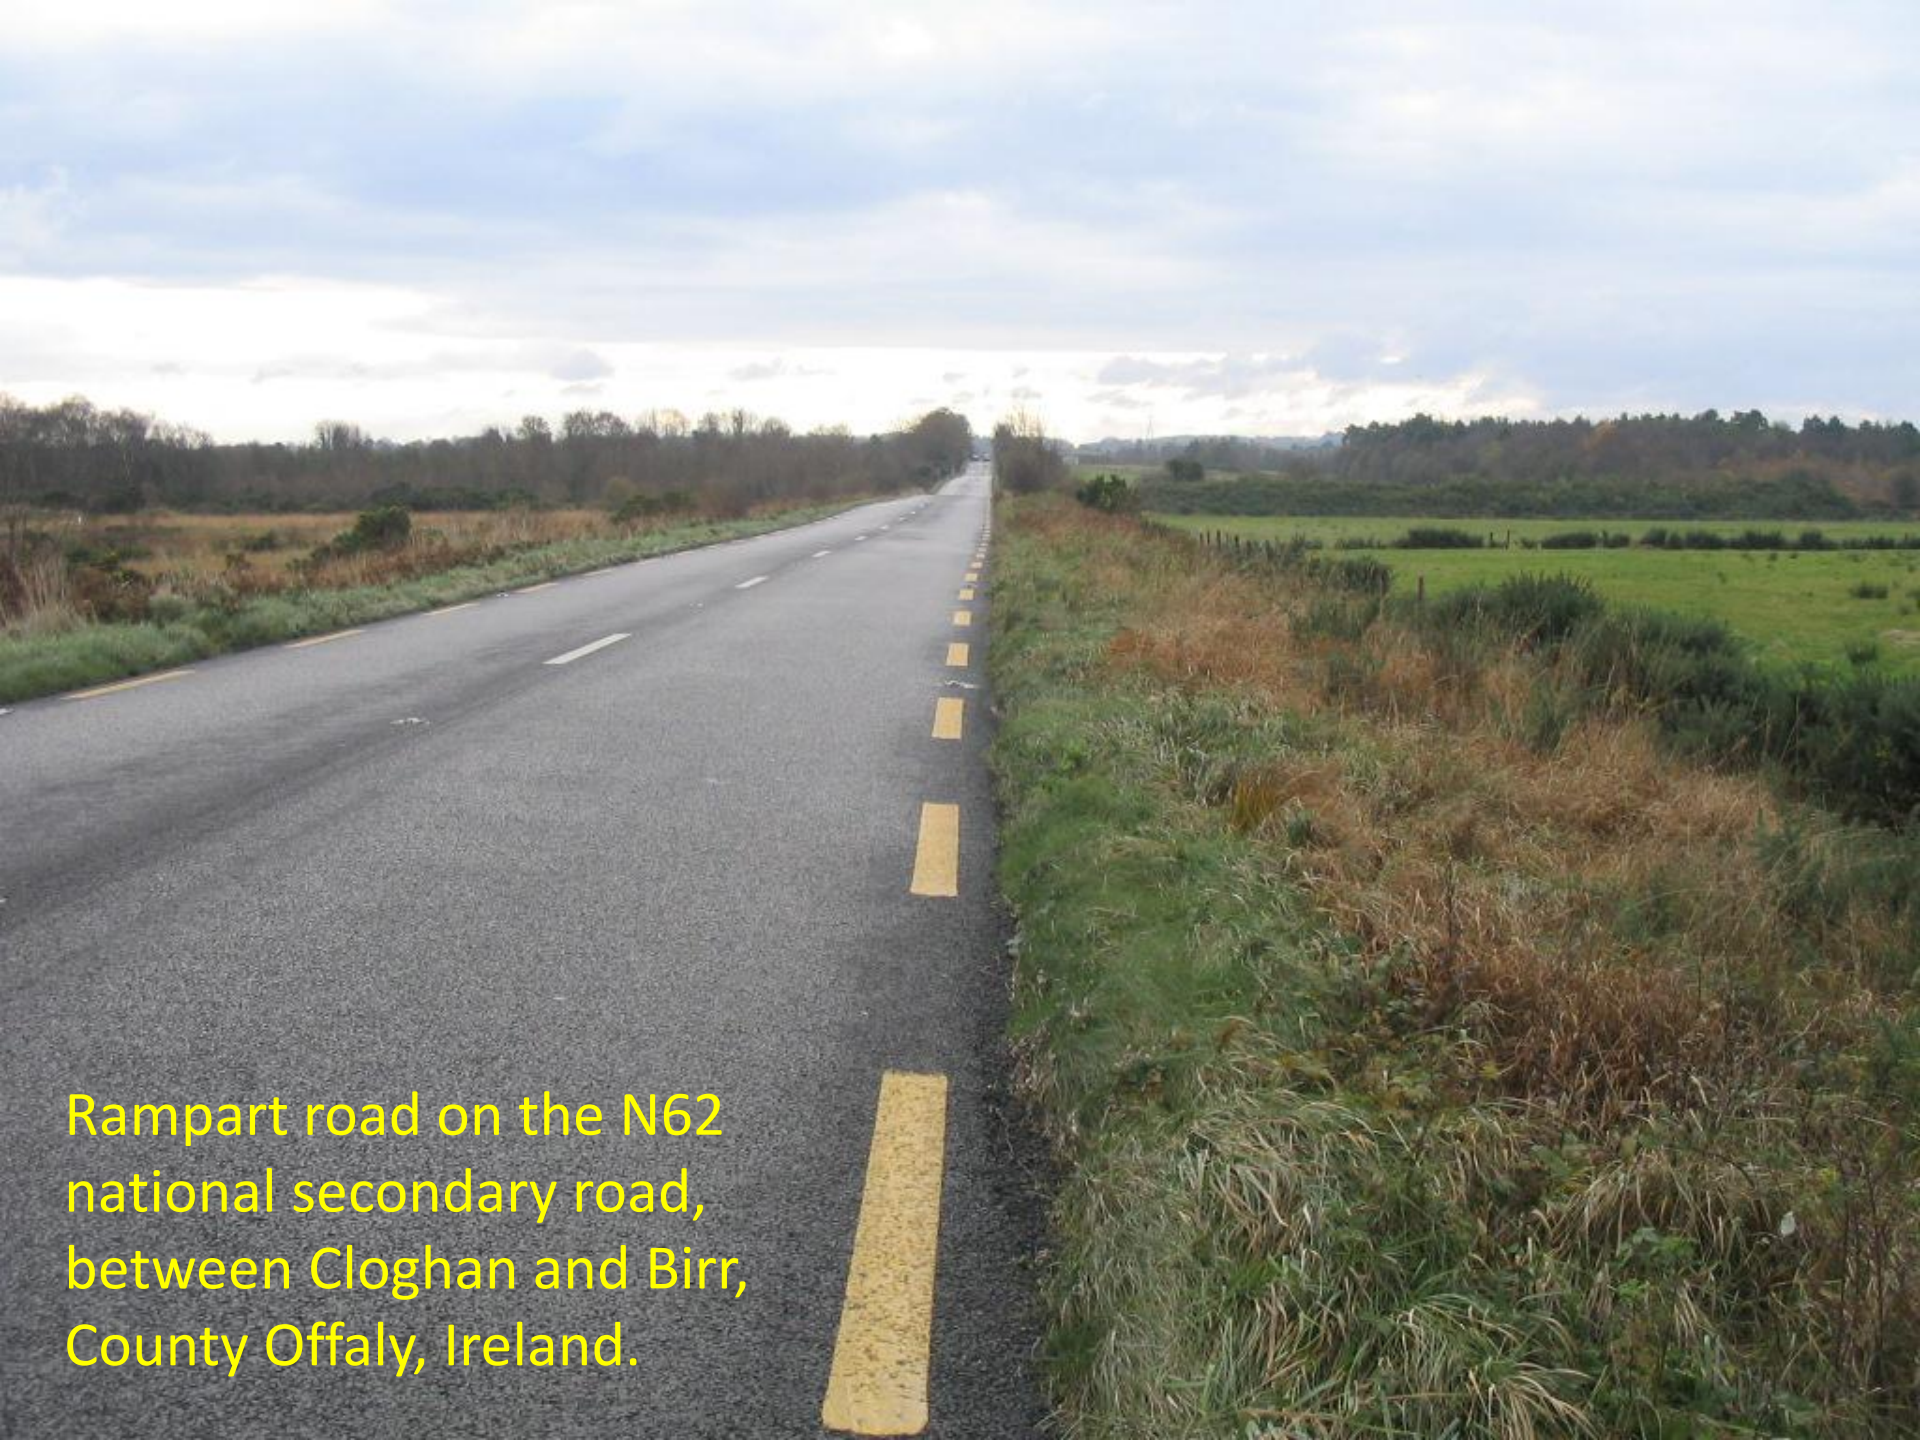
Rampart road on the N62 national secondary road, between Cloghan and Birr, County Offaly, Ireland.

- These elevated bog roads are referred to as rampart roads.
- Leebody (1911) reported rampart roads of between 1.5 and 9.0 m in height.

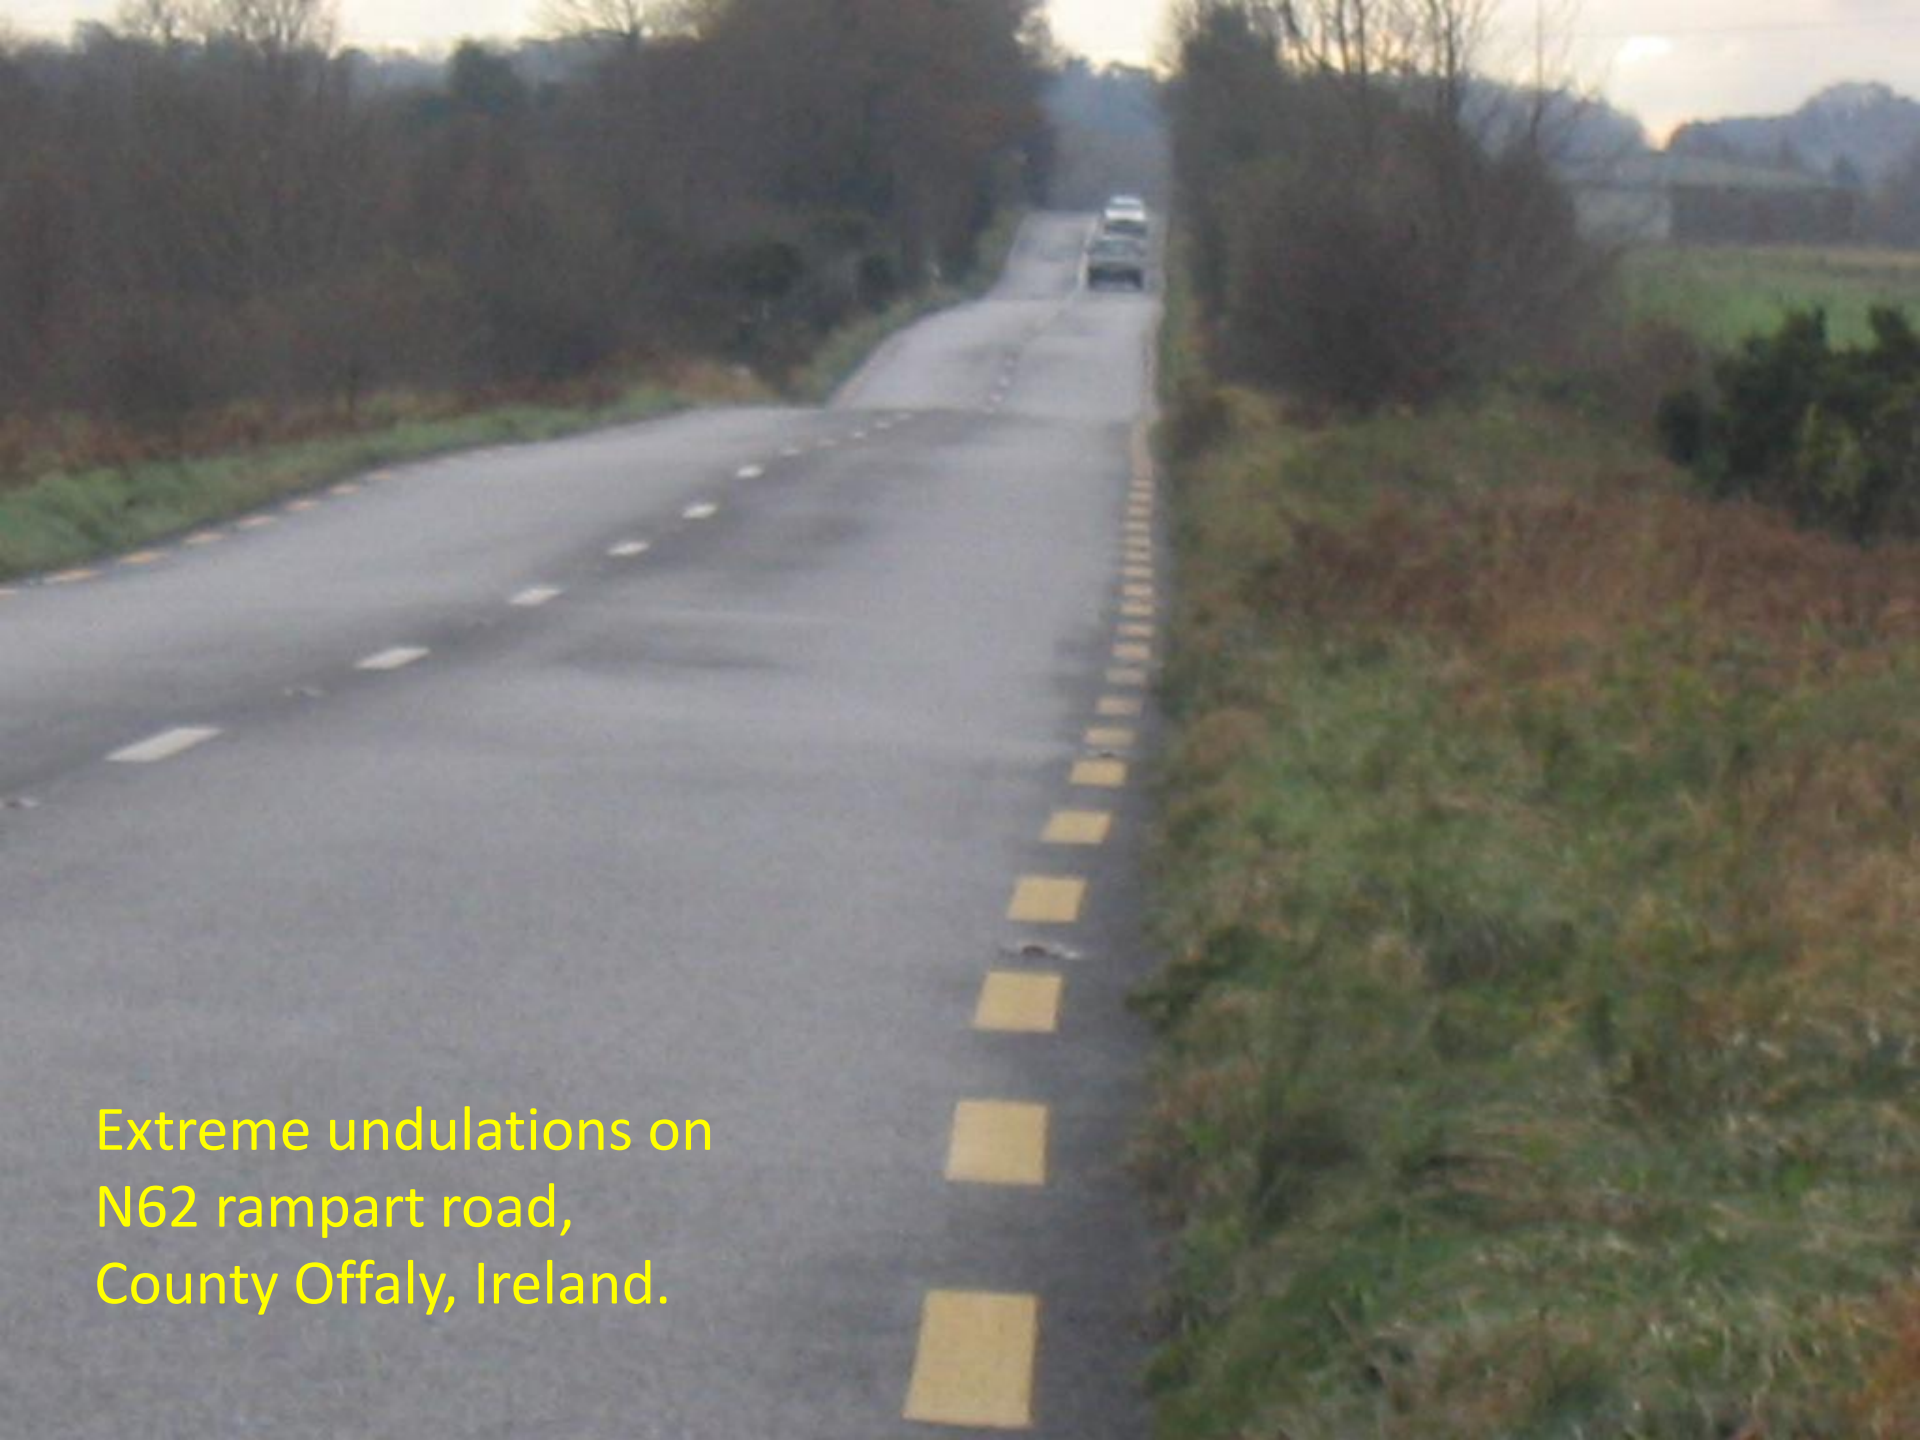
Extreme undulations on  
N62 rampart road,  
County Offaly, Ireland.

- Rampart roads often undergo considerable distortion due to the low shear strength and high compressibility of the peat foundation, which may pose a significant safety hazard.

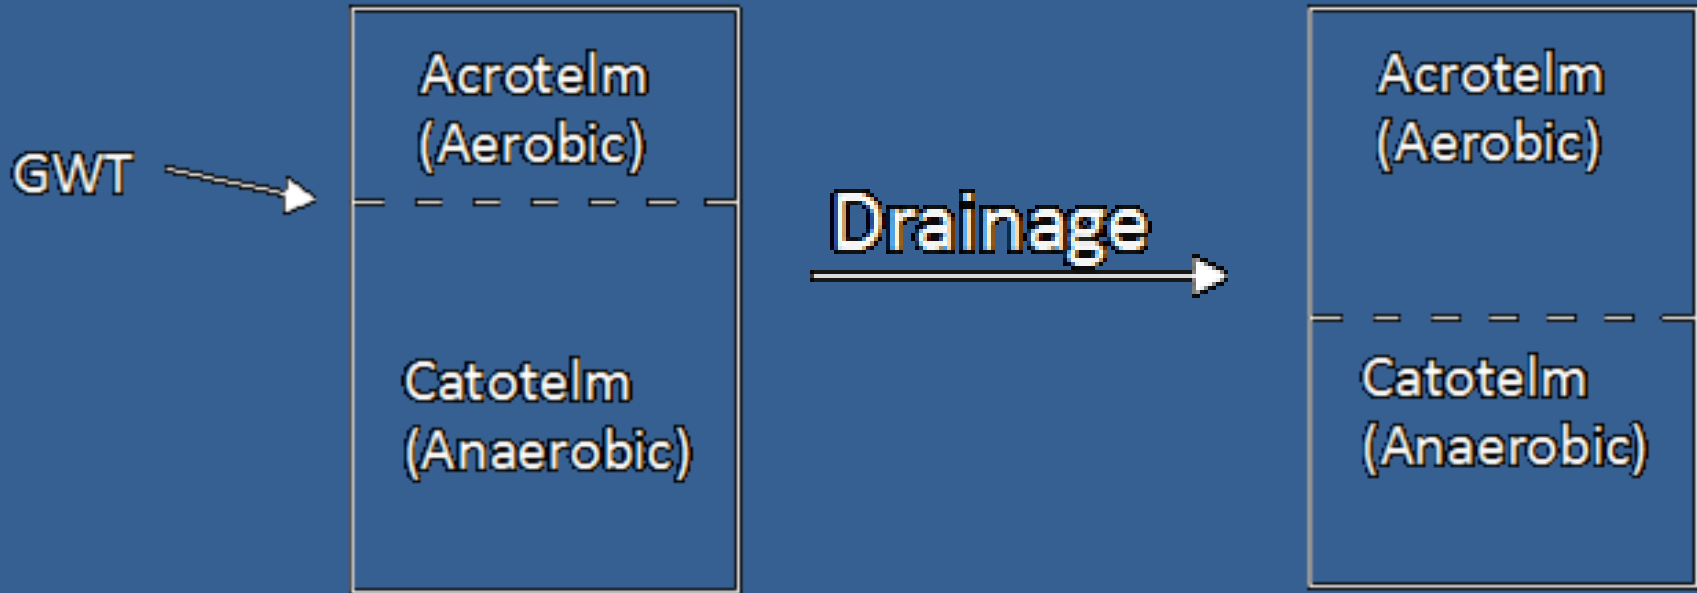
Regain oxygen and become repopulated with aerobic micro-flora, speeding up the decay process and inducing several changes:

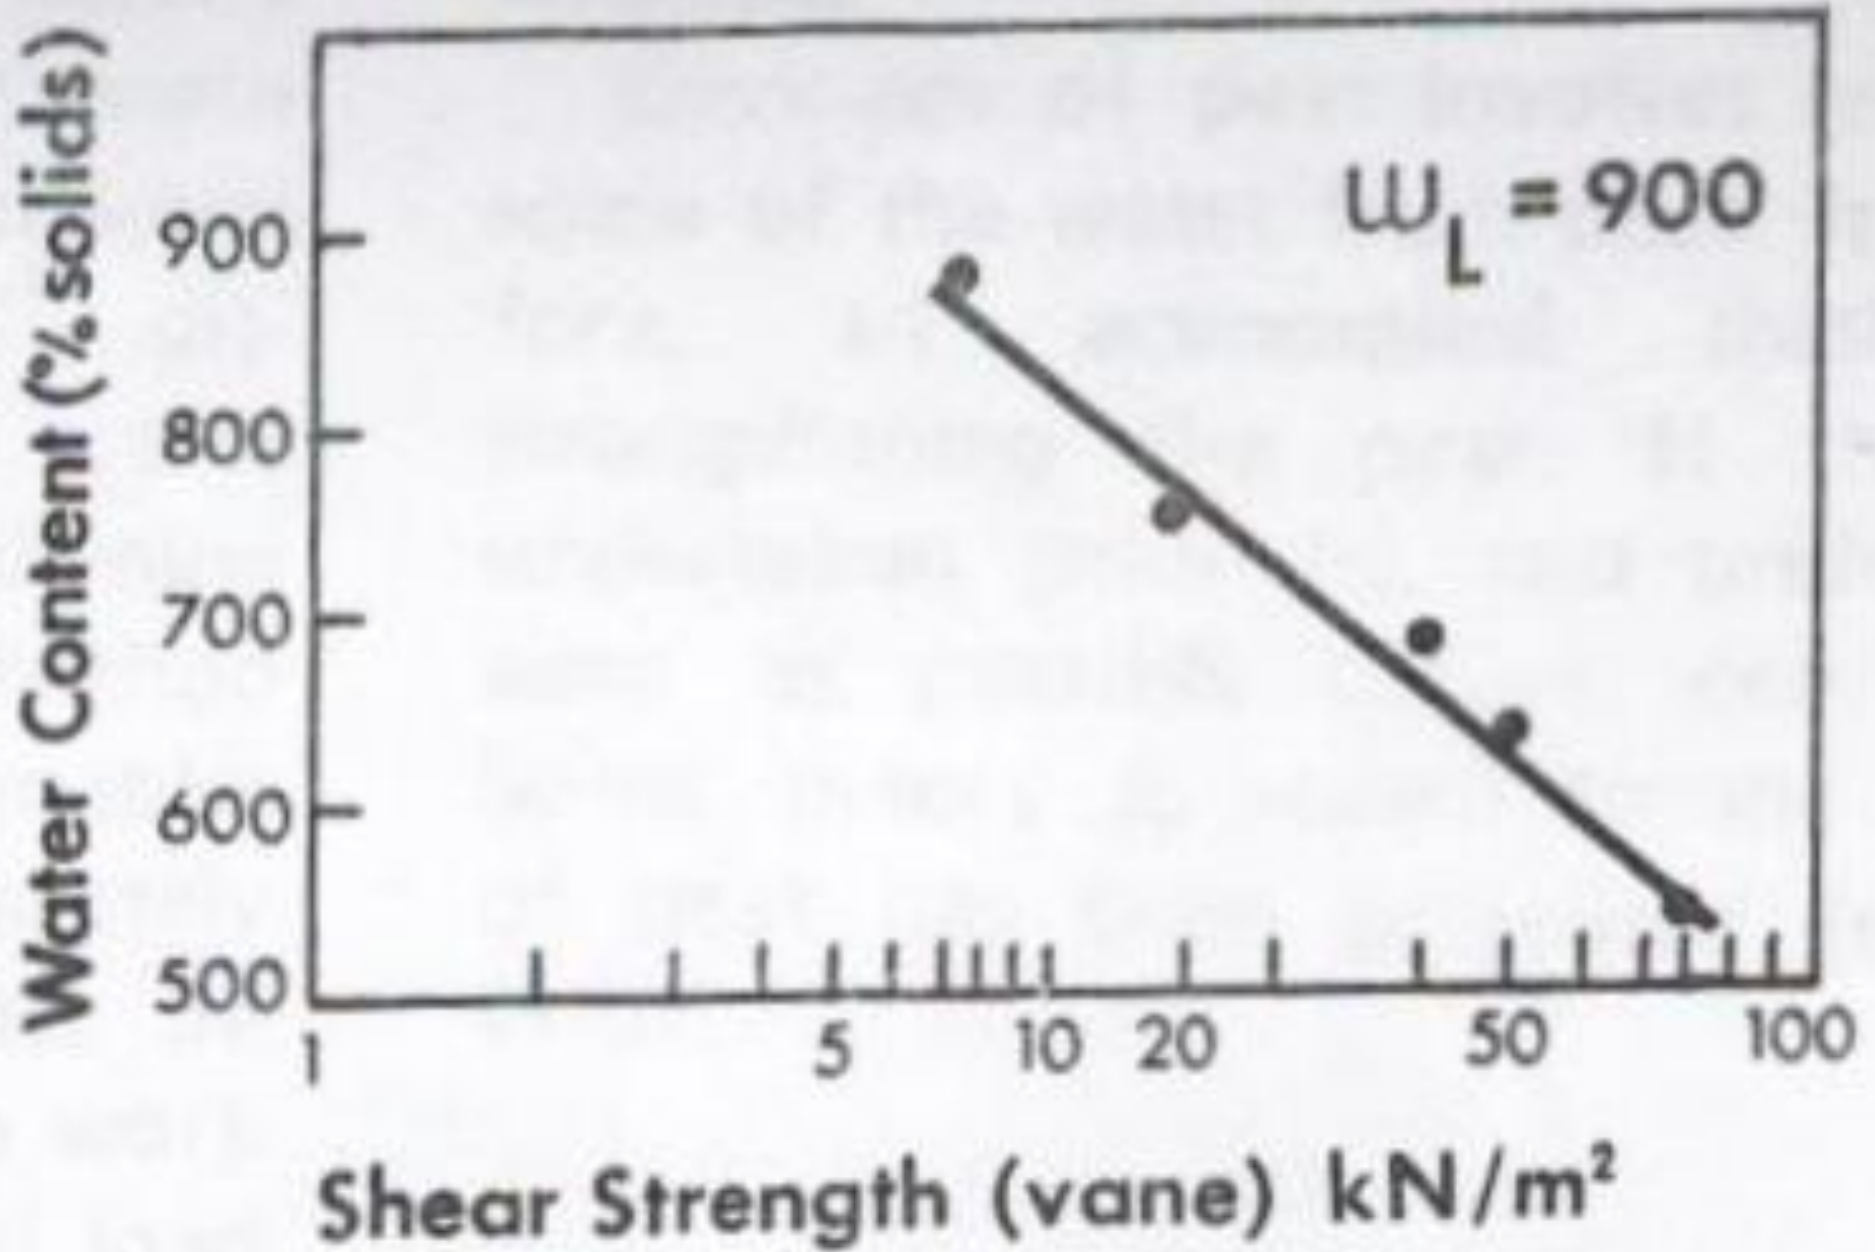
Shear Strength/water content relationship (Hanrahan, 1976)

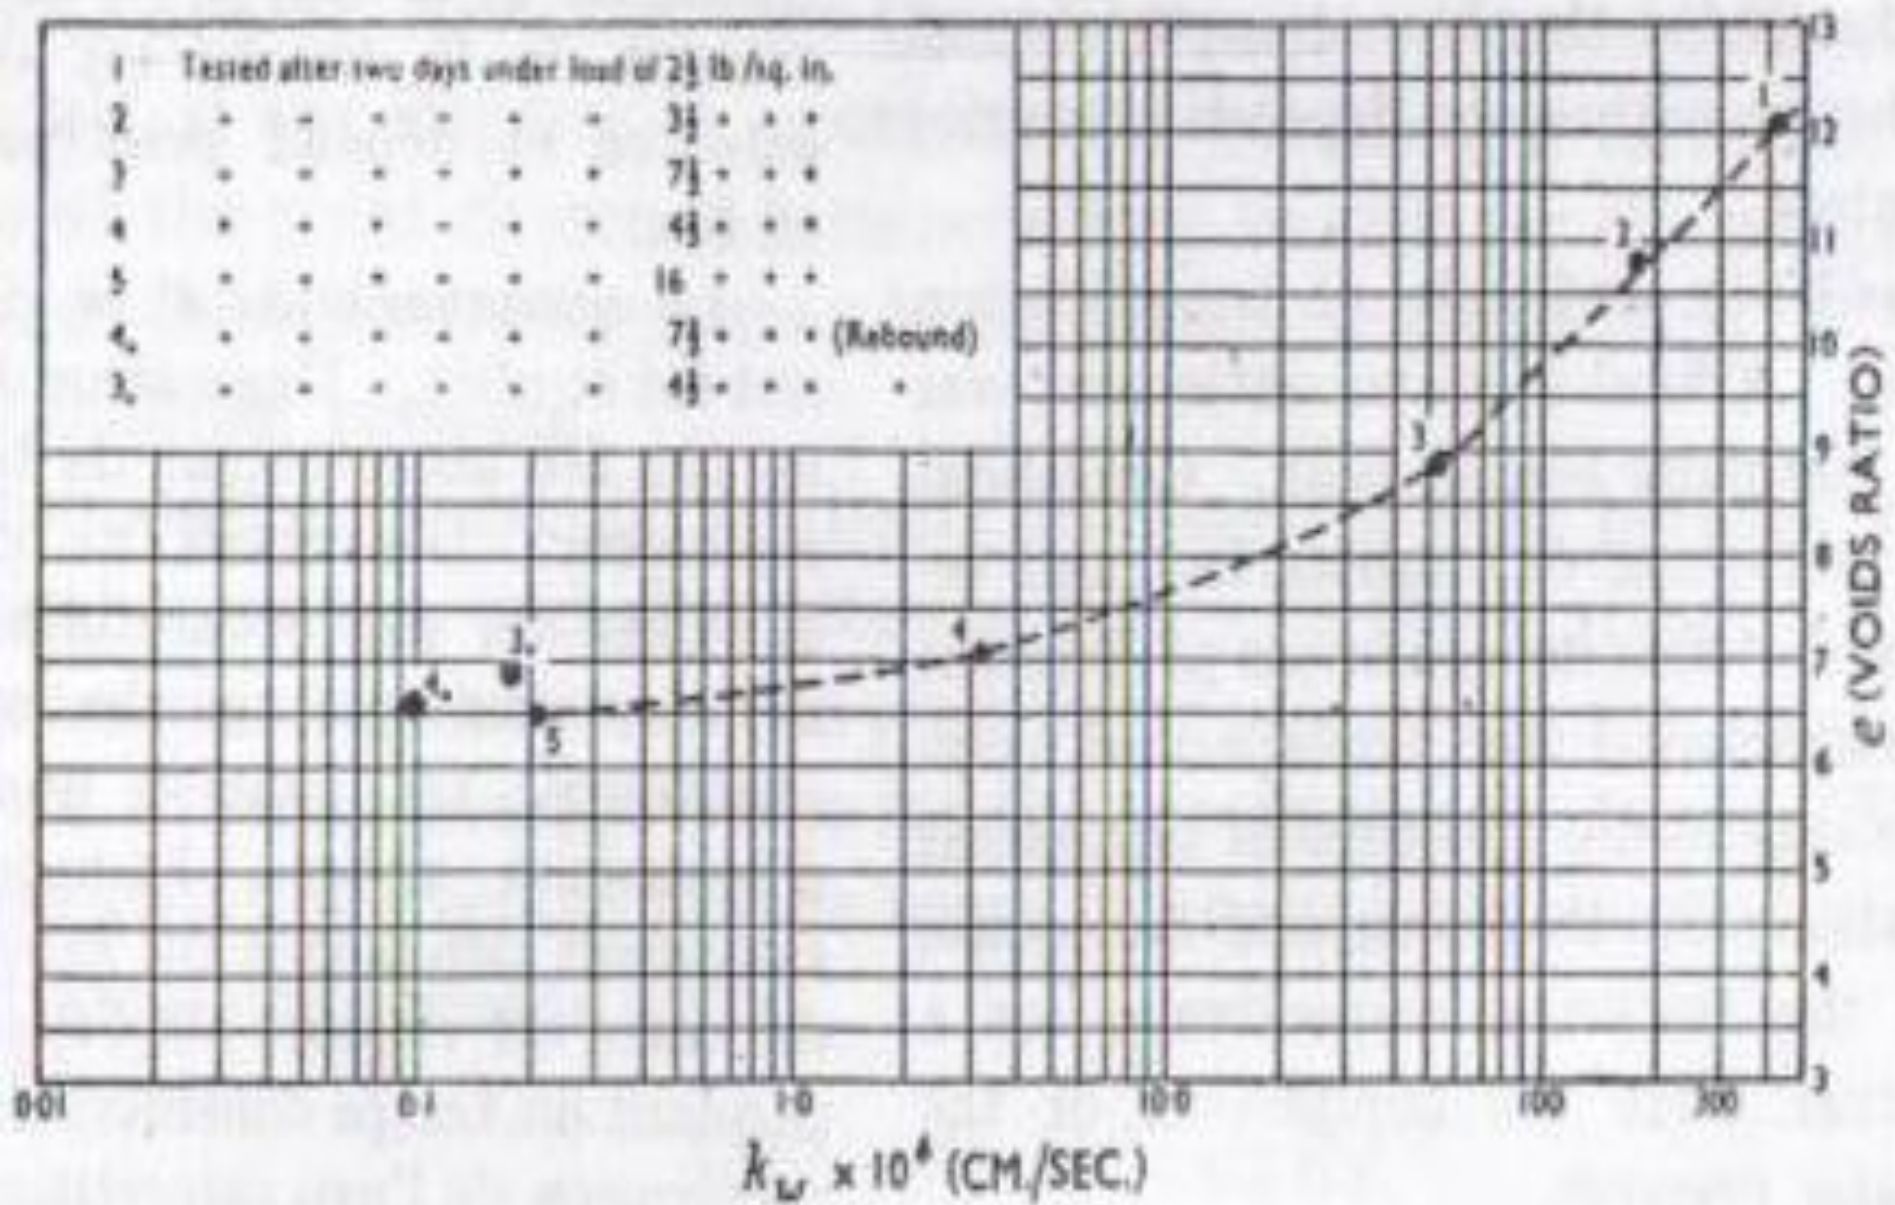
Permeability/voids ratio relationship (Hanrahan, 1954)

- Horizontal-to-vertical coefficient of permeability ratios in the range of 1.7 to 7.5(Hobbs, 1986).
- However, this ratio can be increased up to 300 after vertical loading due to horizontal alignment of the constituent fibres (Cuddy, 1988).
