**REPORT OF AN INVESTIGATION INTO
A MARINE CASUALTY INVOLVING
MULTIPLE ROWING VESSELS
IN OR AROUND SALMON WEIR,
RIVER CORRIB,
CO. GALWAY
14 JANUARY 2023**

**REPORT NO. MCIB/325
(No.4 OF 2024)**

- 1.4 The University of Galway Boat Club experienced this marine casualty event because of a combination of the following causal factors:
 - a. Unsuitable weather conditions.

- b. Unsuitable river conditions.
 - c. Inadequate trip planning.
 - d. Inadequate safety systems.
 - e. Unsuitable Rules of the River.
 - f. Unsuitable weir safety booms.

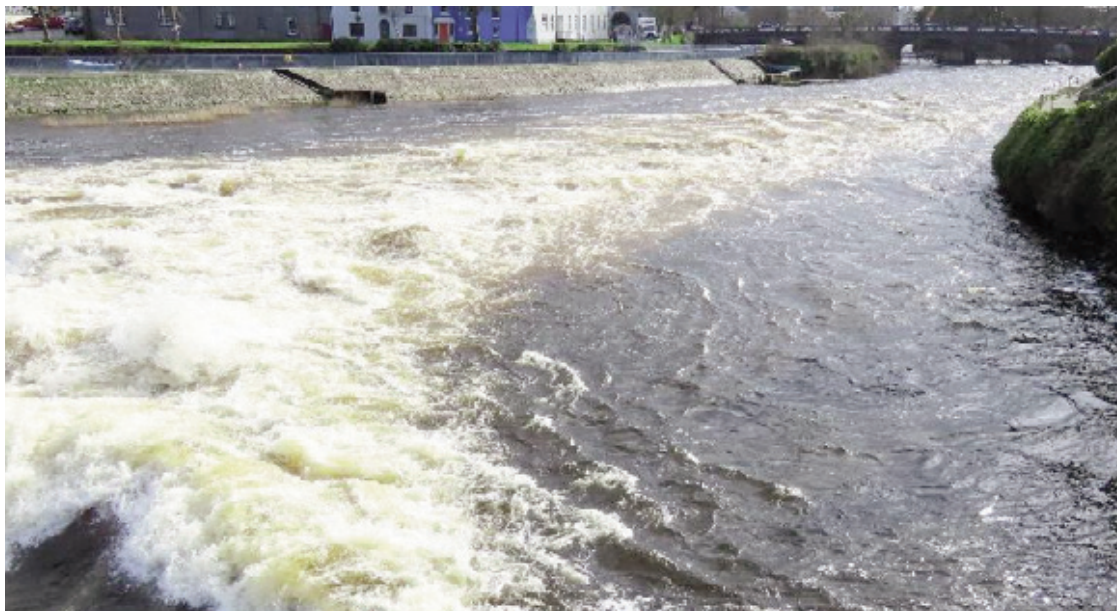
- 2.4.3 The weir presents a number of hazards for persons on or in the river, and for anyone attempting to rescue a person or object from the river. Downstream of the weir is fast flowing whitewater, with a riverbank that is difficult to access from shore or to egress from the river. See Figure 8.

Figure 8: The whitewater extending downstream from the weir. The Salmon Bridge is in the background, located 250 m downstream from weir.

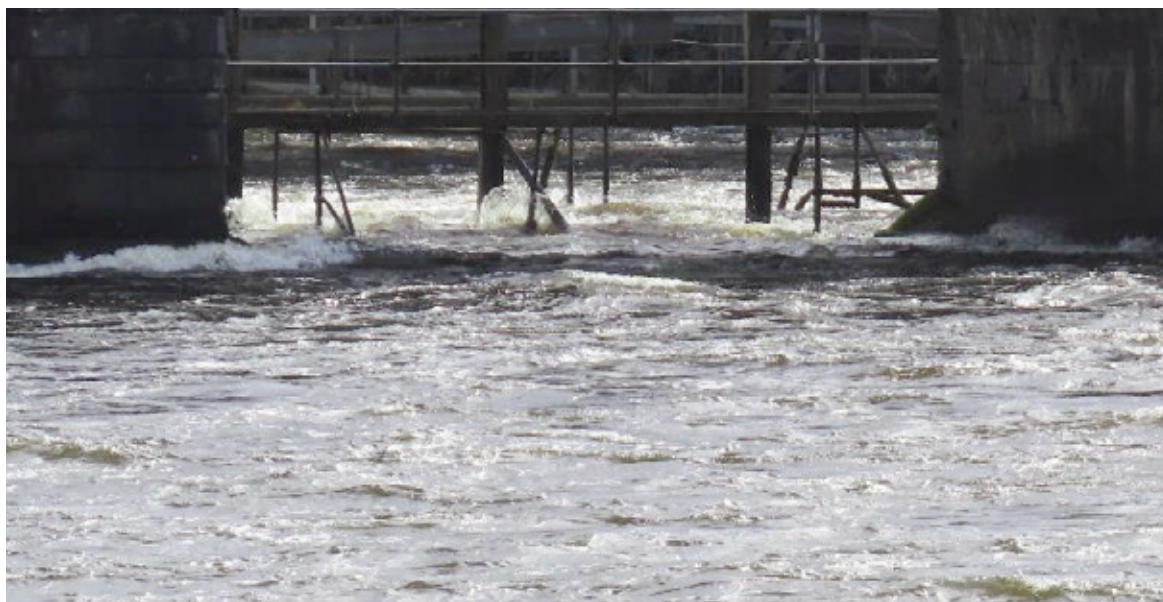
- 2.4.4 Located 250 m downstream of the weir (a float time of 97 seconds¹³ for a person in the water when the river is in spate) is a major hazard to either a person in need of rescue or the emergency services¹⁴ attempting a rescue, consisting of old steel boxes used to trap eels, which forms a man-made, near river-wide obstacle. See Figures 8 - 10. This severely limits the response that the emergency services can provide to an incident at or below the Salmon Weir.

Figure 9: The river-wide obstacle at the Salmon Bridge, viewed from upstream.

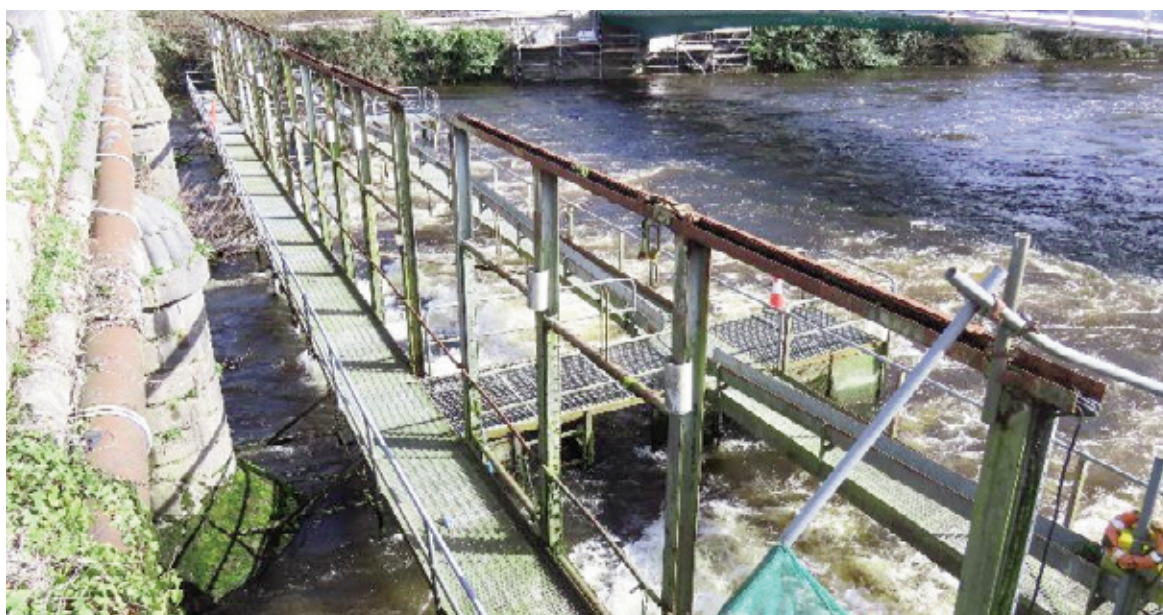
Figure 10: The river-wide obstacle at the Salmon Bridge, viewed from downstream.

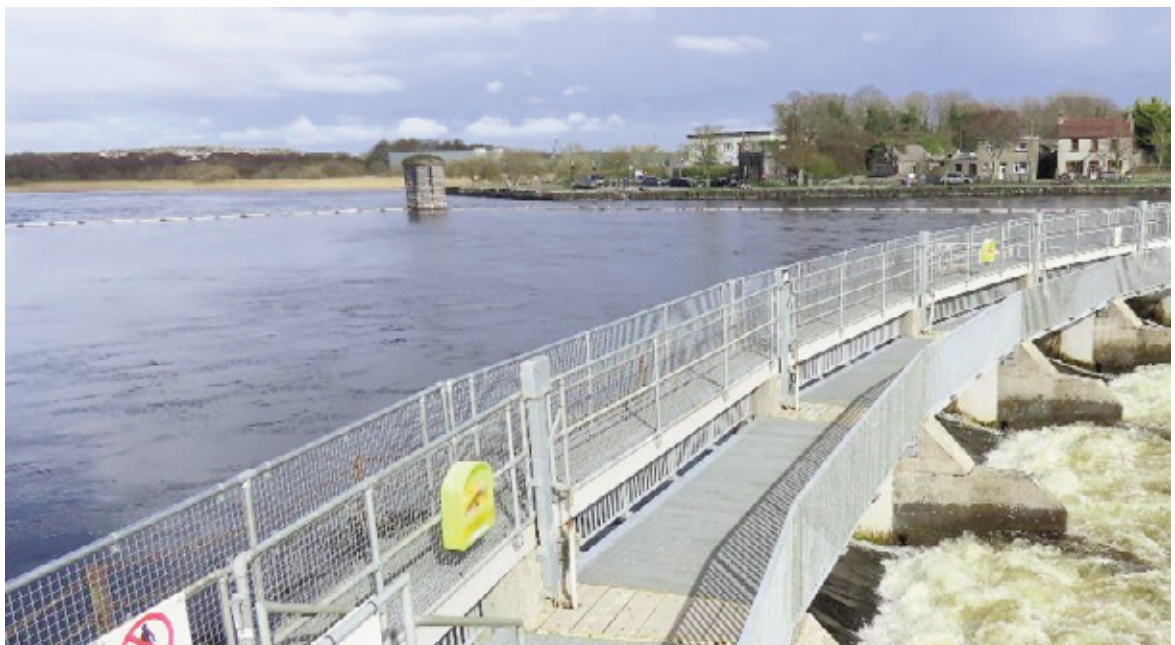
- 2.4.7 Located 100 m upstream of the weir is a river-wide safety boom formed from steel floats interlinked with steel chains. This had the effect of creating an area of enclosed water above the weir. See Figures 13 and 14.

Figure 13: The enclosed water, extending 100 m upstream from the weir.

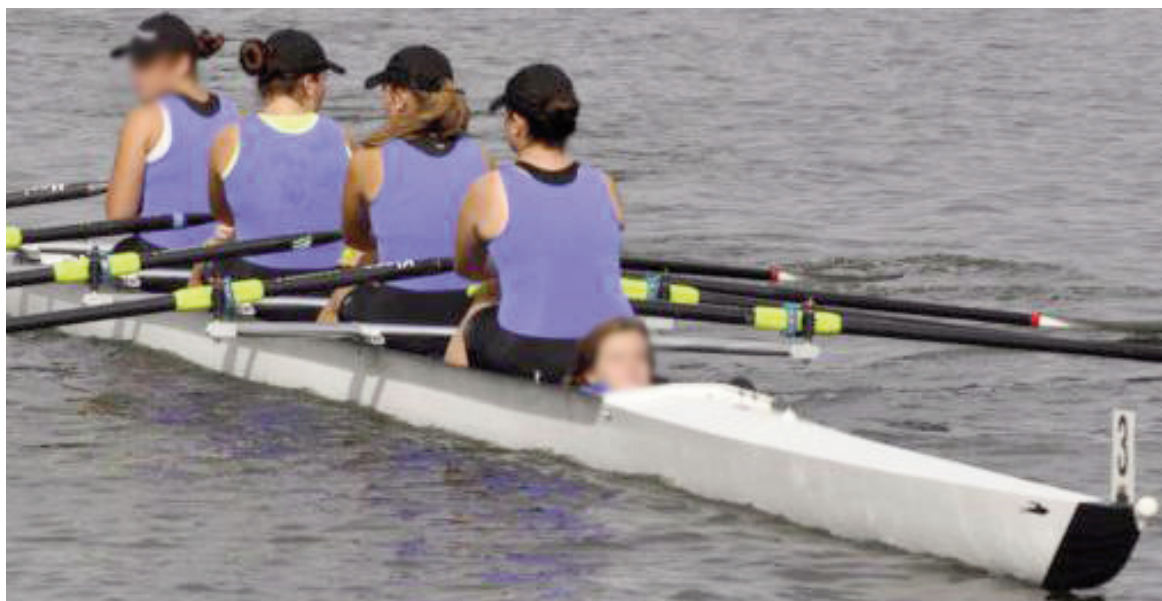
2.6.3 Boat 1 was a Coxed Quadruple (See example in Figure 19). This was a five-person vessel, comprising the coxswain seated near the bow and a crew of four rowers. The boat was configured for scull rowing; each of the rowers had two oars (one held in each hand).

Figure 19: Example of a Coxed Quadruple rowing boat, similar to Boat 1.
Photo Source: <https://rowing-shop.com/shop/equipment/swift/boats/boats-boats/swift-club-a-coxed-quadruple-scutt-rowing-boat/>

2.6.3 & 2.6.4 are incorrect descriptions of the boats involved and do not match with the pictures (Example in figure 19) and (Example in figure 20).

2.6.4 Should reflect the coxed quadruple shown in example figure 19 on page 23

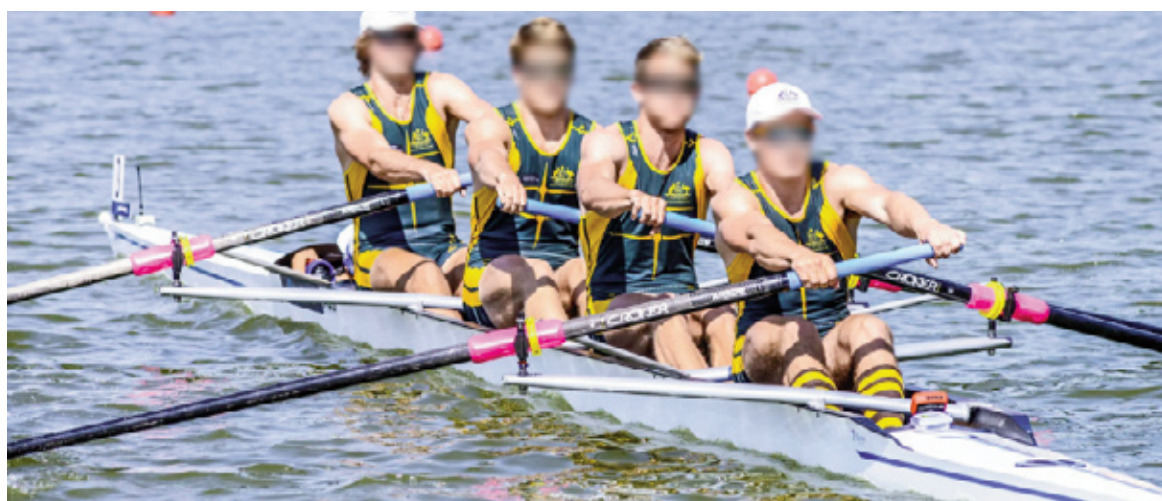
2.6.4 Boat 2 was a Coxed Four (See example in Figure 20). This was a five-person vessel, comprising the coxswain seated near the bow and a crew of four rowers. The boat was configured for sweep rowing; each of the rowers had one oar (held by both hands).

Figure 20: Example of a Coxed Four rowing boat, similar to Boat 2. Photo Source:
www.nauticexpo.com/prod/filippi/product-22350-230243.html

2.6.3 Should reflect the coxed four shown in example in figure 20, on page 23

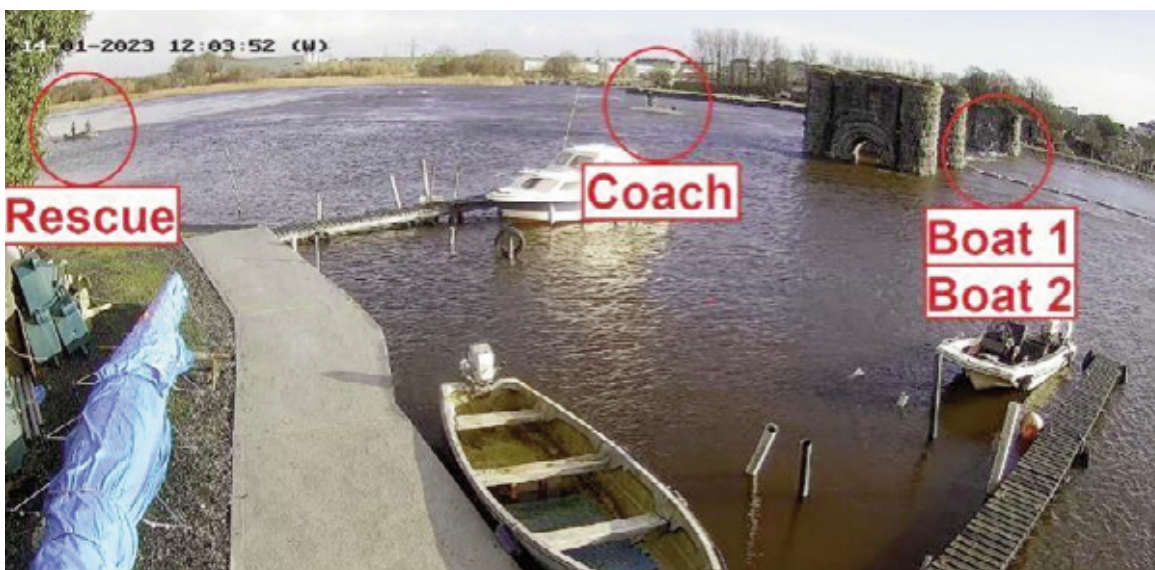
2.14.14 Time stamp 12:03:52 - A further 49 seconds has elapsed. Boat 1 and Boat 2 have allided with the safety booms. The coach's boat remains in a holding position upstream of the old railway piers. A launch boat containing two persons motors towards the scene from the direction of Coláiste Iognáid Rowing Club to start the process of removing crews to shore. The wind gusts continue. See Figure 34.

Figure 34: CCTV still image from time stamp 12:03:52. Source: CRYC

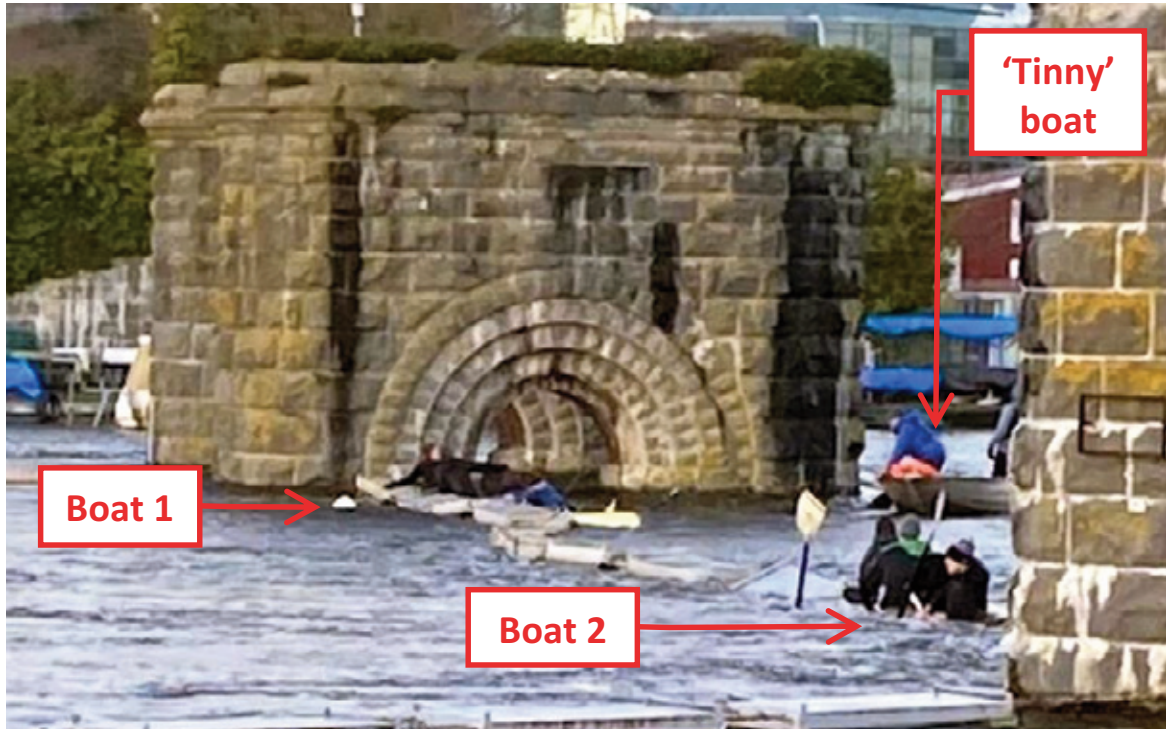
2.14.15 A member of the public on the east bank took a photo of the scene, showing the two rowing boats and their crews on and against the safety booms, while a coach's Tinny launch boat from another rowing club approaches them. See Figure 35.

Figure 35: Contemporaneous photo of the casualty event. Source: Connacht Tribune

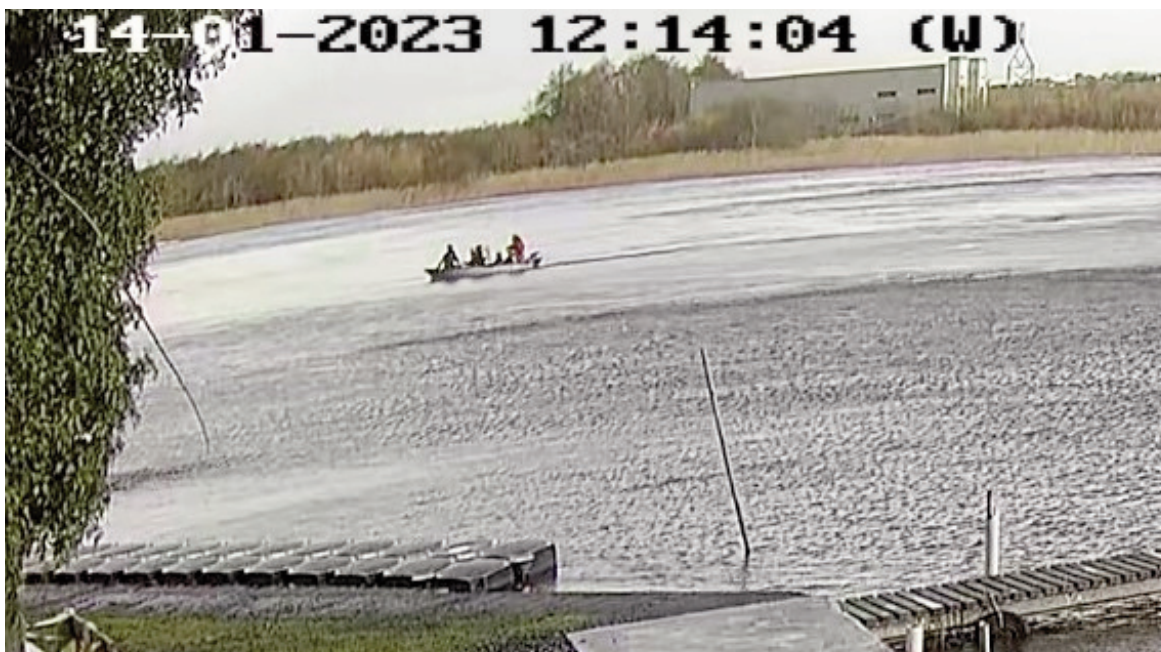
Figure 36: CCTV still image from time stamp 12:14:04. Source: CRYC

2.14.16 **Time stamp 12:14:04** - 12 minutes four seconds has elapsed. The coach's launch boat remains in a holding position upstream of the old railway piers. The wind gusts continue. The rescue of the crews by two Tinny launch boats continues, as they take some of the rescued crews towards Coláiste Iognáid Rowing Club. The coach's Tinny boat from the Coláiste Iognáid Rowing Club, containing the crew from the capsized Octuple, arrives from upstream along the east bank and motors across the river back towards their clubhouse. See Figure 36.

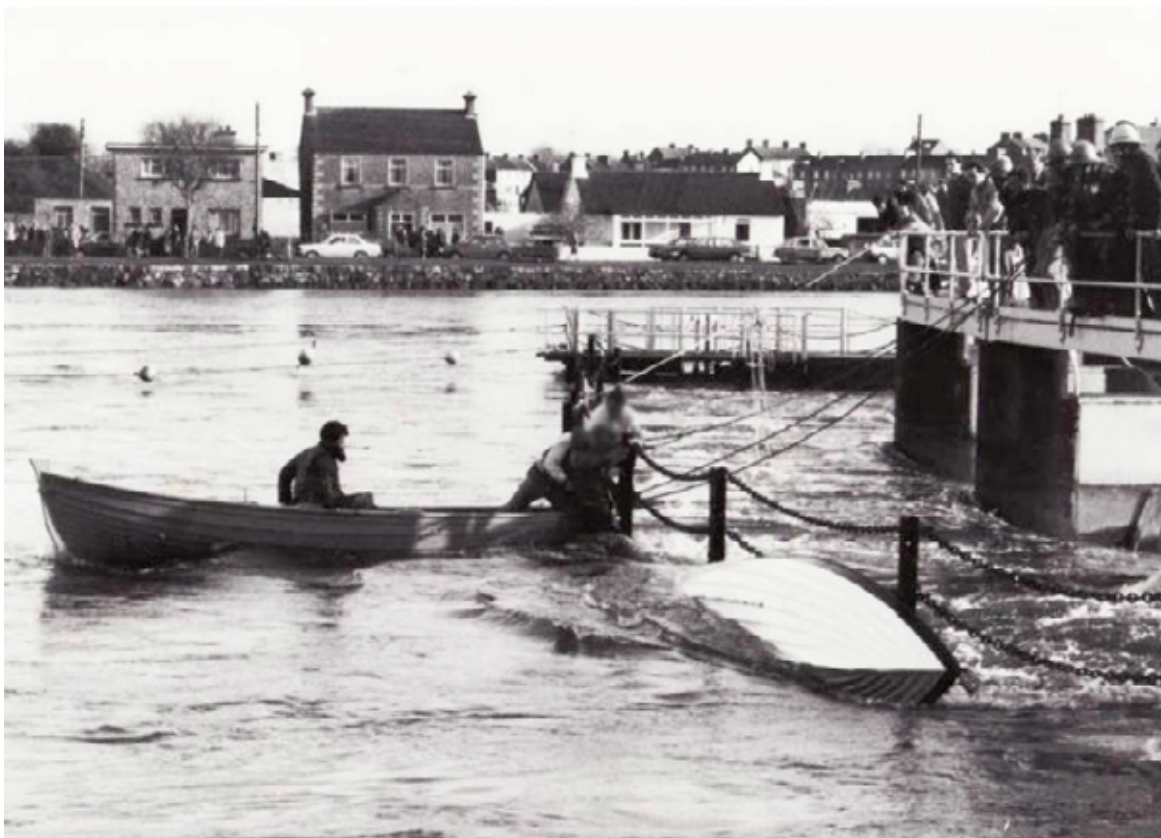
Figure 41: The November 1982 incident. Source: Rowing Ireland Connaught Branch

- 41 years ago, in November 1982³⁸, before the safety booms were in place above the weir, a rowing boat capsized in strong winds and high flow near the old railway pillars. The crew and boat drifted onto the safety chains immediately above the weir. See Figures 41 and 42. Two coach's boats that were effecting rescue then capsized, resulting in a total of 12 persons in the water. All were eventually saved after being rescued. This incident led to the installation of the safety booms that are currently in place above the weir.

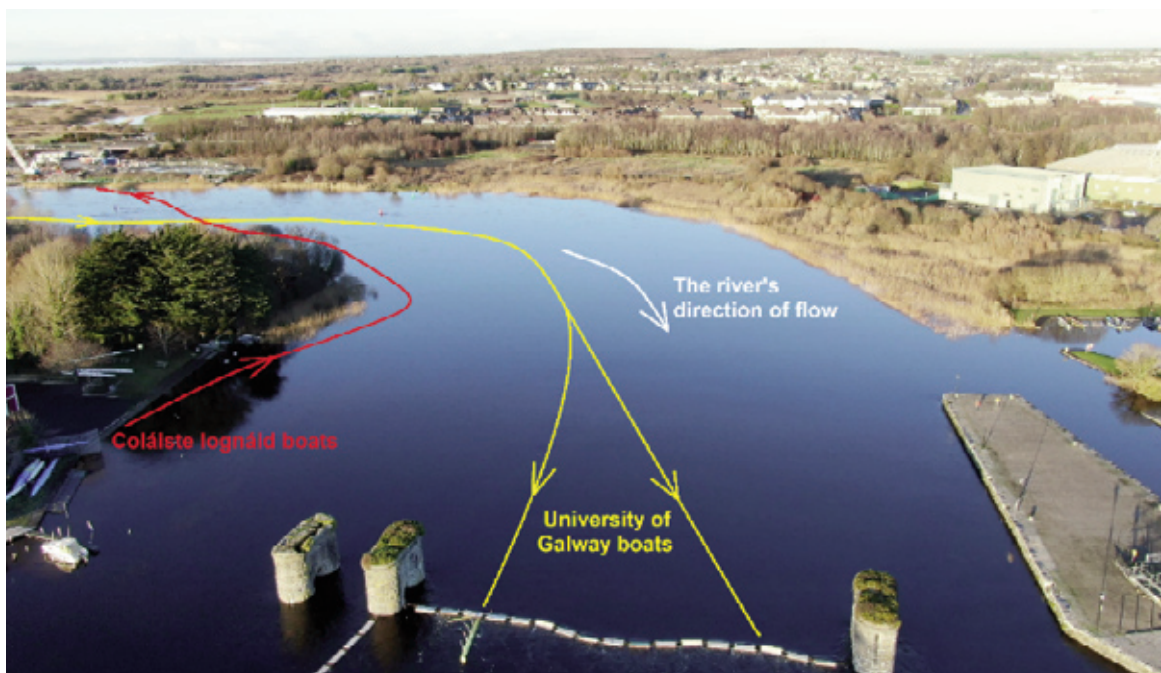
3.1.8 After the boats from the two rowing clubs had passed by one another, they all found themselves out in the river's main flow, away from the river's west bank and its relative shelter from the near-gale force wind that was blowing from the west. Their respective routes are likely to have been similar to what is illustrated in Figure 43.

Figure 43: Illustration of the approximate courses followed by the various boats. Source: MCIB Investigation. Image Source: Galway Aerial Cinematography

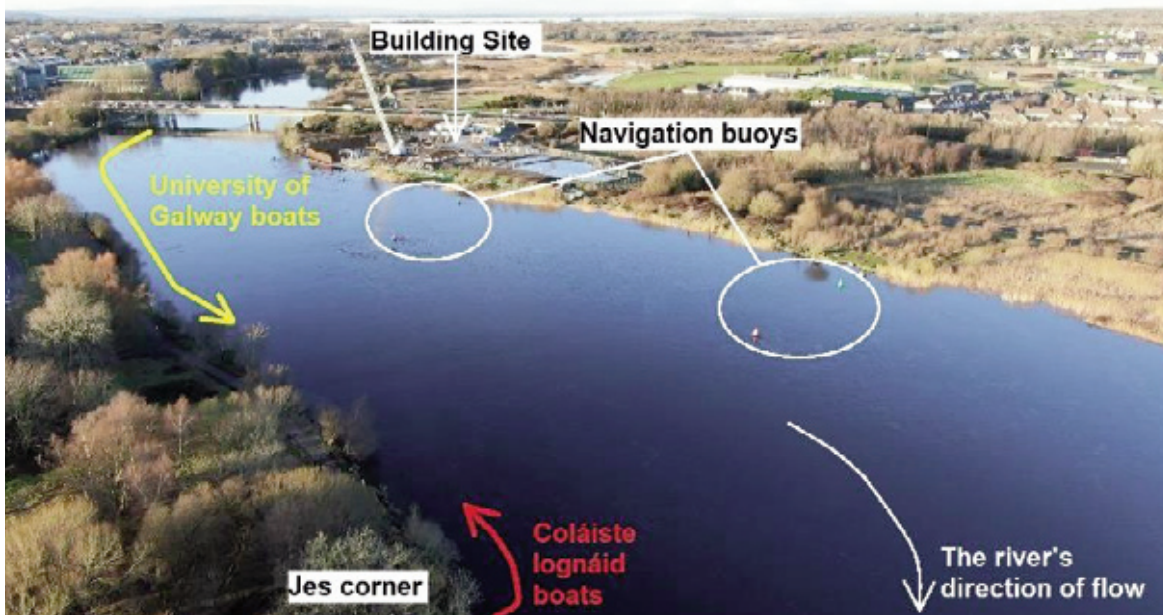
- 3.2.10 The coach first saw the boats of another rowing club up ahead after he and his crew had rounded the Jes corner. He saw two rowing boats and a coach's launch boat up ahead along the straight part of the river. See Figure 44.

Figure 44: Illustration of the approximate positions and courses of the boats from the two rowing clubs when they were first observed by each other, as described by the Coláiste Iognáid Rowing Club's coach. Source: MCIB Investigation. Image Source: Galway Aerial Cinematography

- 4.6.4 There are navigation buoys in the immediate vicinity of the location of events that were a factor in this marine incident (see Figure 44). The navigation buoys are immediately upstream of the river's Jes corner that was a significant factor in the actions and outcome for the vessels involved in this marine incident. It is the understanding of the MCIB based on evidence obtained during this investigation, that these navigation buoys were installed by the Lough Corrib Navigation Trustees because silt deposits had created a potential hazard for vessels navigating the river. The navigation buoys have the effect of reducing the likelihood of vessels experiencing this hazard. The navigation buoys may have reduced the risk associated with this hazard for certain (larger) vessels but the effects of the silting likely remain a factor for other (smaller) vessels, including the silting's effect on the river's speed and potentially also currents.

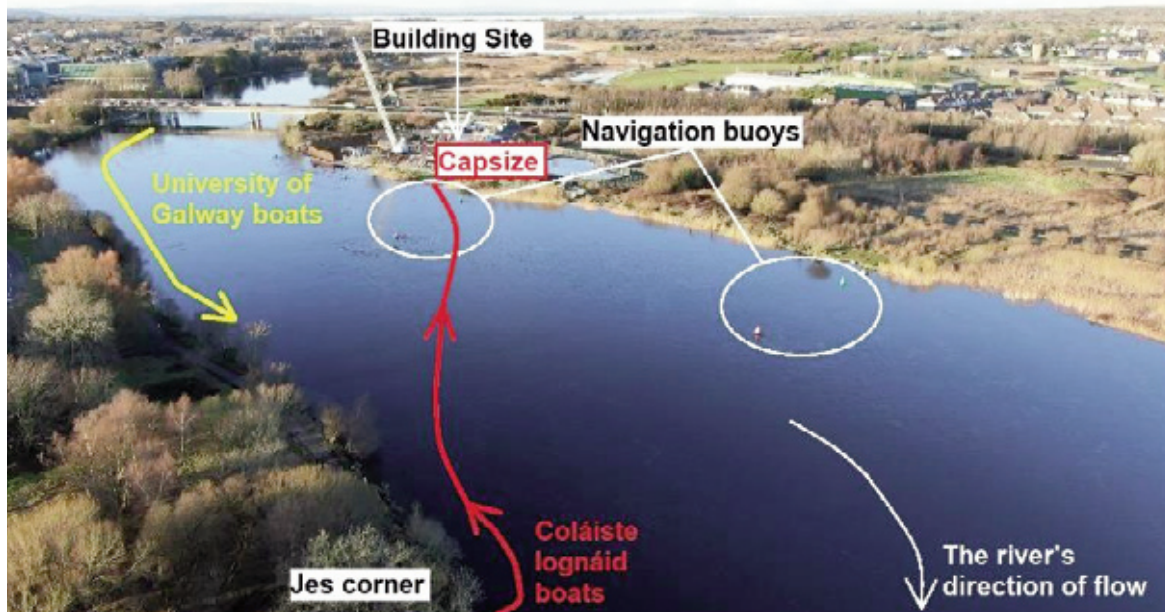
- 3.2.15 They made some further progress up the river along the east bank but they capsized in the reeds during wind gusts. The capsized occurred at a position between the navigation buoys and the building site. See Figure 45.

Figure 45: The course taken by the boats from Coláiste Iognáid Rowing Club, as described by their coach. Source: MCIB Investigation. Image Source: Galway Aerial Cinematography
